## Marine Occurrence Report

### Uncontrolled Fall of a Lifeboat

on the General Cargo "IRAN SALAM"  
Port of Montreal, Quebec  
29 November 1993

Report Number M93L0006

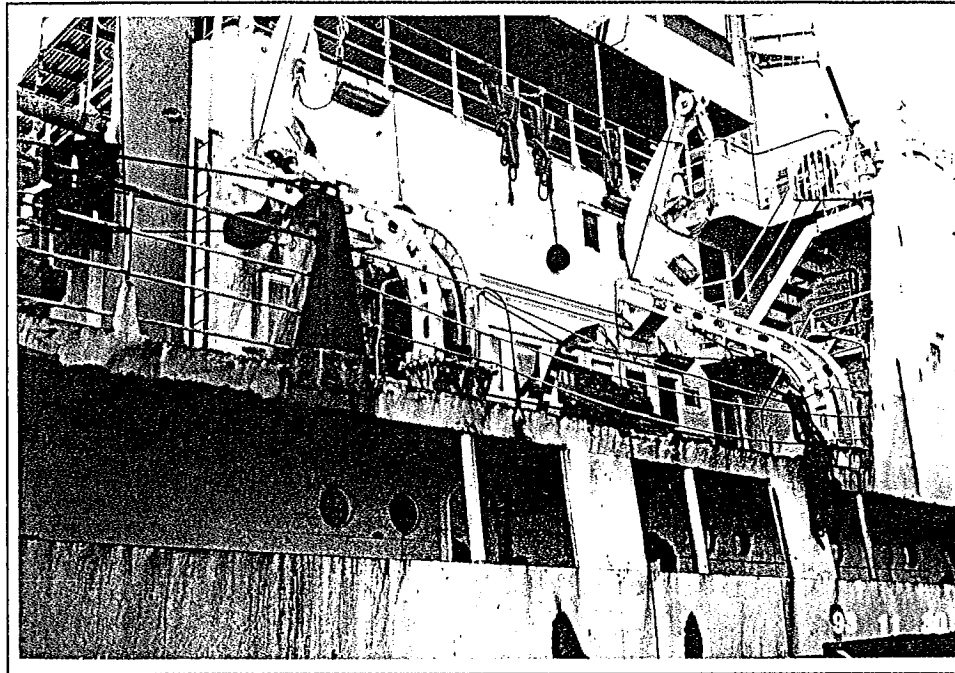
Starboard davit as seen from the wharf.

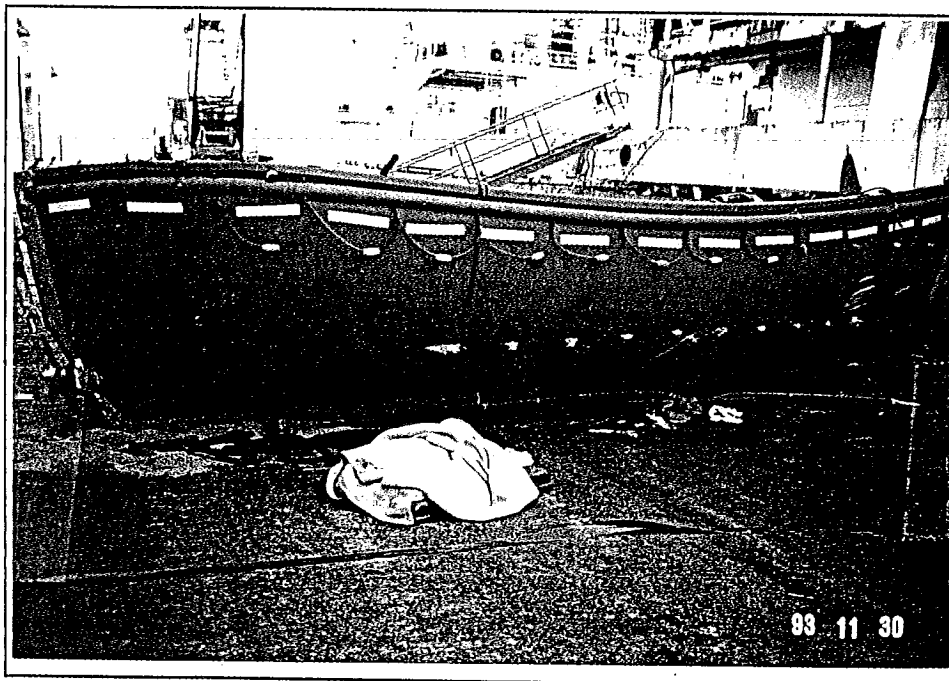
Starboard side of the lifeboat.

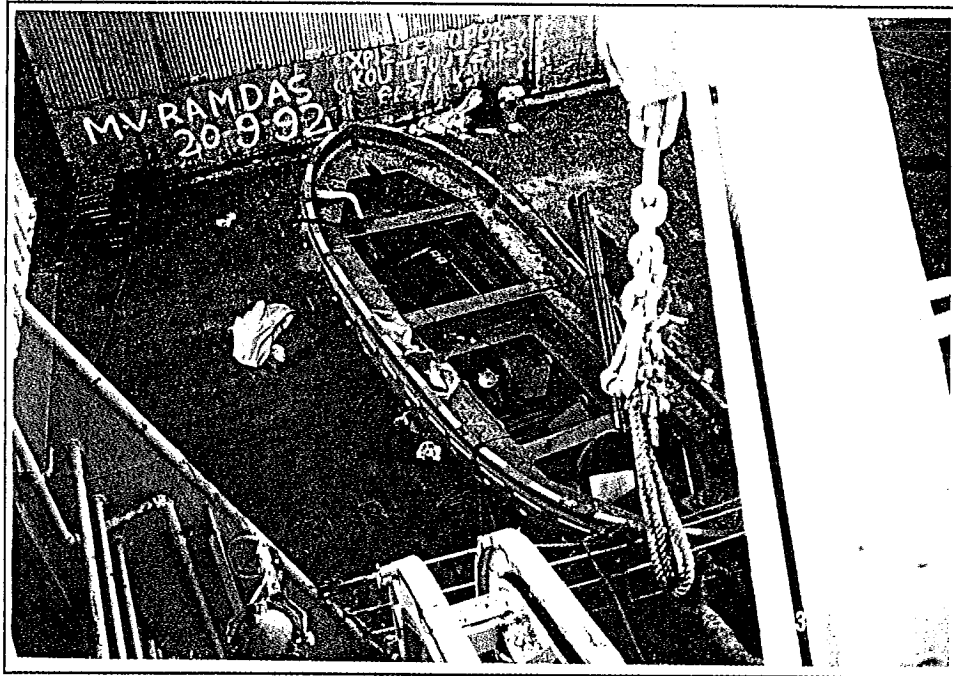
The starboard lifeboat sustained considerable damage when it crashed on to the wharf. The propeller and propeller shaft were bent in the impact, pieces of fibreglass broke off in some places, and the grab rails along the outside of the hull failed. The lifeboat was repaired and put back in service before the "IRAN SALAM" departed.

Lifeboat on the wharf.

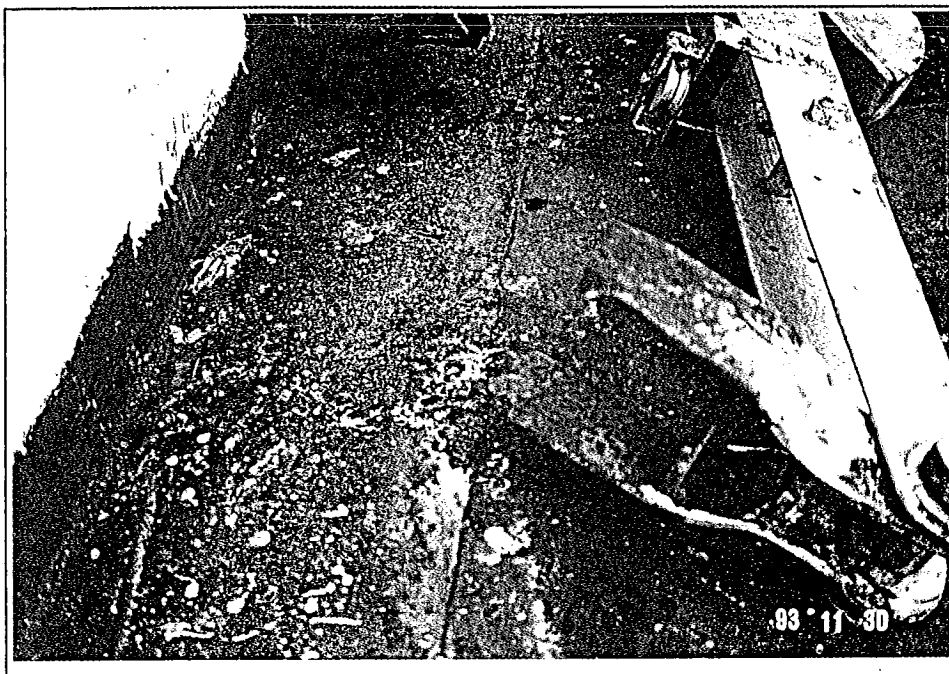
The lifting hook connections on the starboard lifeboat were in an advanced state of corrosion, especially the connection of the after lifting hook which had deteriorated further than the forward connection.

Analysis of the connection metal plates indicated that, in way of the point of failure, the two plates comprising the after connection were 1.03 mm and 1.12 mm thick, respectively, and those comprising the forward connection were 1.48 mm and 1.84 mm thick, respectively. These metal plates are normally 0.952 cm thick. The failure of the forward and after connections occurred 7.62 cm from the lifting hook base plate. In addition, discoloration was observed on the inside surface of the lifeboat, indicating an accumulation of water in the bilges, which could have contributed to the corrosion at the base of the connections.

It was determined that the forward connection was as much as 88 to 89 per cent deteriorated, and the after connection was deteriorated as much as 90 to 94 per cent. Such a considerable deterioration only could have developed over a period of several years. In addition, a post-occurrence examination of the connections revealed that the fractures were not fresh over their full width.

However, the analysis of the sequence of events confirms that the after lifting hook connection was capable of supporting only a light load because of its advanced state of corrosion, which greatly exceeded safety standards.

Connection of the after lifting hook of the lifeboat.

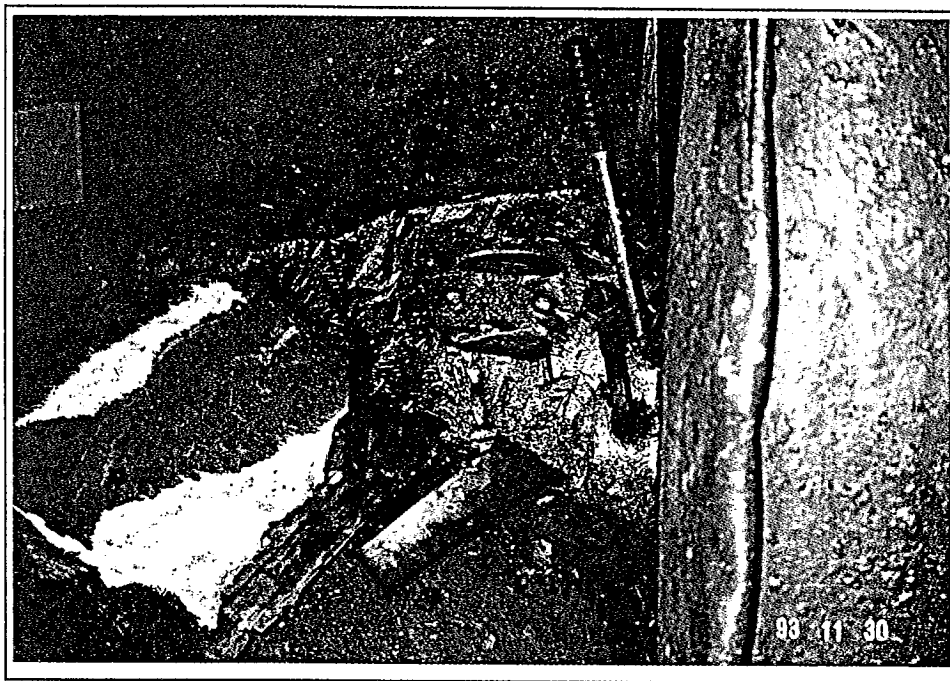
Lower end of the connection of the forward lifting hook of the lifeboat.

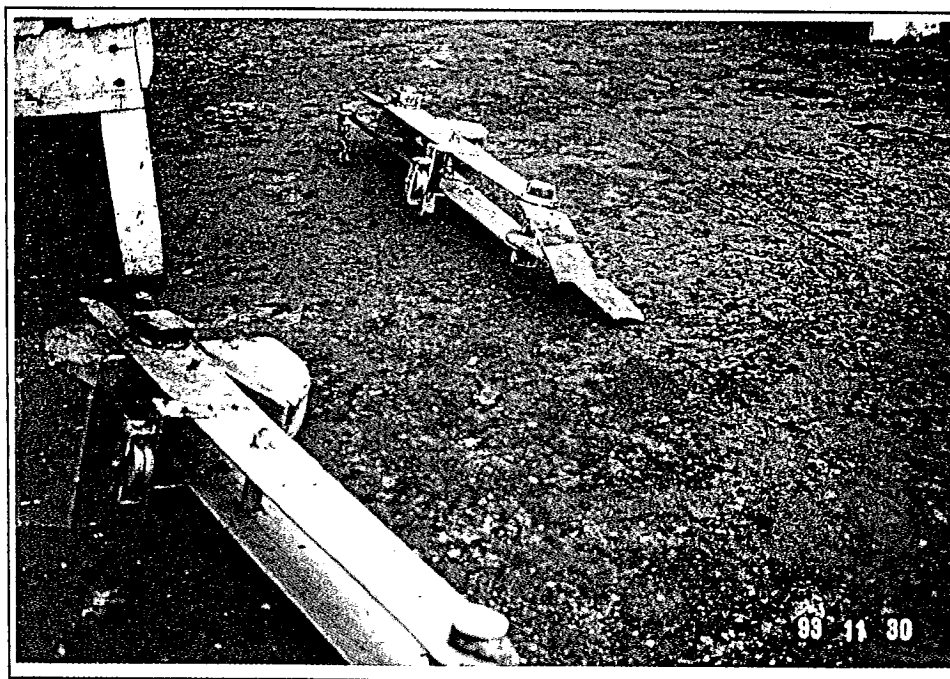
Connection of the forward lifting hook of the lifeboat.
