## Marine Occurrence Report

### Sinking

of the Small Fishing Vessel "JU JU"  
Queen's Sound, British Columbia  
19 March 1993

Report Number M93W0003

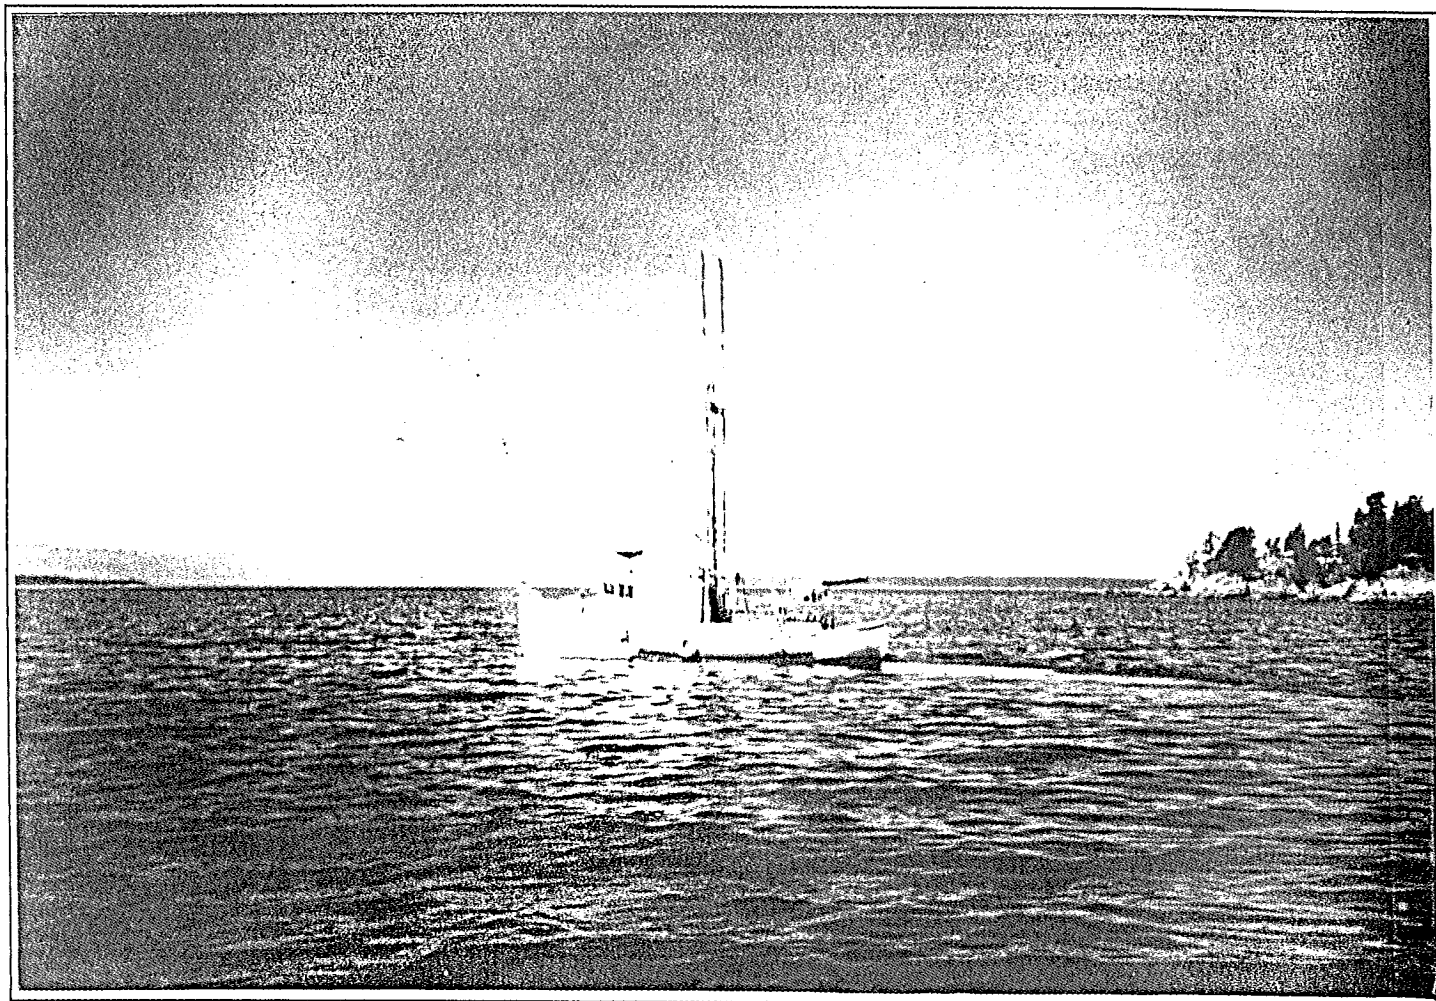
The only available photograph of the "JU JU" reveals that the vessel was provided with freeing ports for clearing shipped water from the main deck.

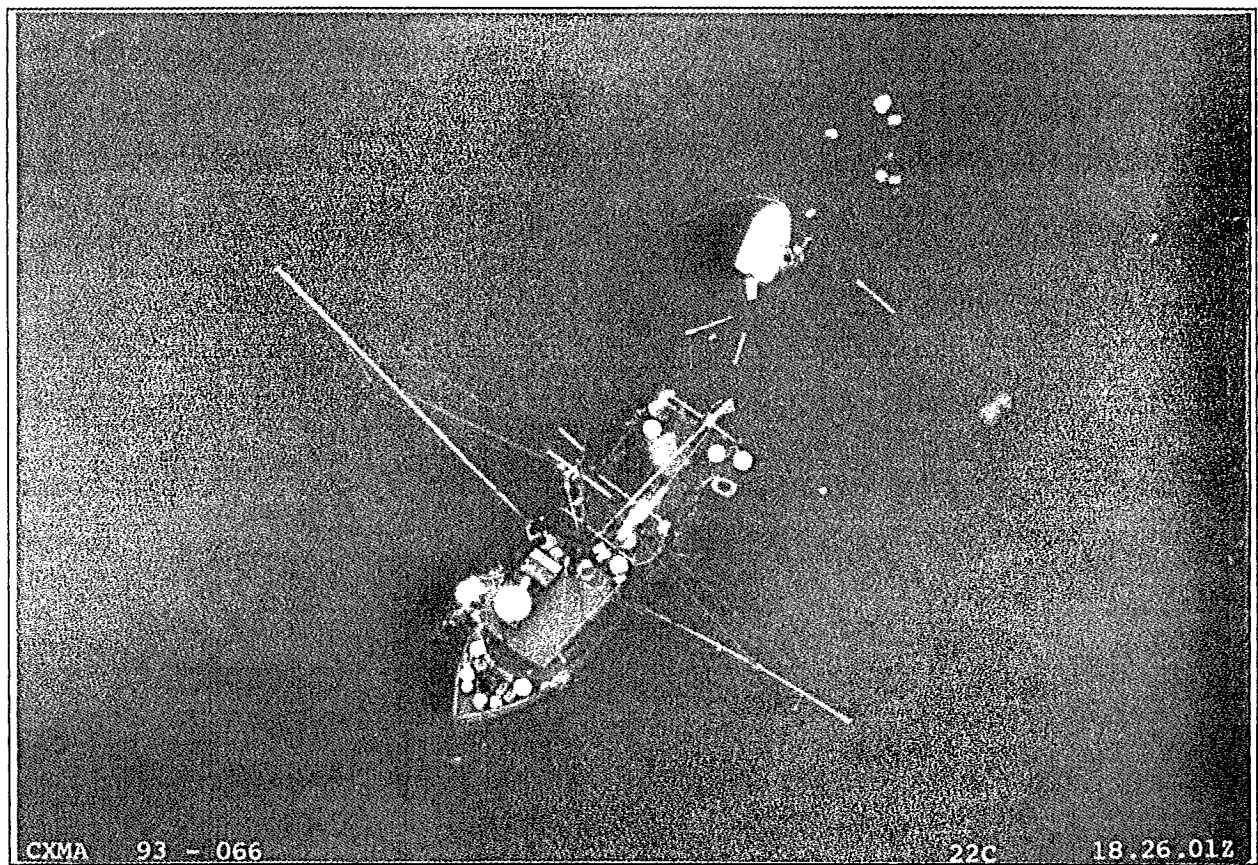
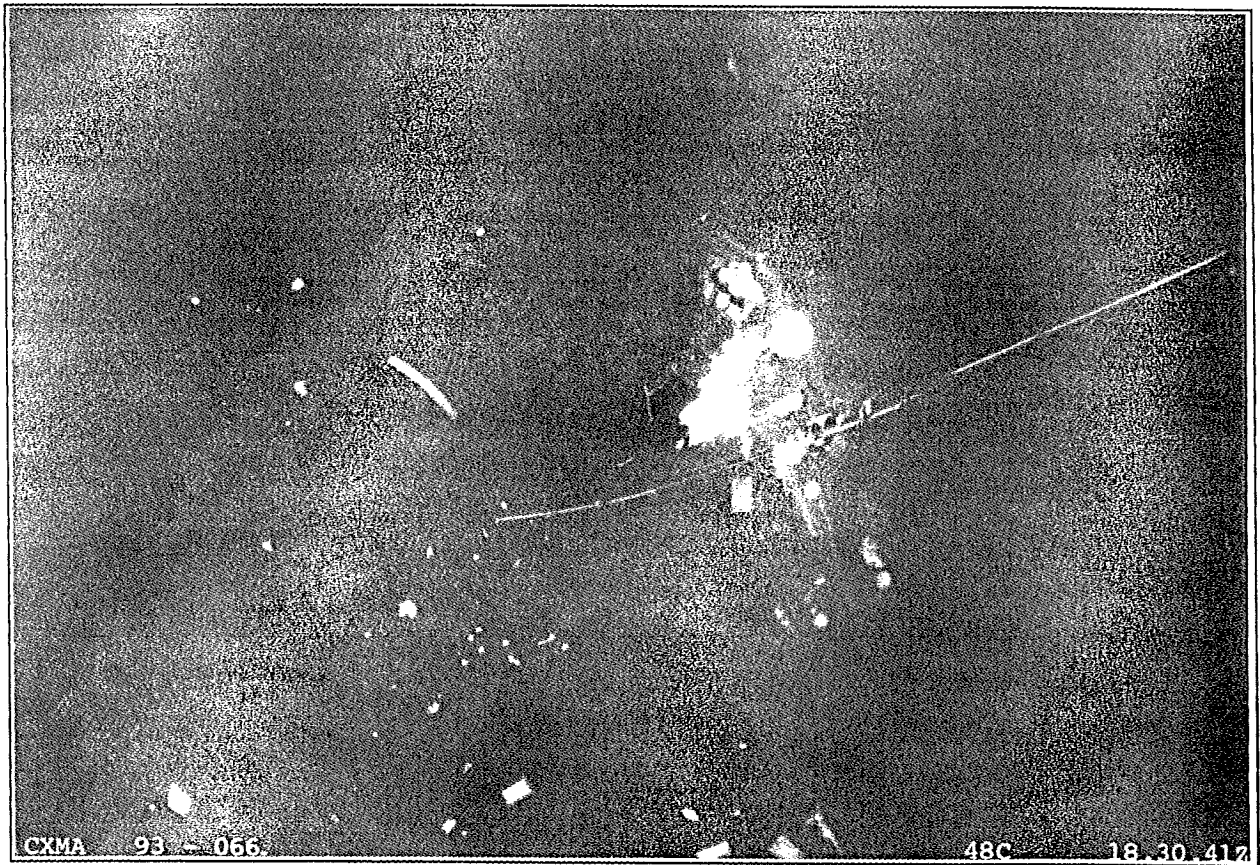
Aerial photographs that the R105 took of the "JU JU" sinking were sent to the TSB Engineering Laboratory for imagery analysis. This analysis confirmed that the fish hold hatch cover was in place at the time of sinking.

Aerial photographs taken at the time of the sinking.

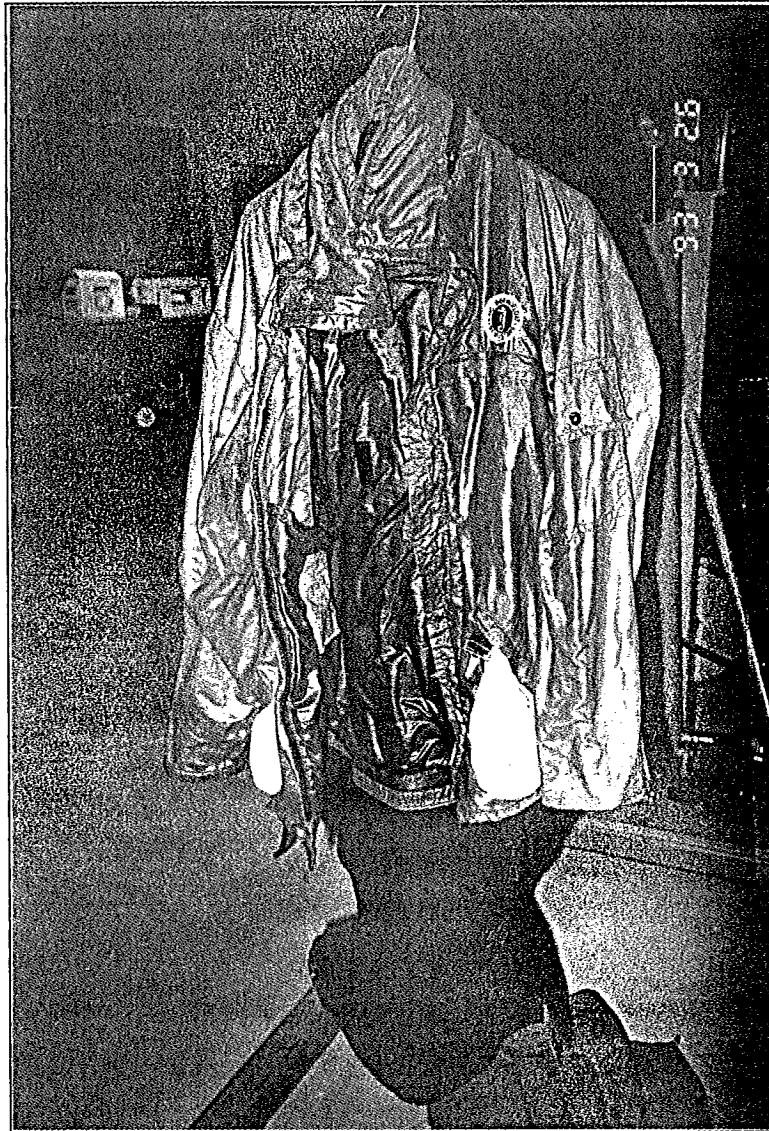
The deceased wore an orange-coloured floater jacket, complete with attached crotch piece. The jacket was a CCG-approved Type 1 personal flotation device (PFD), and it conformed to Canadian Government Specifications Board (CGSB) Standard 65-GP-11. The jacket was of a type that provides flotation for the wearer without turning the wearer face down in the water. The jacket was also designed to afford the wearer some protection against hypothermia. It had been used for some time as a work jacket but was in good condition. The victim was not a strong swimmer, and he reportedly succumbed to the cold shortly after entering the water.

Personal flotation device (PFD)  
worn by the victim.

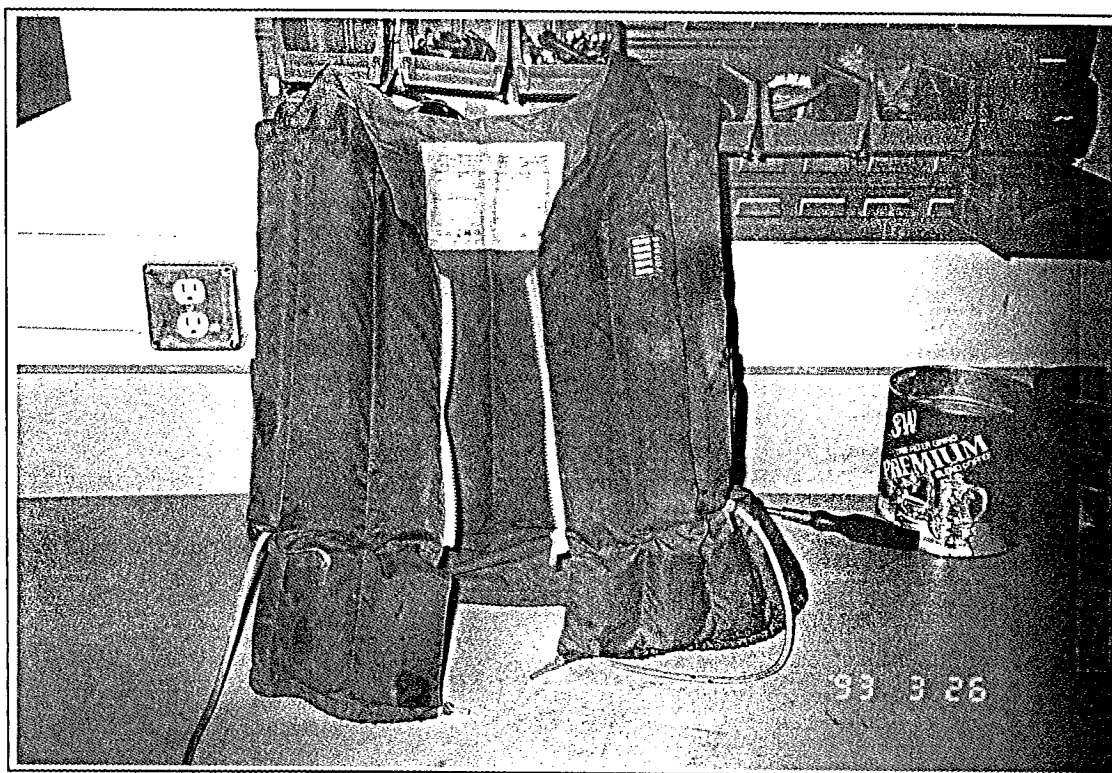
The surviving deck-hand wore an orange-coloured life-vest that was CCG-approved for canoeing. He is a strong swimmer and is familiar with survival techniques.

The life-vest worn by the surviving deck-hand was not a PFD that was approved for the purpose for which it was being used. Regulations require that a properly approved standard lifejacket be carried for each crew member.

Canoeing life-vest worn by the surviving deck-hand.
