Marine Occurrence Report

Multiple Capsizings

Group of Chartered Sea Kayaks
Laskeek Bay, Queen Charlotte Islands,
British Columbia
30 July 1993

Report Number M93W0008

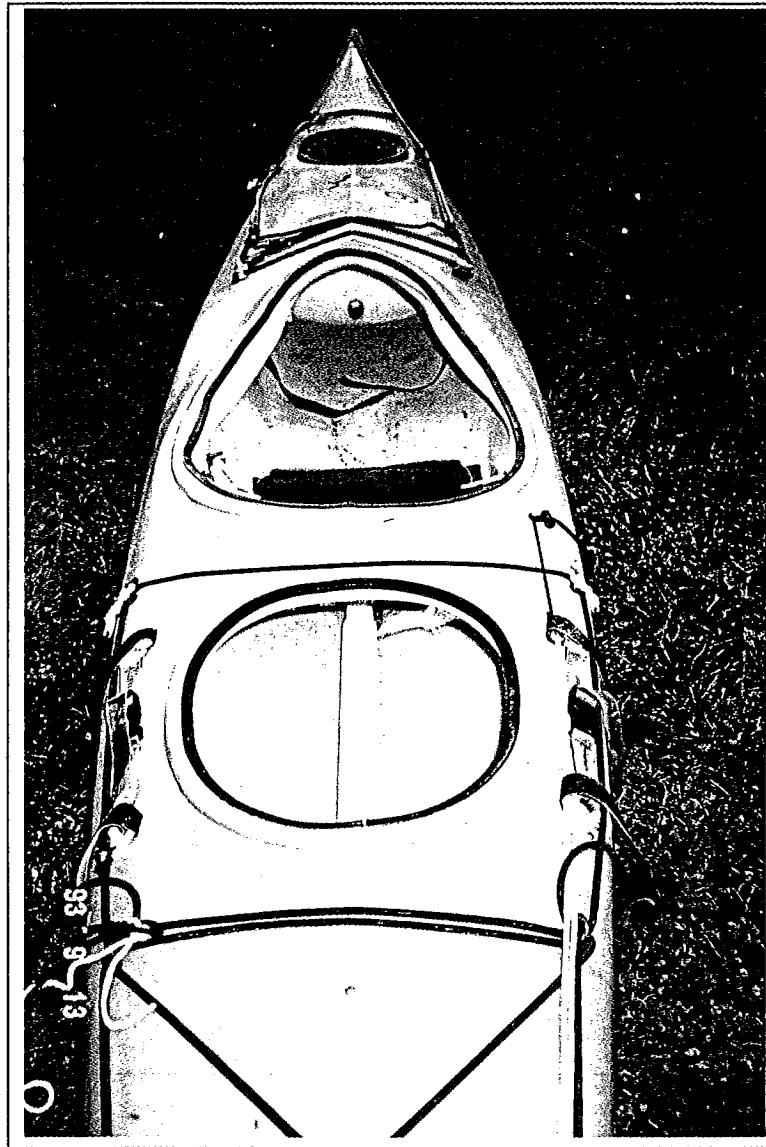
Type C Kayak

Type C is a single-seat sea kayak, 5.0 m in length and 0.603 m in breadth. It is made of cross-linked polyethylene. The one-piece hull is constructed in a heated mould. In this particular design, bulkheads are replaced by a permanently installed rigid sea-sock or pod. Such an installation reduces the size of the cockpit. There is a pumping arrangement for the pod but not for the hull compartment.

The polyethylene single-seat kayak which sank was later recovered. As the forward and after watertight hatch covers were still intact, it appeared that downflooding had occurred through the pod seal. There was no damage to the other kayaks.

The capsizing and downflooding of the second kayak are probably attributable to the fact that the U-shaped outer pod seal had been pulled off the coaming probably as the occupant exited the pod when the kayak capsized. It could not be determined if the inner seal was defective because the owner later replaced both seals. These replacements cured the leak but it is unknown which replacement cured the problem.
