MARINE OCCURRENCE REPORT

M95N0053

STRIKING AND SINKING

TUG "SEA ALERT"
NEAR NAIN, LABRADOR
01 NOVEMBER 1995

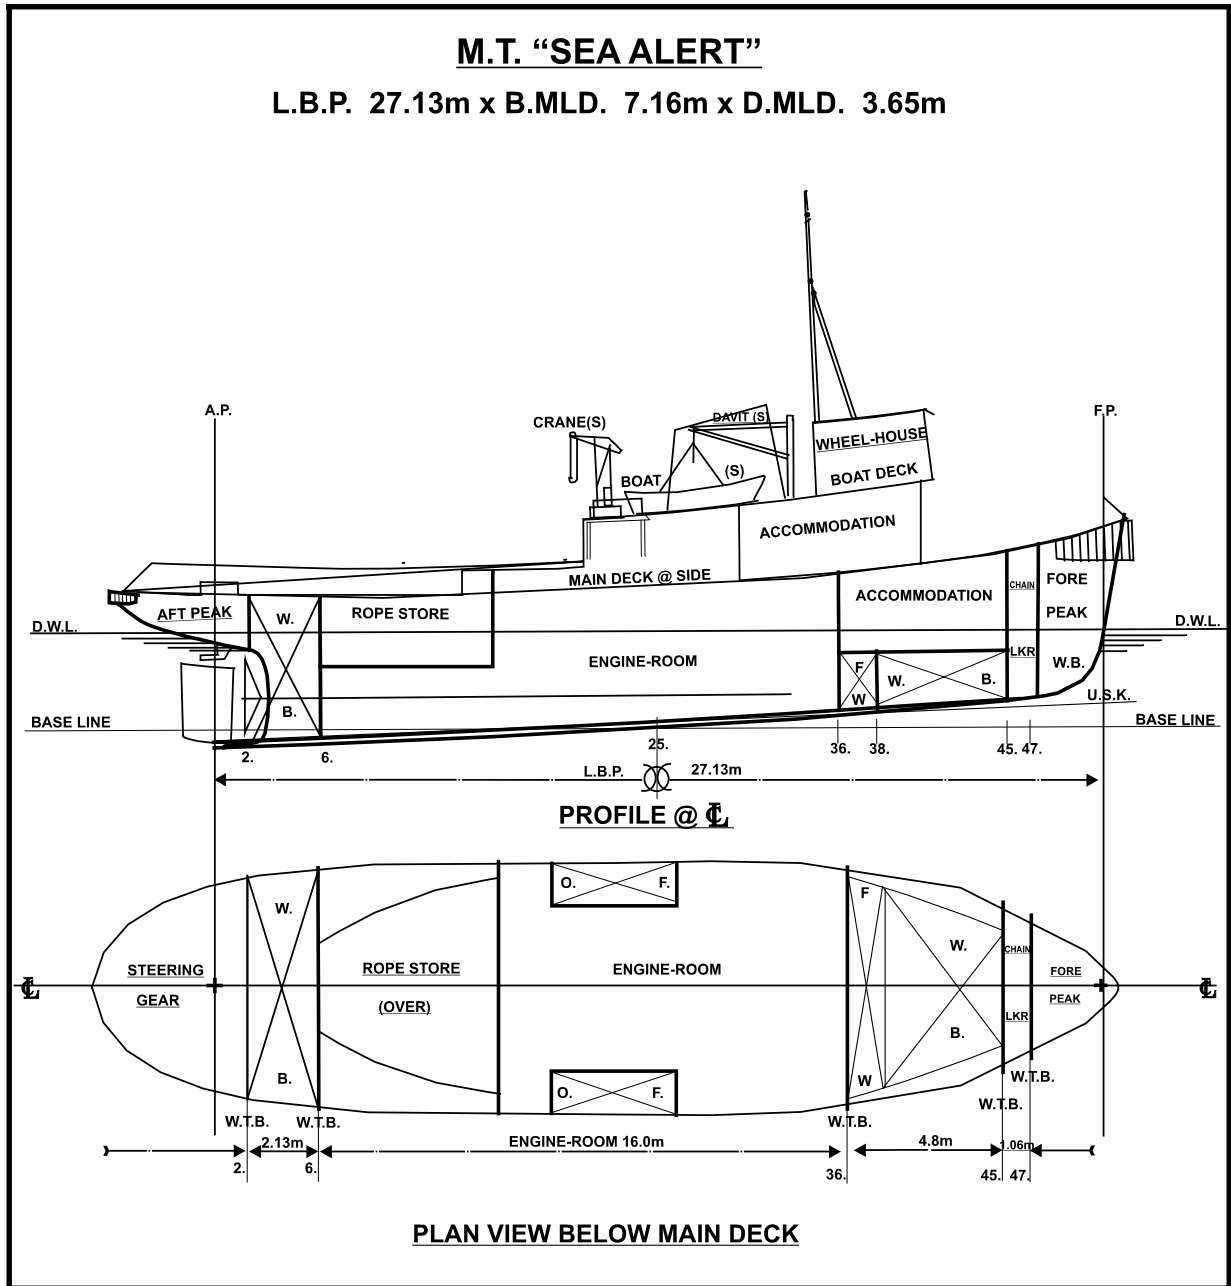
Appendix A - Outline General Arrangement

The tugboat was of all-welded single-shell steel construction, with a round bilge hull form. The hull below the main deck was subdivided by five transverse watertight bulkheads, such that the engine-room extended over approximately 60 per cent of the vessel's length (see Appendix A). The engine was operable from the wheel-house.

The engine-room of the "SEA ALERT" extended over nearly 60 per cent of her length, and post-casualty calculations based on the reported departure loading condition show that uncontrolled flooding of this compartment would have caused the vessel to settle and trim by the stern, downflood, lose reserve buoyancy, and sink stern first.

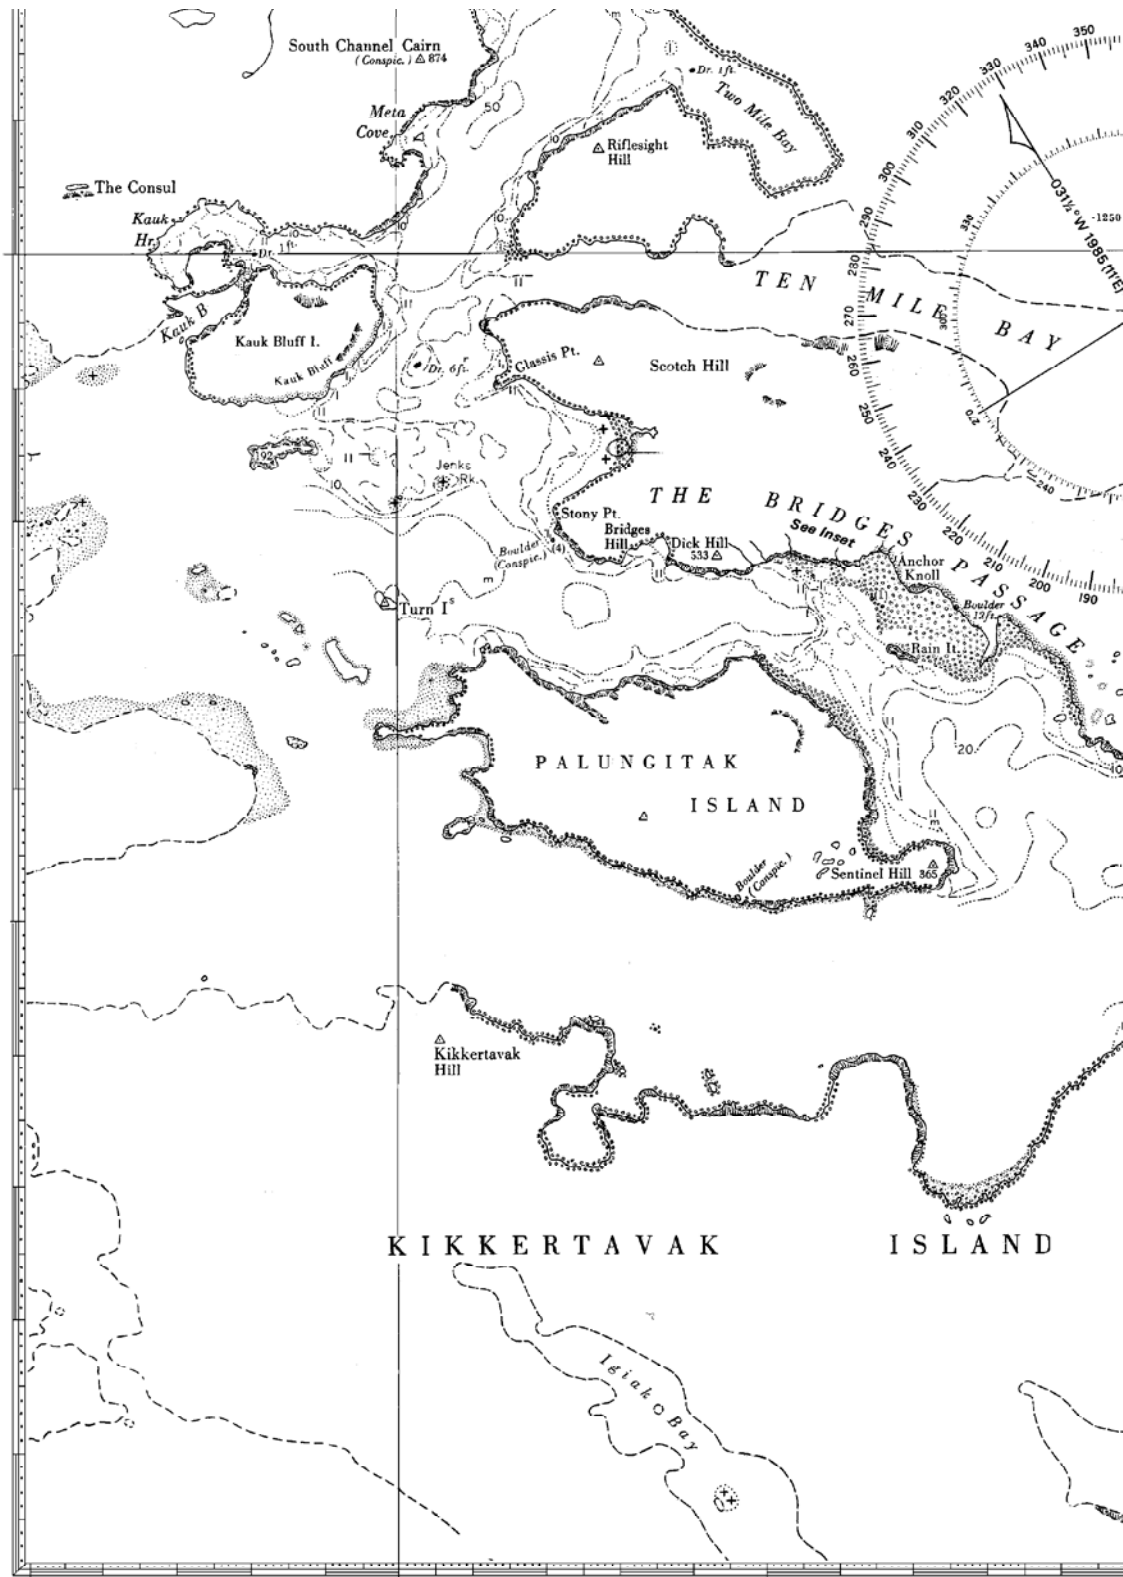
Appendix B - Sketch of the Occurrence Area

Dangers. — A large shoal area charted 0.7 to 1.2 miles north of Turn Island has a rock 8 feet (2.4 m) high near its south extremity. Jenks Rock, with 2 feet (0.6 m) over it lies 0.4 mile ENE of this rock.

The route taken on this occasion was reportedly different from the route usually taken when towing. It was slightly shorter and took the vessel to the east of Jenks Rock, whereas the usual course would have taken the vessel to the westward.
