MARINE OCCURRENCE REPORT

M96W0187

NEAR-COLLISION

DISCOVERY PASSAGE, BRITISH COLUMBIA

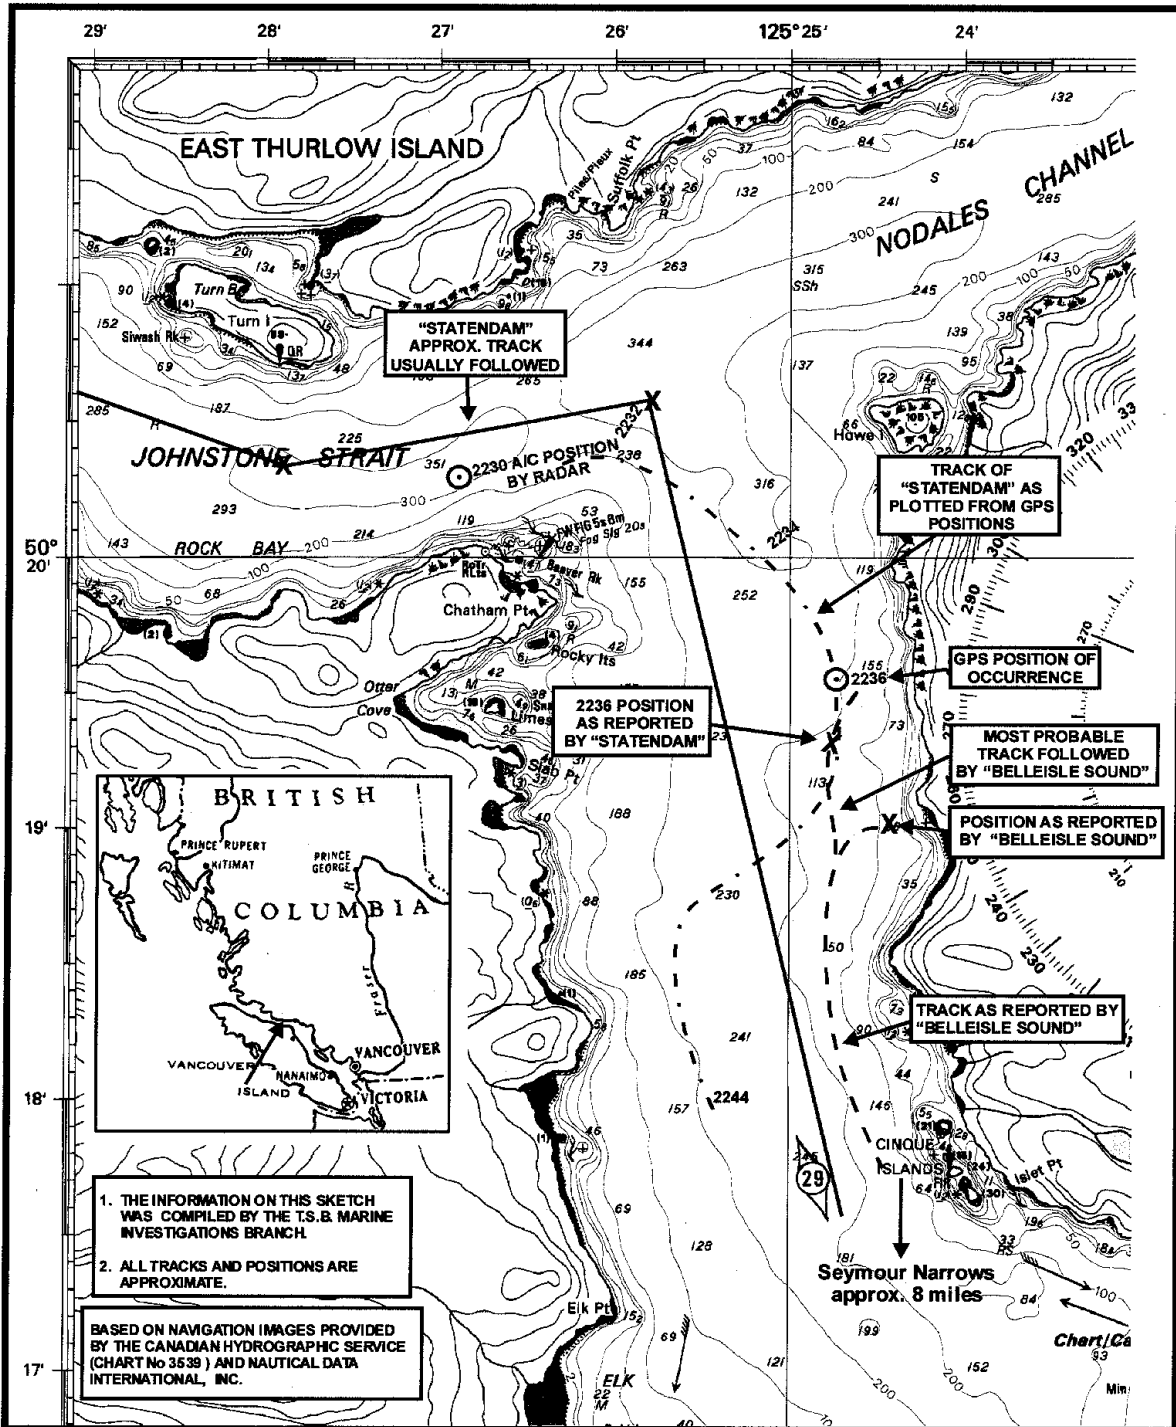
Appendix B Sketch of the Occurrence Area

The slow turn placed the "STATENDAM" well to the east of her intended track, on the east side of Discovery Passage, some two to three cables off Sonora Island.

At 2236, the "STATENDAM" crossed an estimated 60 to 90 m ahead of the "BELLEISLE SOUND"/"RADIUM 622". The pilot ordered hard-a-starboard helm when the tug/barge unit was abeam to starboard of the navigation bridge of the "STATENDAM". This allowed the stern of the cruise ship to swing clear of the bow of the "RADIUM 622", and also allowed the cruise ship to swing clear of Sonora Island. The position of the occurrence was approximately 50°19.3'N, 125°24.7'W.
