MARINE OCCURRENCE REPORT

M97N0099

EXPLOSION AND FIRE ABOARD

THE PETROLEUM TANKER "PETROLAB"  
AND THE SUBSEQUENT DESTRUCTION OF  
THE GOVERNMENT WHARF AT  
ST. BARBE, NEWFOUNDLAND

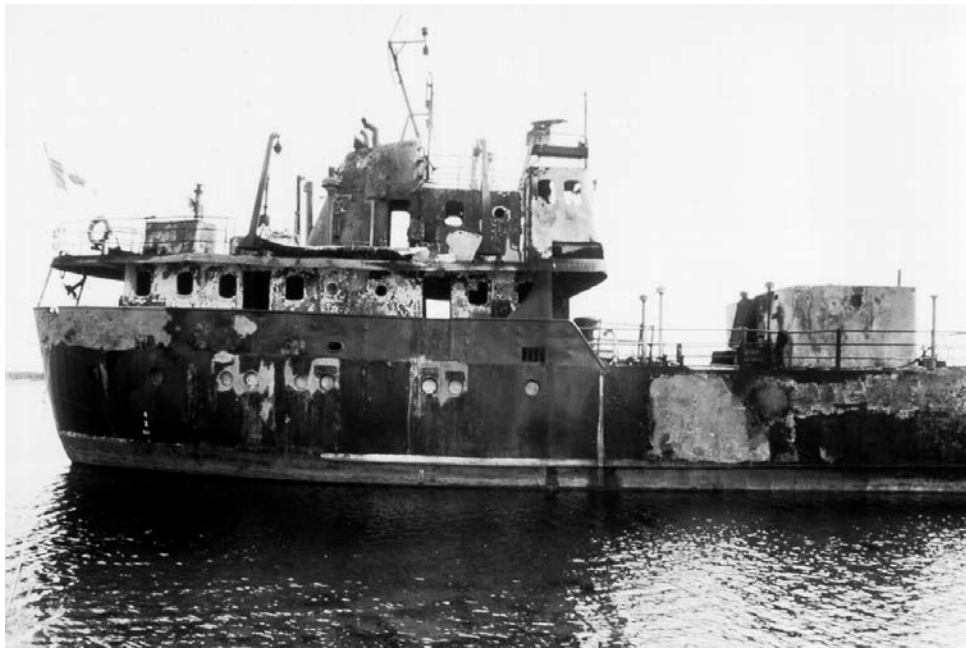
As a result of the explosion, the deck house structure was distorted and its port holes shattered. The vessel was damaged extensively by the fire. The accommodation was completely gutted and the aluminium superstructure extensively deformed. All combustible materials in the ‘tween-deck were destroyed and the structure of the ‘tween-deck was extensively damaged. There is no indication of fire in the engine-room although heat and smoke damage from the fire above was present on the upper portions, particularly the deckhead. The COTs were not breached during the explosion and fire. Since the fire, the “PETROLAB” has been declared a constructive total loss and has been sold.

The "PETROLAB" after the explosion and fire

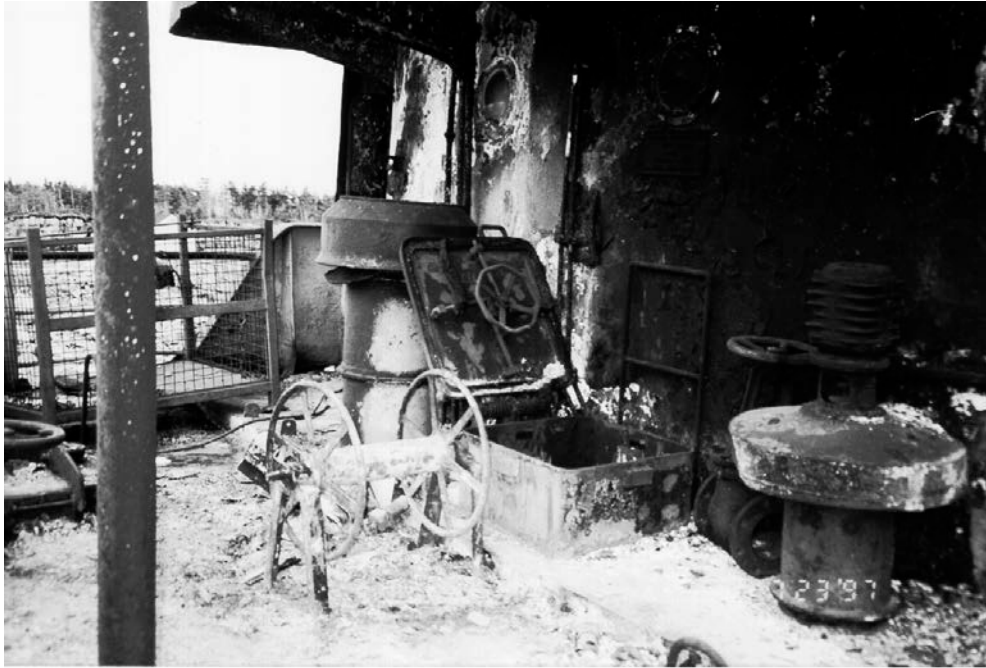
18. The slops were allowed to free-fall into the cofferdam from an uncertified and ungrounded rubber hose, creating vapour concentrations in excess of the lower explosive limit (LEL) and a static electricity hazard.

'Tween-deck escape hatch leading to the after cofferdam,  
through which slops were being pumped.

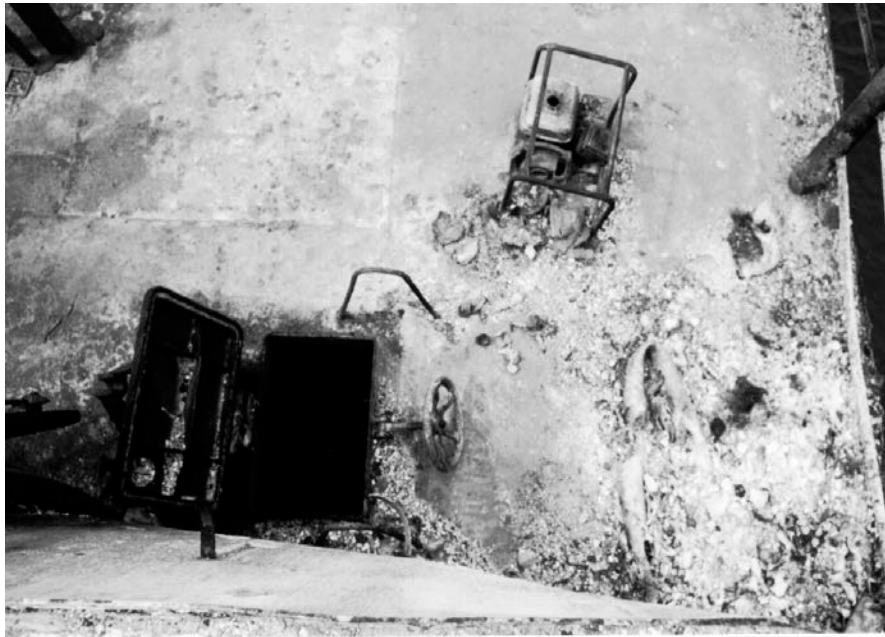
At the time of the explosion, the pump was being used to pump a mixture of gasoline and seawater; substances specifically warned against by the pump manufacturer. The fuel cap on the pump's tank was not in place and the fuel tank was nearly full, indicating that it had been filled recently. The TSB Engineering Laboratory inspection found that the cap was not blown off by an explosion.

Internal inspection of the pump revealed a damaged impeller that caused an imbalance and vibration when the pump was running. Earlier in the day, the pump had been mounted on rubber tires to prevent it from "walking" around the deck while it was running, but at the time of the explosion the pump was sitting directly on deck. The Safe Working Practices Regulations state:

Portable Honda pump in way of the open hatch to No. 5 port COT

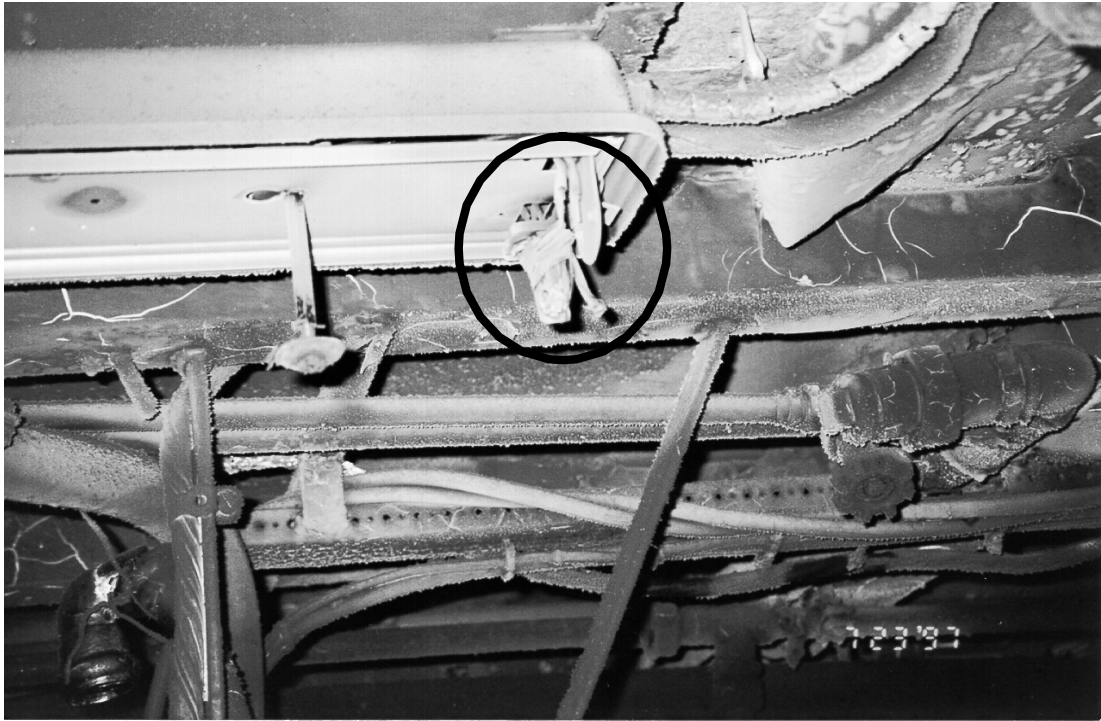
- Post-occurrence examination of the engine-room found that covers were missing from several light fixtures and lights were jury-rigged with substandard wiring.
- A portable DC bilge pump was used to transfer oily waste from the engine-room bilges to the cofferdam through a non-grounded plastic discharge hose. The pump wiring was jury-rigged to the port generator starter motor.
- There was an oil-fired domestic hot water boiler in the engine-room.
- The port ship's service generator, located adjacent to the escape door, was running and supplying power to the vessel at the time of the explosion.

23. Engine-room bilge slops were present in the cofferdam.
24. Much of the electrical equipment in the engine-room was not certified for use in a hazardous area and some wiring and fixtures were non-standard.

Sub-standard wiring in engine-room

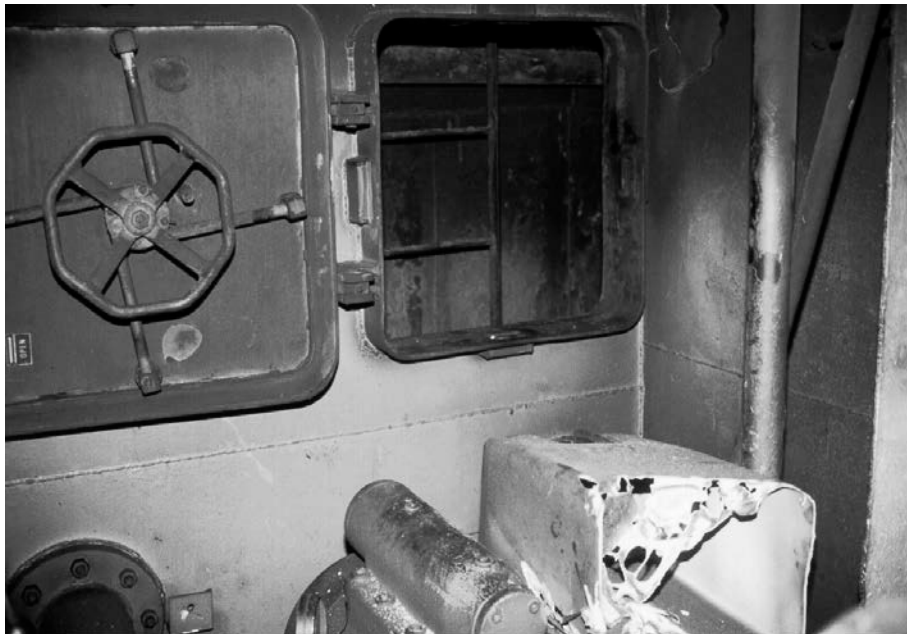
Given the relatively small size of the engine-room and the location of the door, the door’s benefit as an escape route was minimal. On the day of the explosion, not only did it not provide an escape route, it enabled the passage of gasoline vapours (or of a flame front) from the cofferdam into the engine-room, which caused the chief engineer’s fatal injuries.

21. The emergency escape door between the engine-room and the cofferdam was open during the transfer of slops.
22. A small, non-standard submersible electric bilge pump was found in the forward engine-room bilge with its discharge hose leading toward the engine-room escape door.

Open engine-room escape door in forward engine-room bulkhead;  
cofferdam beyond.

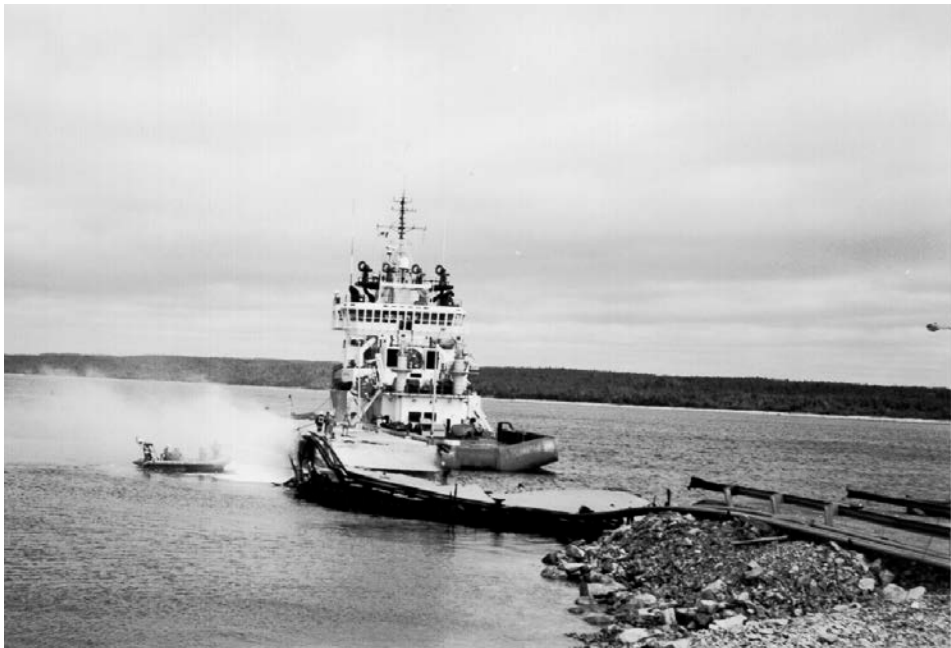
The fire on board the vessel was left to burn out of control, and it eventually spread to the creosote-impregnated pilings under the dock. Once the piles caught fire, the concrete deck hampered the efforts of the firefighters and of the CCG vessels to reach the seat of the fire under the dock. The "SIR WILFRED GRENFELL" attempted to use her winches to dismantle the dock, with little success.

34. The fire departments did not bring the shipboard fire under control in its early stages, and burning paint on the vessel's outer hull spread the fire to the creosote-impregnated piles of the government wharf.

Government wharf burning
