MARINE INVESTIGATION REPORT

M98C0066

GROUNDING

SELF-UNLOADING BULK CARRIER "ALGOLAKE"

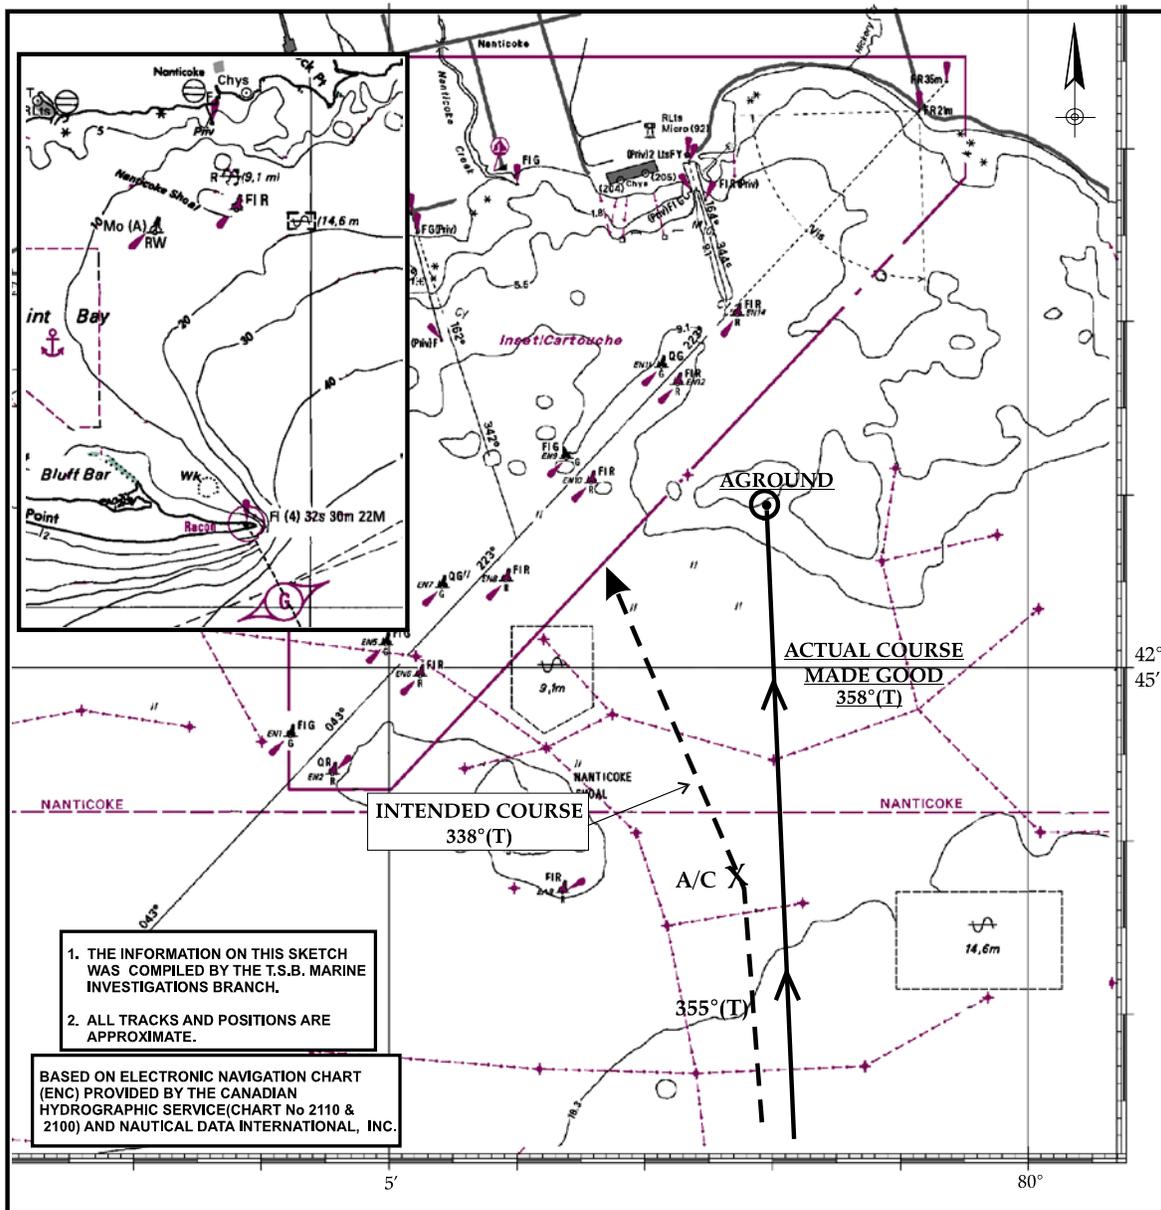
Appendix A - Sketch of the Occurrence Area

7. After the 0615 vessel position plot, no further position fix was plotted until the vessel ran aground at 0650.
8. The "ALGOLAKE" grounded in shallows, ESE of buoy EN10, having passed the course-alteration point by 2.1 M.

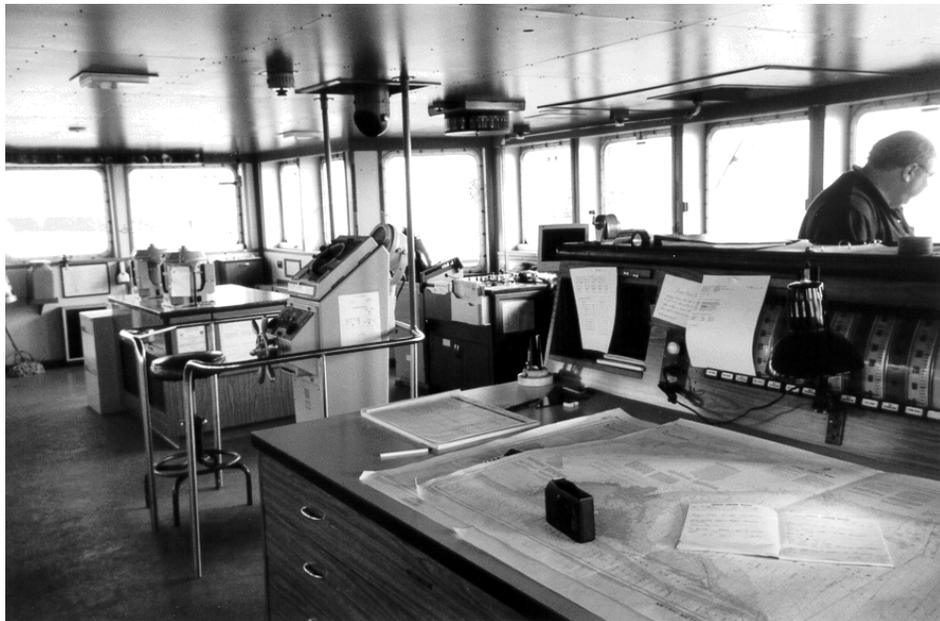
BRIDGE VIEW AND CHARTWORK AREA

Between 0534, rounding Long Point Bay, and 0650, the time of running aground, there was only one position fix, at 0615.

2. The interval between position fixes was too large to effectively monitor the vessel's progress along her intended track.
3. The influence of strong westerly winds caused the "ALGOLAKE" to drift east of her intended track, but no allowance was made for this leeway.

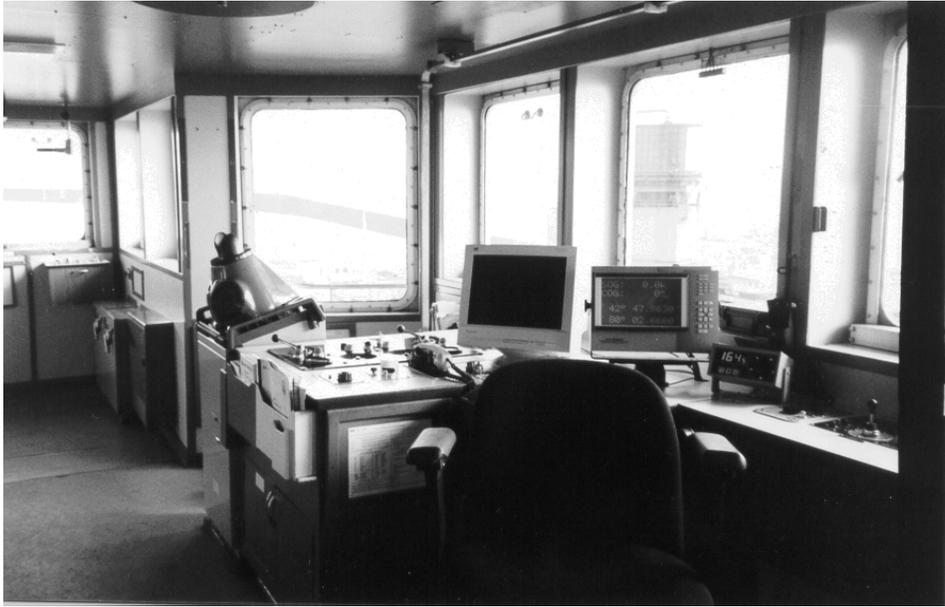
ECDIS REPEATER AT CENTRE CONTROL STATION

Problems with the ECDIS unit had begun the previous day while downbound from Lake Huron and in the St. Clair River. The master had requested the shore superintendent to arrange for a manufacturer's service representative to look at the unit upon the vessel's arrival at Nanticoke. Until a properly qualified ECDIS technician had examined and serviced the unit, the information it provided could not be relied upon.

When the master arrived on the bridge, in addition to engaging in non-essential conversation, he also became preoccupied with the ECDIS unit, which he knew had been malfunctioning. As the vessel approached Nanticoke, its manoeuvring room diminished. The master's attempts to operate the ECDIS distracted his attention from the need to confirm the vessel's position by the other means available. The ambient light from the unit's display screen also affected the master's night vision and reduced his ability to appreciate other visual clues to the vessel's position.

- both the master and the chief officer were required to attend a refresher BRM course;
- the ECDIS unit was serviced and repaired;
- a new depth sounder was installed on board the vessel;
- instructions were sent to the fleet on the proper use of cadets while on a navigational watch; and
- a third party was recruited to carry out an independent audit of bridge practices of a number of Algoma ships. These audits will continue in the future.
