MARINE INVESTIGATION REPORT

M98F0039

COLLISION

Between
the Self-unloading Bulk Carrier
“AGAWA CANYON”
and
the Tanker “EMERALD STAR”
Sault Ste. Marie, Michigan, United States
10 April 1998

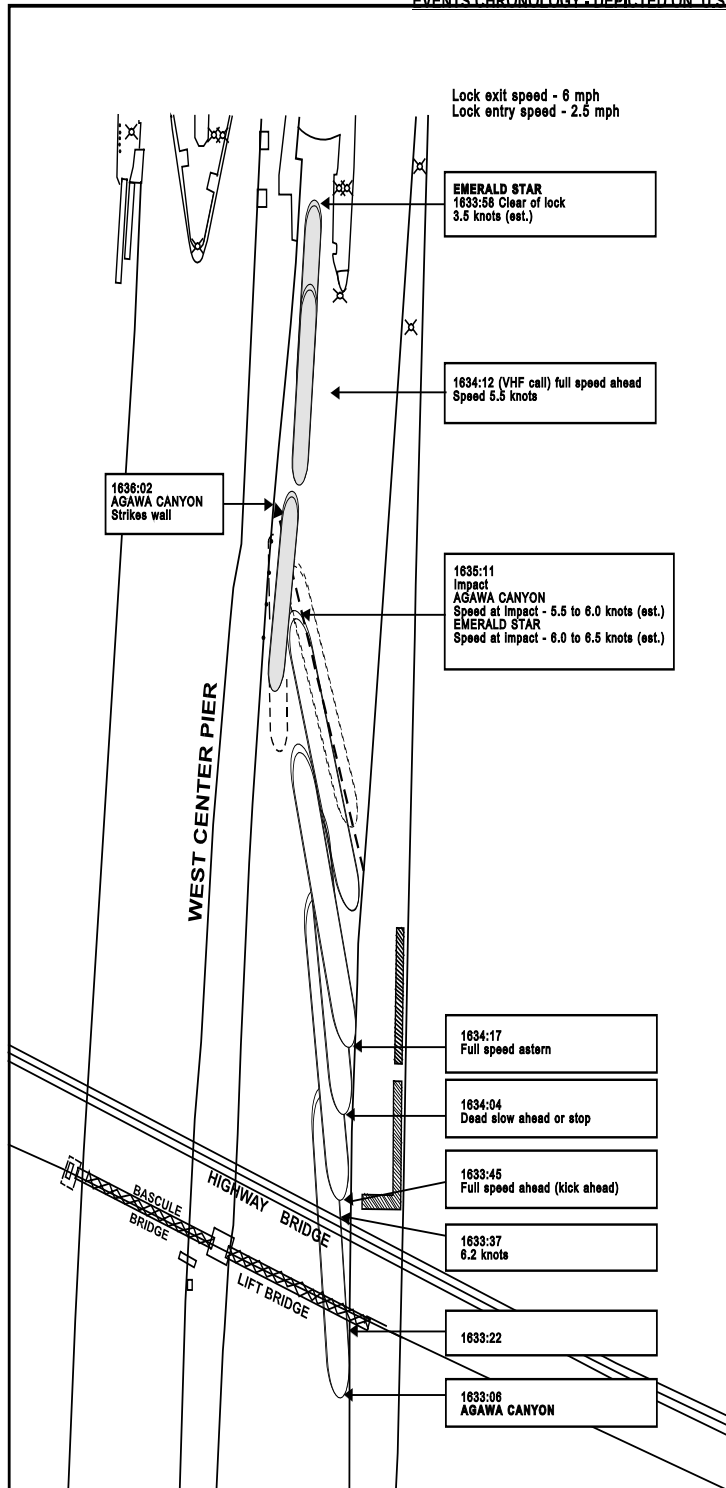
Appendix B - Chronology

EVENTS CHRONOLOGY - DEPICTED ON U.S. ARMY CORPS OF ENGINEERS CHART

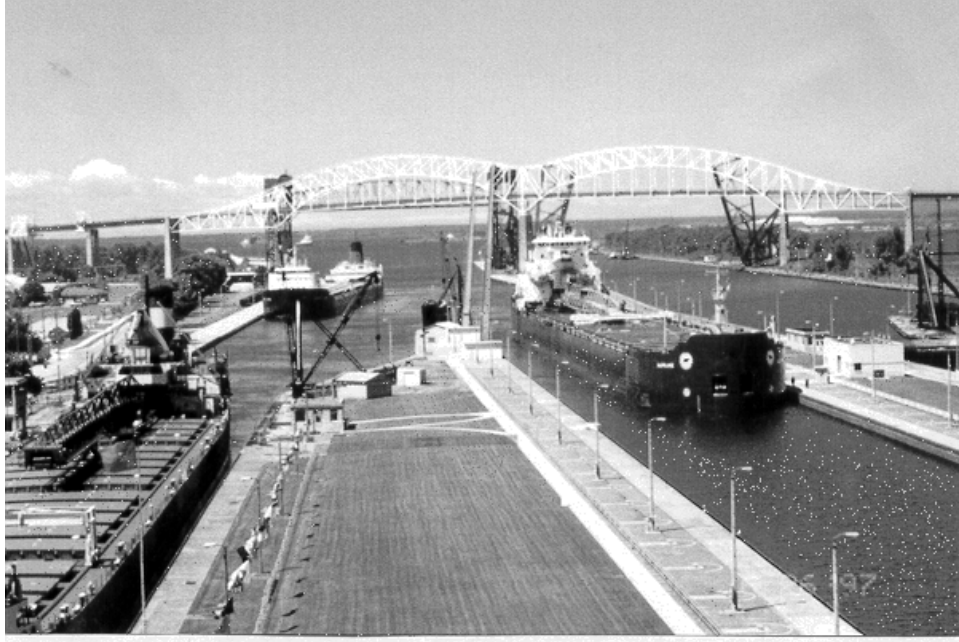
ST. MARYS FALLS CANAL LOCKS -LOOKING WEST

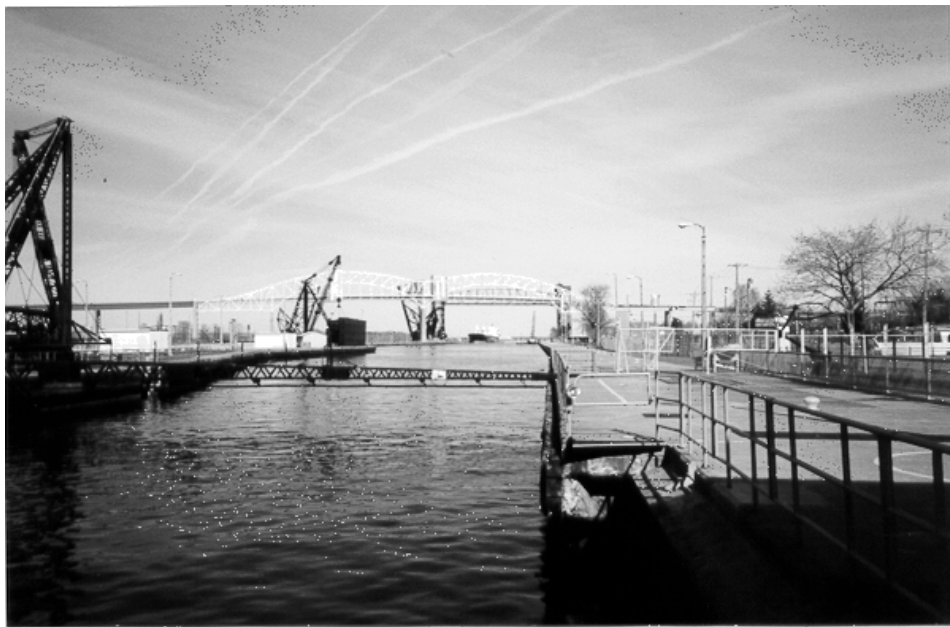
EXIT VIEW FROM POE LOCK
