MARINE INVESTIGATION REPORT

M98L0149

SWAMPING AND SINKING

OF THE SCALLOP DRAGGER "BRIER MIST"

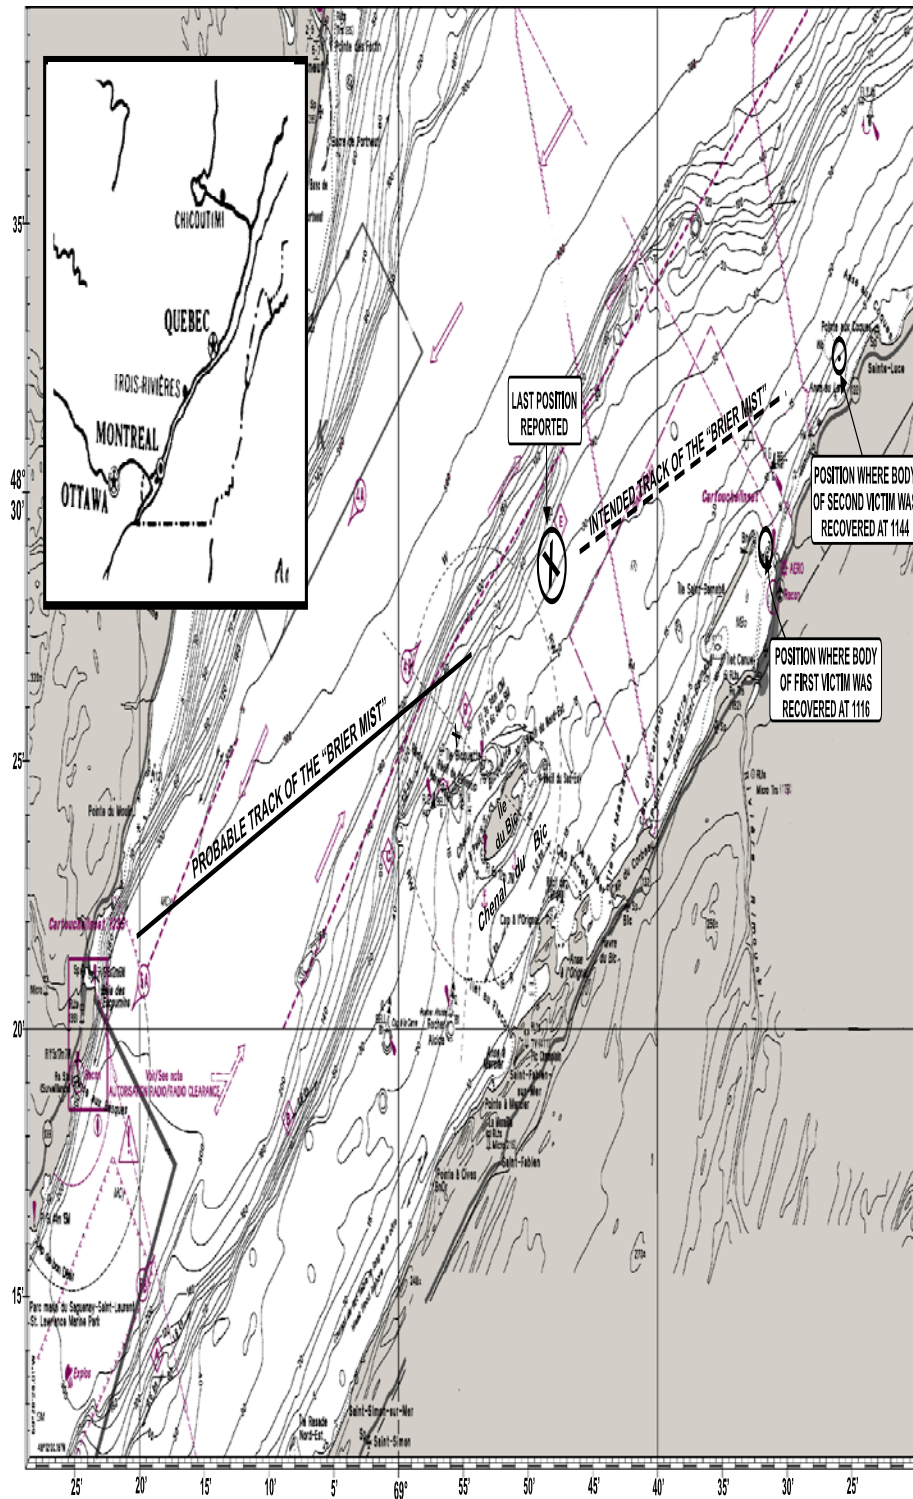
Appendix A - Sketch of the Occurrence Area

Staff at the MCTS centre observed the vessel leaving the north shore heading for Île du Bic, but they lost sight of her in snow flurries a few miles offshore. At 0938, the master reported that he expected to arrive in Rimouski at about 1430. At about 1230, during a telephone call to his home, he said that the voyage was going well. However, at about 1330, during a call to his agent in Rimouski, he stated that waves were washing over the vessel and that speed was reduced. He then indicated that he expected to arrive at about 1500, but he did not mention if he intended to change routes. Finally, according to the position given at 1347, the vessel was 10.76 M from Rimouski, at 48°28.29' N and 068°46.81' W (see the route followed in Appendix A).

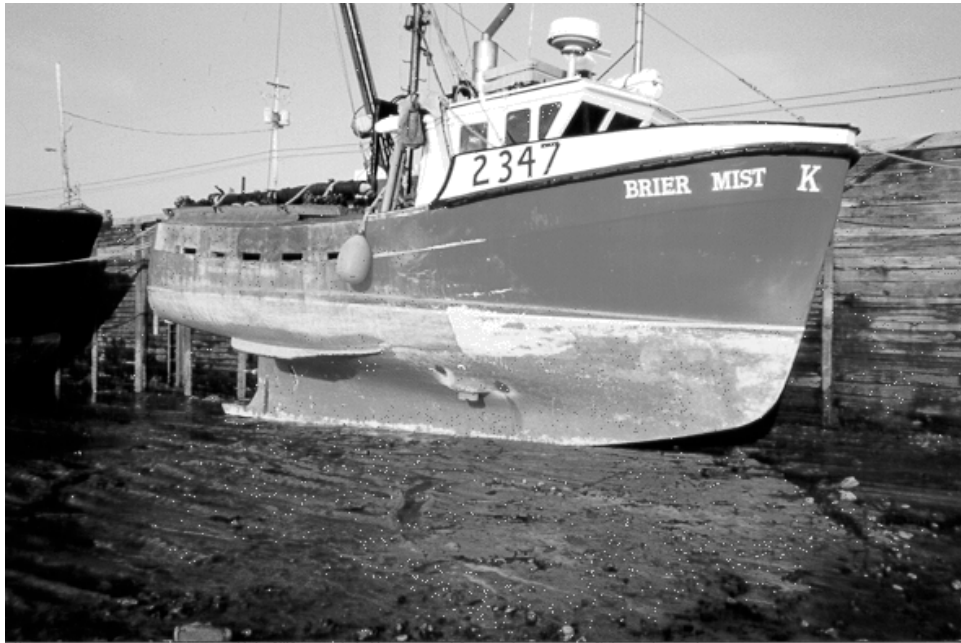
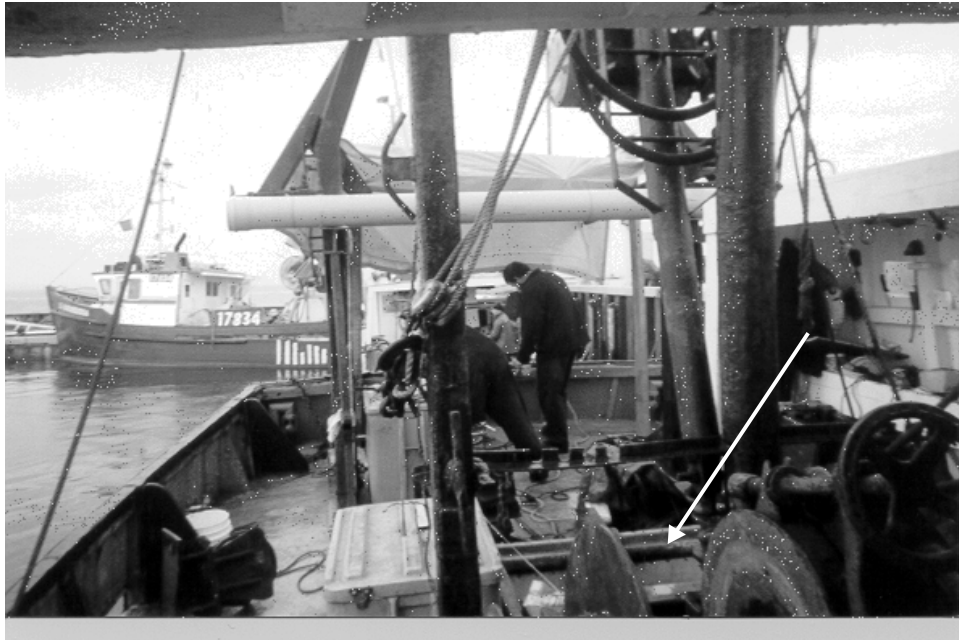
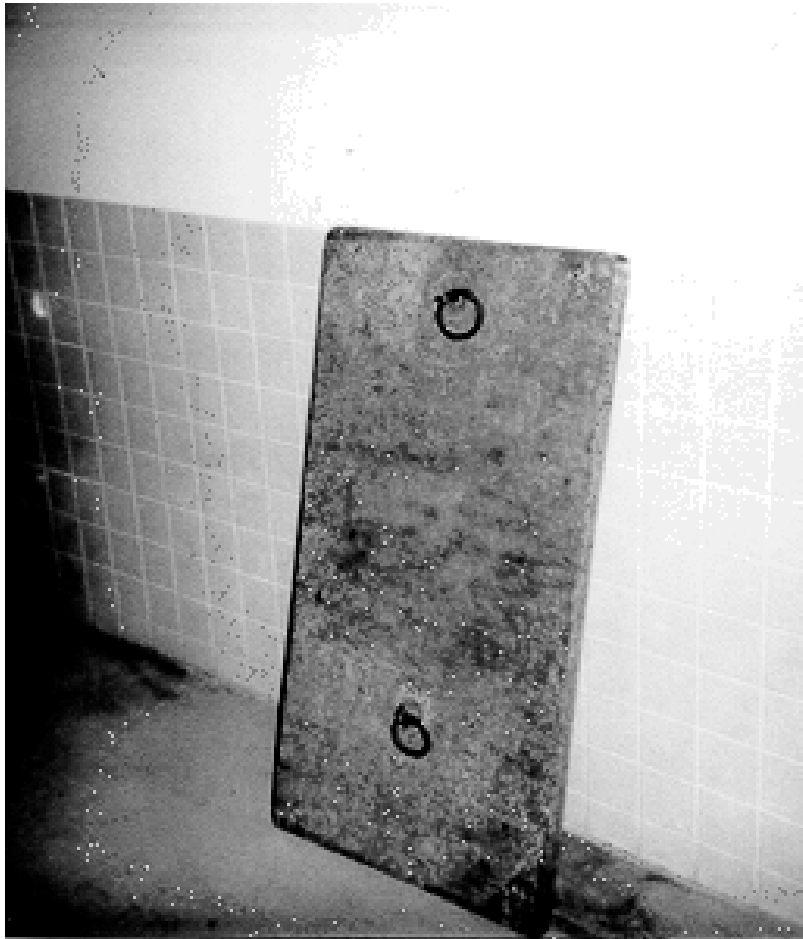
Appendix B - Photographs

The fish hold of the “BRIER MIST” had four circular scuttles approximately 35 cm in diameter and a hold hatch one metre square with a coaming about 40 cm high. To close the fish hold, the main hatch was covered by two fibreglassed wood covers. These covers were simply placed on the coaming flange. There was no watertight seal for the main hatch. Because there was a gap of about 2 cm between the two covers, water could enter the hatch. One of the two covers became dislodged and was found on the shore 100 km downstream of the position of the sinking. Because there was no system for permanently securing or lashing these covers in place, routine practice on board the “BRIER MIST” was not to secure or cover these panels. Since the vessel was built in 1981, no owner had considered it necessary to install a permanent lashing device for these main hatch covers. TC had not required the two covers to be watertight.

The two fibreglassed wood covers used to close the main fish hold hatch were simply placed on the hatch coaming flange. Because there was no permanent securing system to prevent the hatch covers from moving, routine practice on the “BRIER MIST” was not to secure them. One of the two covers was found on the south shore 100 km downstream from the position of the sinking. It is possible that the movement of water in the hold or a breaking wave raised these covers and caused the hold to be flooded. However, the covers could also have floated free as the vessel sank.
