RAILWAY INVESTIGATION REPORT  
R01T0255

MAIN TRACK DERAILMENT

CANADIAN NATIONAL  
TRAIN NO. M-337-31-24  
MILE 20.0, BALA SUBDIVISION  
RICHMOND HILL, ONTARIO  
24 SEPTEMBER 2001

Report Number R01T0255

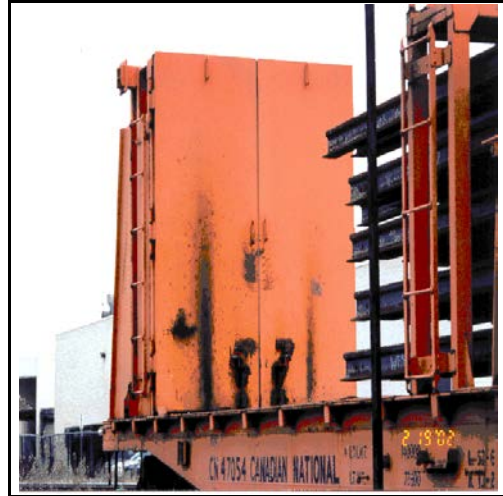
The rail transporter consist is marshalled with a bulkhead door car at each end (see Figure 1). The doors open towards the rail and ensures containment of the rail should it shift in transit. This type of equipment is restricted to a maximum speed of 40 mph.

The door had been supported by three hinges. The hinge weld areas on the fallen door were shiny and rust free, indicating that they had been recently torn off. The door locking device consisted of two brackets welded to the door face with a pin that slides through the brackets into the car floor (see Figure 2).

TC stated that CN has now inspected all of their rail transporter cars and completed a program to repair and modify the locking pin mechanisms. CN has also reiterated its loading and unloading inspection program for these cars with their mechanical inspectors and advised them to pay particular attention to the door locking mechanisms and doorstops.

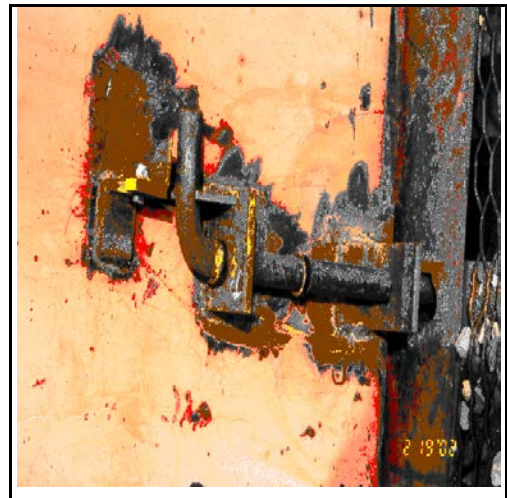
The door brackets and locking pin were missing and the weldment areas for the brackets were rust covered. It was determined that a piece of piping with a small valve attached had been inserted into the car floor in front of the door as a means of securement for an undetermined period of time. This makeshift device was not recovered. The door stop, welded to the side of CN 46570 to restrict door swing, was missing and the weldment area was rust covered.

The manner of train operation played no role in the accident. Train 337 derailed due to track shift attributable to contact with the bulkhead door from CN 46570. The door, having become loose after the makeshift securement device had failed, swung foul of, and contacted, the adjacent train as the stop mechanism was missing. Having been torn from its securement, the bulkhead door fell between the two trains and was jammed against, and shifted, the track.
