RAILWAY INVESTIGATION REPORT

R02W0063

CROSSING ACCIDENT AND DERAILMENT

NEAR FIRDALE, MANITOBA

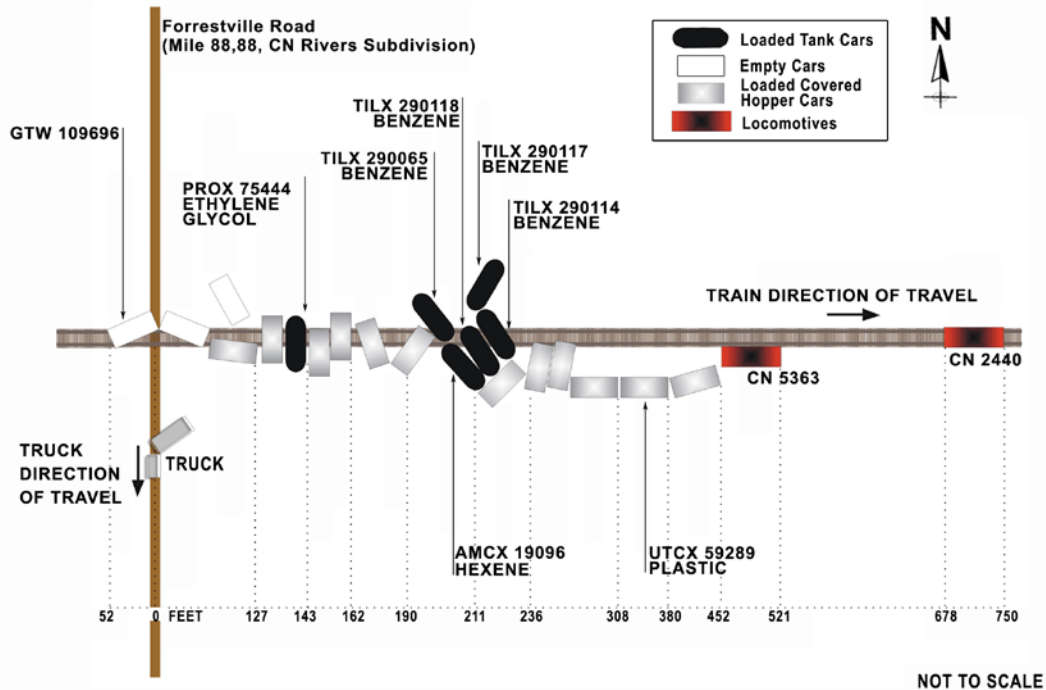
displayed various dents, scrapes and gouges, as well as fire damage from flame impingement. The other four tank cars lost most of their product after sustaining multiple punctures to the tank shells. These cars also sustained significant fire damage.

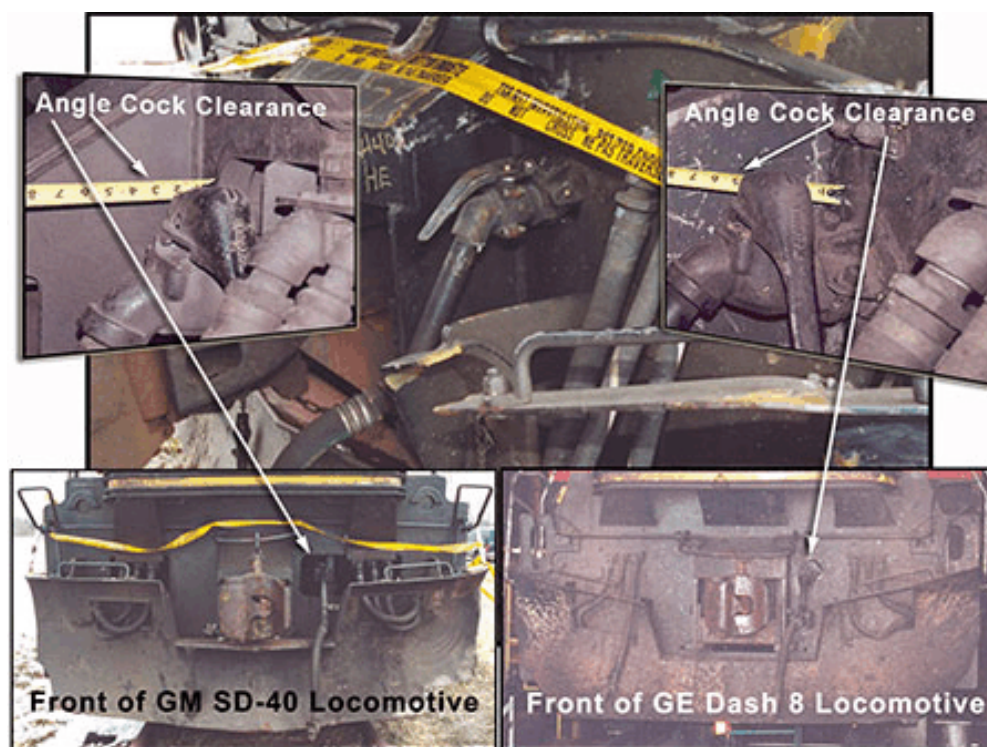
The positioning of the front angle cock and the size and configuration of various components (e.g. locomotive pilots/snow plows) on the front of locomotives can affect the survivability of the front angle cock during a head-end collision. Locomotive snow plow arrangements and the location of the front angle cock vary slightly from one type of locomotive series to another. On GE Dash 8 locomotive units, the snow plow in the area of the angle cock measures approximately 28 inches high and is located approximately 17 inches beyond the front of the locomotive frame. In contrast, the snow plow on GM SD-40-2 locomotives measures approximately 33 inches and is located approximately 19 inches beyond the front of the locomotive frame. In addition, the front angle cock on a GE Dash 8 locomotive extends approximately three inches further than the angle cock on a GM SD-40-2 locomotive. On the whole, the front angle cock of the GE Dash 8 locomotive is more exposed than on the GM SD-40-2 locomotive. Photo 2 shows the configuration of the angle cock on the two locomotives.

Due to its location, the front angle cock on locomotives is partially exposed and susceptible to failure upon impact. GE offers alternate locations for the angle cock at the time of locomotive manufacture; however, the locations of the valve and brake pipe hose are typically specified by the purchasing railway, based on the railway's needs. Although the locomotive snow plow was not designed to protect the front angle cock, these attachments do provide a measure of protection. In the event of a head-end collision with a vehicle at a crossing, insufficient protection and/or the location of the angle cock on the lead locomotive increases the risk of an angle cock valve failure. Such valve failures have been known to initiate a UDE from the head end of the train, and the resulting in-train buff forces can potentially cause a rail rollover, jackknife, wheel climb and/or wheel-lift derailment.
