RAILWAY INVESTIGATION REPORT

R03Q0022

MAIN-TRACK DERAILMENT

Canadian National
Train Q-149-11-12
Mile 53.1, Drummondville Subdivision
Manseau, Quebec
12 May 2003

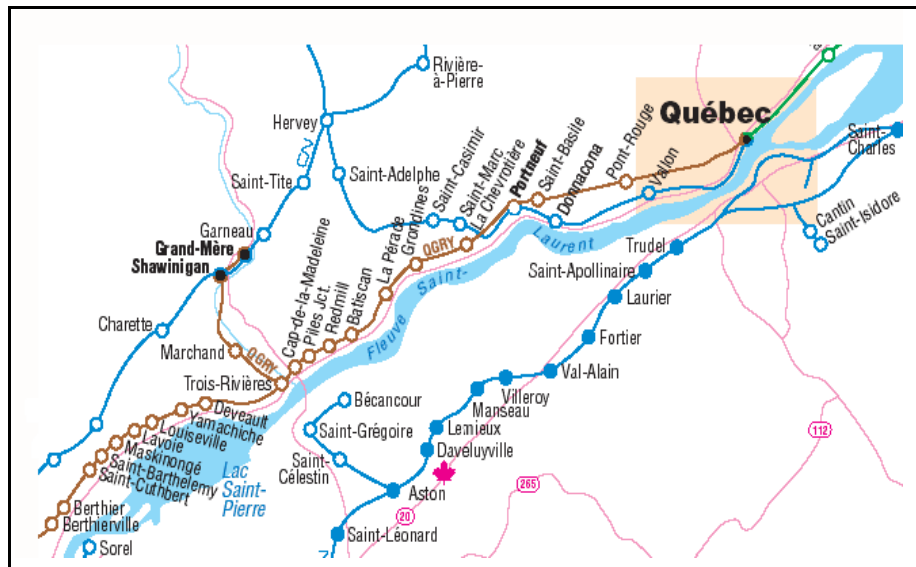
The derailment occurred within the limits of Manseau, Quebec, population of approximately 700 persons. The area includes a mixture of residential and farm properties (see Figure 1).

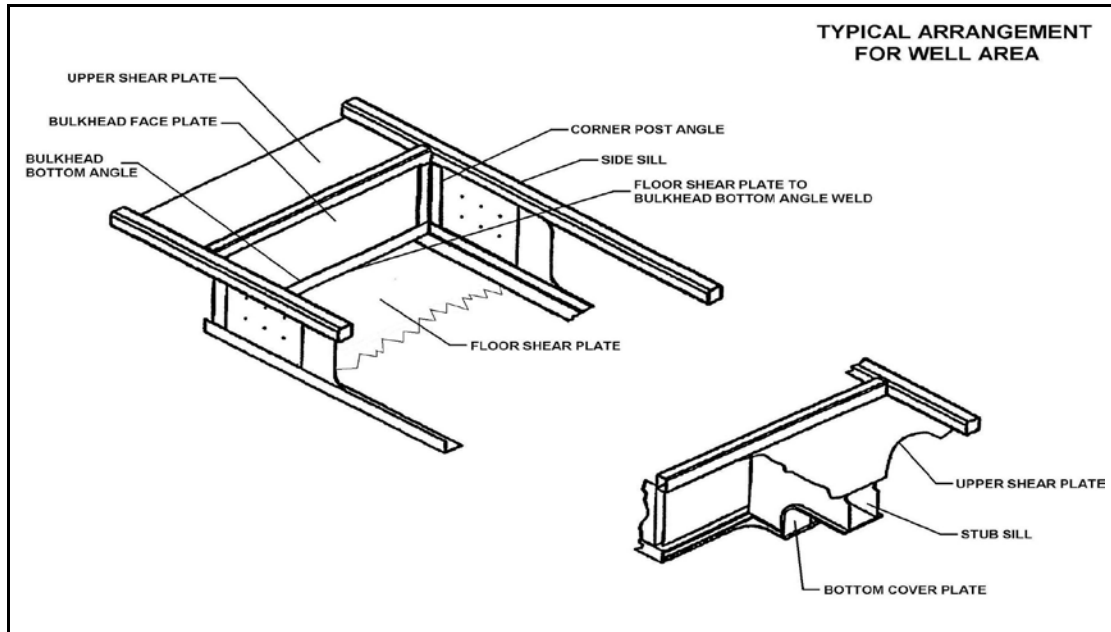
In the stub sill area of the well, the floor and end wall (or bulkhead) of the car meet at a right angle (see Figure 3). The bulkhead bottom angle is attached between the floor shear plate and bulkhead face plate. Corner post angles are connected to the bulkhead face plates and the left and right sidewalls. All components are connected to each other with fillet welds.

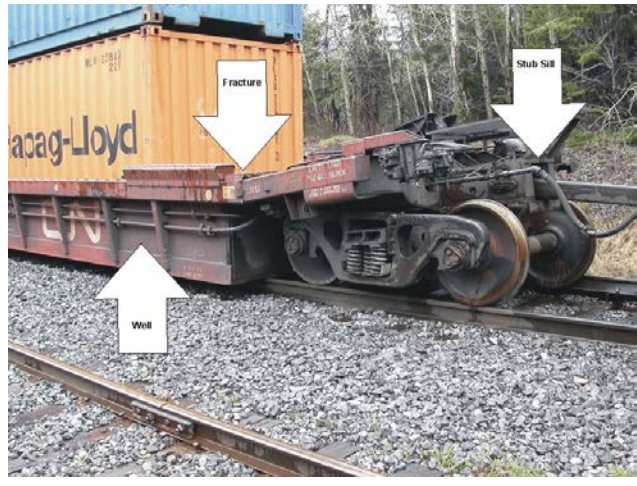
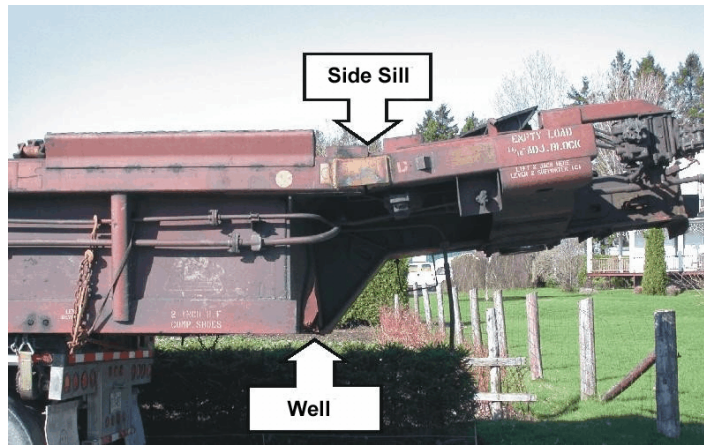
Overview. Photo 1 shows the fractured car on the track, and Photo 2 shows the same car after the wheel sets had been removed. The cargo area of this car is box-shaped, and referred to as the "well." These photos show fractured side sills, and the fracture along the forward lower edge of the well, where the lower edge of the stub sill attaches.

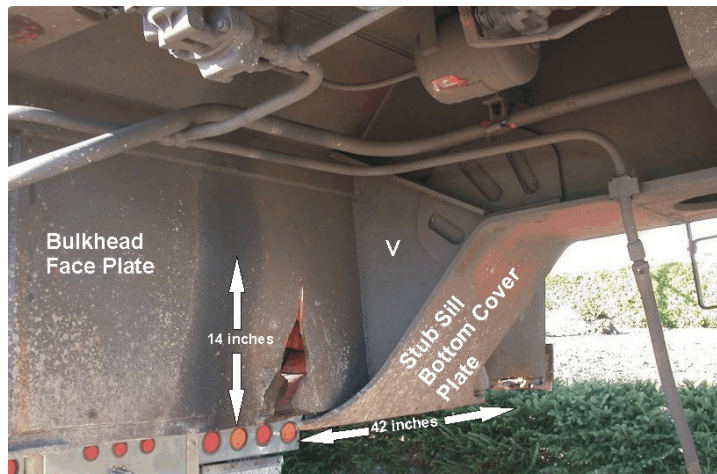
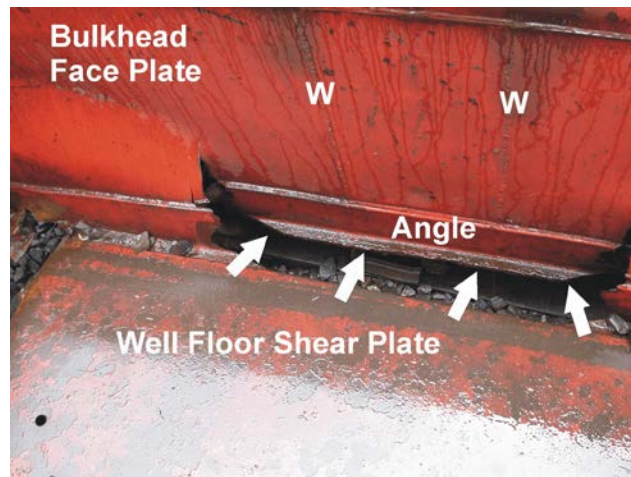
Well Fracture. Photos 3 and 4 show the fracture along the lower front edge of the well, where the lower edge of the stub sill tore away from the bulkhead face plate. The lower front edge of the bulkhead face plate was attached to a steel angle. The fracture occurred through the steel angle, at the toe of the weld that attached the steel angle to the floor, and was approximately 42 inches in length. The vertical fracture surfaces were of different lengths. For the side of the car that was on the high side of the curve, the fracture measured approximately 14 inches, and for the low side, it measured 12 ½ inches. There were red paint flecks noted within the weld area at the fracture surface. There were also signs of rust, fretting, and contamination similar to that produced by wayside lubricators on the fracture surfaces. It was also noted that there were two vertical welds (item W, Photo 4) in the bulkhead face plate behind the stub sill attachment area. Other than ballast that entered the well area during the derailment sequence, there was only a minor amount of debris noted (e.g. a worn brake shoe and rubber air brake gaskets).

The fracture occurred at a location where a number of design features intersected. The structural design of this car was such that all the car loads, whether they were loads caused by the weight of the cargo or coupler loads due to buff and draft forces in the train, passed through this location as they transferred from the well to the stub sill. These loads were concentrated in the area where the well attached to the stub sill. Therefore, there was a highly concentrated force in this region. In addition, there was a local stress raiser in the form of the weld that attached the well floor plate to the steel angle.

The location of the five-pak at the initial point of derailment in the exit spiral of the curve and the uneven lengths of the two vertical fracture surfaces in the bulkhead face plate indicate that the car platform was in torsion at the time it collapsed.⁴ The rust and contamination within some of the fracture surfaces indicate that the fractures were not new.

Because there was a missing weld under the car where the well attached to the steel angle, loads were transferred through this highly stressed region through just one weld instead of through two. Therefore, the region around that single weld was subjected to higher stresses than the opposite end of the car. This accelerated the growth of the fatigue cracks on the end that collapsed to the point where the car body could not support normal loads. As the five-pak was traversing the exit spiral, the torsional forces on the car, in combination with the in-train coupler forces and container weights, exceeded the strength of the weakened structure, at which time the structure yielded and fell onto the right-of-way.

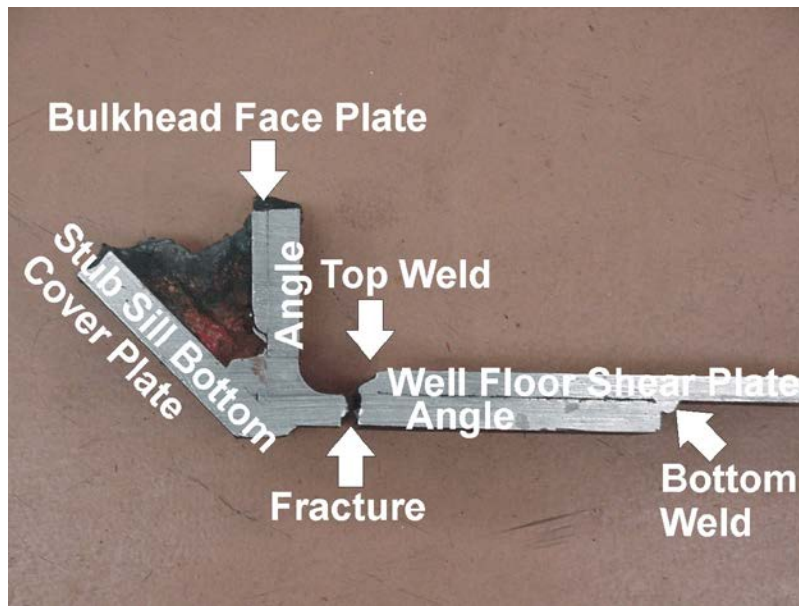
Photo 5 shows a cross-sectional view of the geometry of the parts involved in the area where the bottom steel angle attaches to the stub sill and floor. The specimen was taken from the opposite undamaged end of car CN 677048-E after a pre-existing crack was mechanically opened.

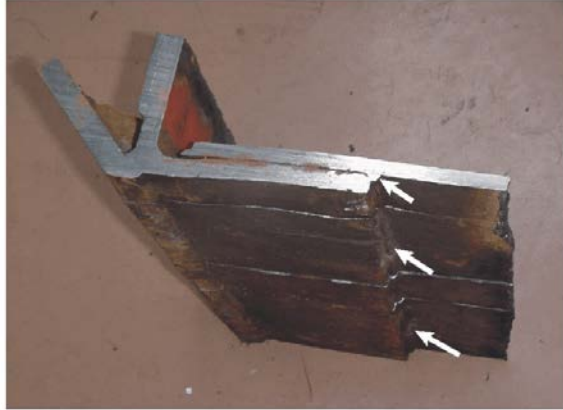
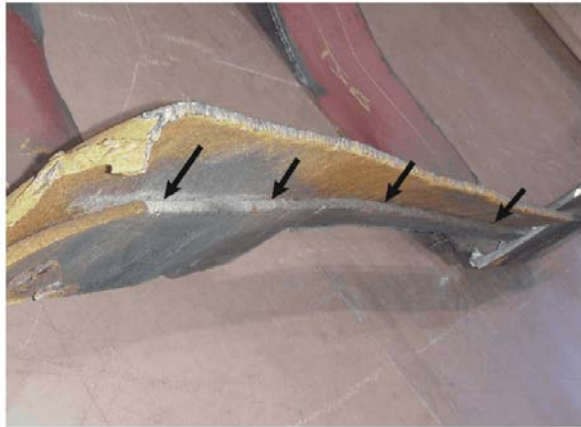
Pre-existing cracking was noted in similar locations at both ends of the platform, and a fillet weld in a critical area was missing on the end that collapsed (see Photos 6 and 7).

- The principal failure occurred in the steel angle along the lower front edge of the well. The failure of the side sills was a secondary failure.
- The steel angle conformed to specified material and dimensional requirements.
- The fracture surface at the principal failure showed evidence of significant pre-existing cracks.
- A pre-existing crack was present at the opposite undamaged end of the same car, along the lower edge of the well, having the same appearance and location as the principal fracture.
- The visual appearance of the pre-existing cracks and their locations were consistent with their being of fatigue in origin.
- The cracks have been growing very slowly.

- The presence of the large pre-existing crack at the principal failure location would have reduced the strength of the structure at that location to roughly one-third of its original strength.
- The weld that normally connects the steel angle to the underside of the well floor was missing at the failed end. This would have resulted in higher-than-normal loads at the failure location, and would have accelerated the fatigue process. The extent of this acceleration could not be quantified.
- The overall weld quality at the failure location was not considered to have been a significant contributing factor.
- It was not possible to determine to what extent the previous derailment and the subsequent repairs contributed to the failure.

On 14 May 2003, Canadian National (CN) issued instructions to all its field inspection forces to visually inspect all cars in the CN 677 series (Appendix B). All welds and the area around where the stub sill and the lower shear plate attached to the end sill of the car were inspected for cracks or any sign of failure both inside and outside the container well. The welds were cleaned with a wire brush to provide a good visual inspection. As this inspection was considered critical,
