RAILWAY INVESTIGATION REPORT

R03Q0036

MAIN-TRACK DERAILMENT

MILE 46.0, DRUMMONDVILLE SUBDIVISION

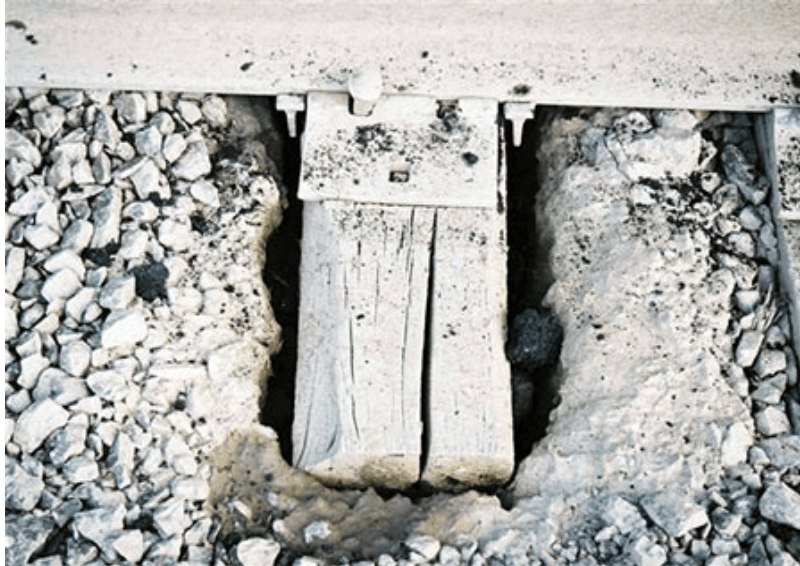
Throughout the entire derailment zone, including the crossings, the ballast was contaminated, water saturated, and the track was pumping (see Figure 2). The surrounding land area was essentially flat farmland, some in pasturage and some with crops, with drainage ditches intersecting with the railway and road ditches. There were three culverts and one bridge between Mile 44 and the 16th Line Road crossing. The culverts were not obstructed. The ditches on both sides of the track were approximately six feet below the base of the rail and contained water.

Figure 2. Contaminated ballast and pumping ties

The track showed signs of severe pumping from the public crossing to the rear of the last derailed car at Mile 46. The ballast was completely saturated with fines and mud. Where the ties had shifted, the voids at the end of the old ties were filled with water and mud.

Ballast friction generated by passing trains will cause the ballast material to abrade over time, creating a fine powder that will fill the interstices between the ballast, reducing friction and resistance to movement, and impeding proper drainage. Normal flexing of the track under vertical load will cause the finer particles in the sub-ballast layer and roadbed to migrate into the ballast layer over time, progressively contaminating the ballast layer and reducing its effectiveness. In the presence of water, the contaminated ballast turns into a liquefied mud layer.

On 14 August 2003, CN informed TC that the slow order would be maintained until the rehabilitation of the contaminated ballast on 08 September 2003. A follow-up audit was carried out by TC on 18 August 2003 from Mile 46.0 to Mile 74.5 and from Mile 100.5 to Mile 101.4. On 19 August 2003, TC issued a Notice and Order to CN imposing a speed reduction at 22 additional locations due to ballast contamination.

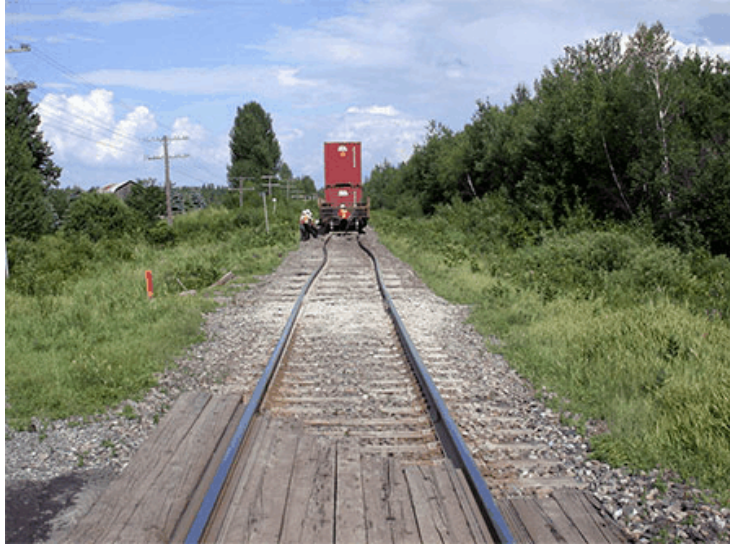
The track had buckled outwards to the south side. The buckle, starting approximately 30 feet east of the public crossing, reached a maximum of eight inches at a distance of 56 feet from the crossing (see Figure 3), where fresh wheel flange marks were noted on the gauge side of the south rail. Wheel flange marks were noted through the entire derailment zone, ending underneath the first derailed car.

Figure 3. Track buckle looking east

As the lateral resistance of the track had been reduced, the forces exerted on the track structure by the moving train could not be contained, allowing the track to shift out of alignment and buckle. The initial track buckle caused a wheel climb and derailment of the trailing truck of the 39th car. The track buckle increased under the passing train until the 66th platform derailed, followed by the cars behind it.
