## **RAILWAY INVESTIGATION REPORT**

**R04C0110**

### **CROSSING ACCIDENT**

**CANADIAN PACIFIC RAILWAY**

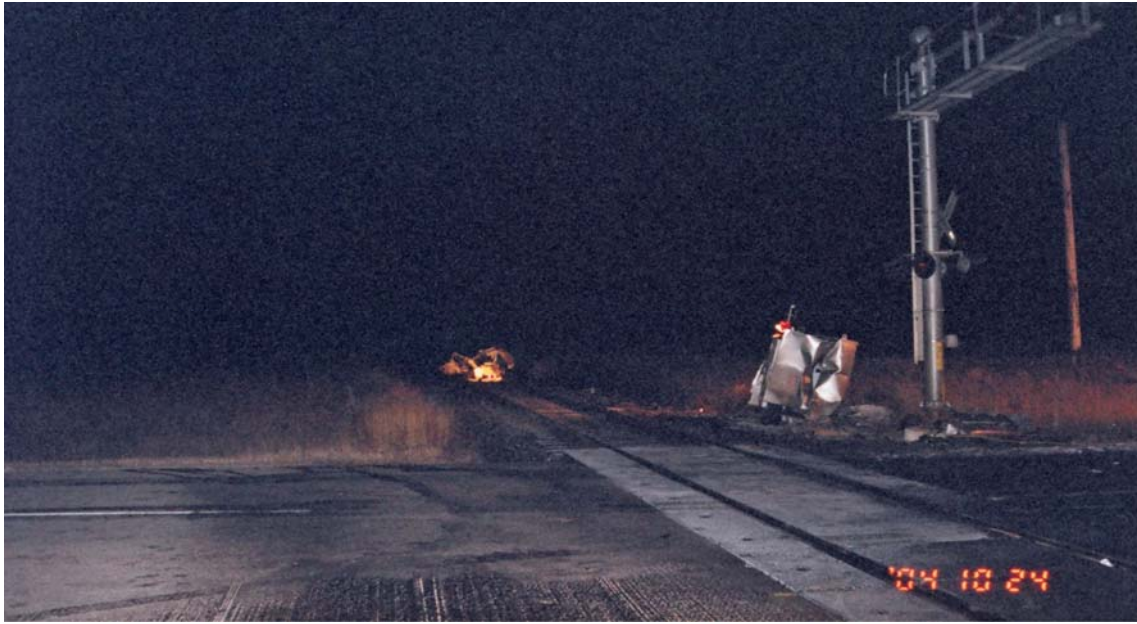
**Photo 1.** Looking south at the damaged signal bungalow and the tractor cab

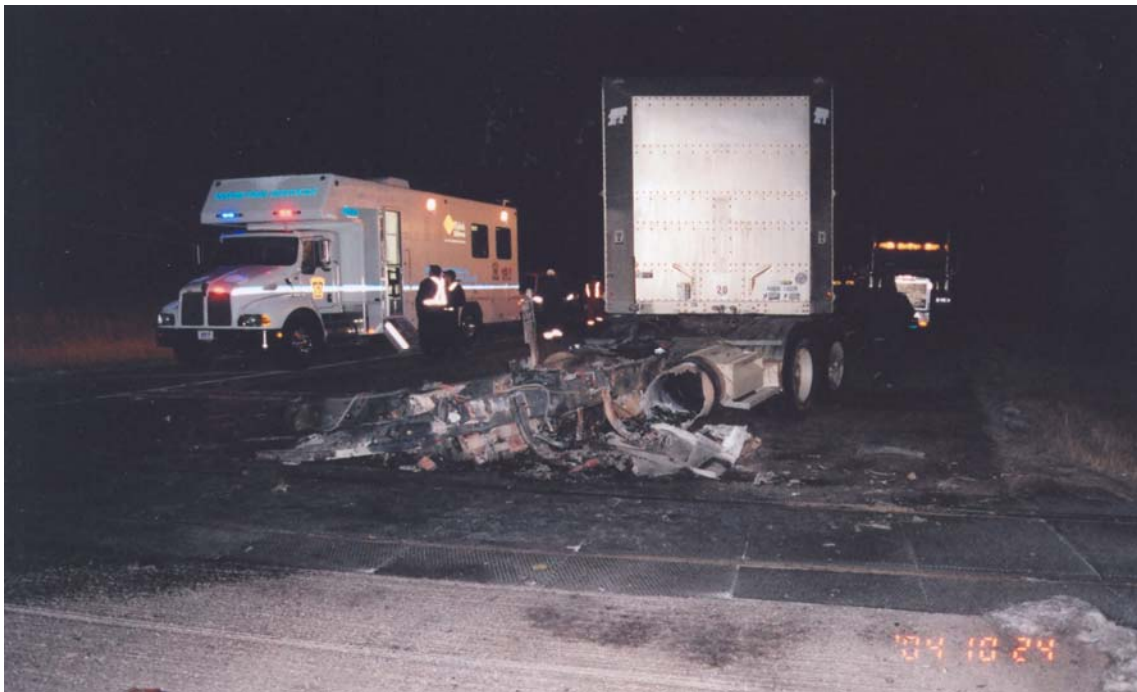
**Photo 2.** Looking west at the Highway 23 crossing, and the trailer and damaged tractor

After the accident, an inspection by RCMP and Alberta Infrastructure and Transportation inspectors determined that only one of the six trailer brakes was within working adjustment. Also, one tire was worn out. The inspectors concluded that the trailer had no effective brakes.

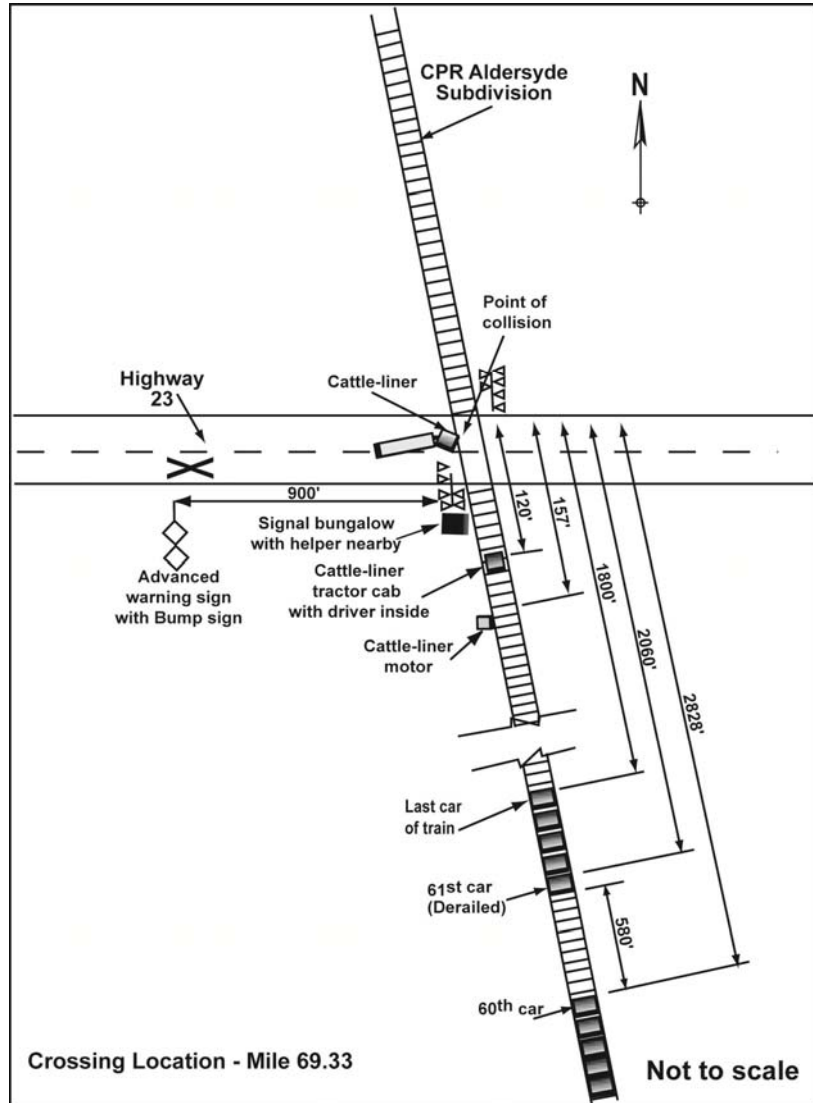
**Figure 2.** Diagram of accident site showing location of cattle-liner and train 2nd 269-23
