RAILWAY INVESTIGATION REPORT

R04M0032

MAIN-TRACK DERAILMENT

CAPE BRETON AND CENTRAL NOVA SCOTIA RAILWAY

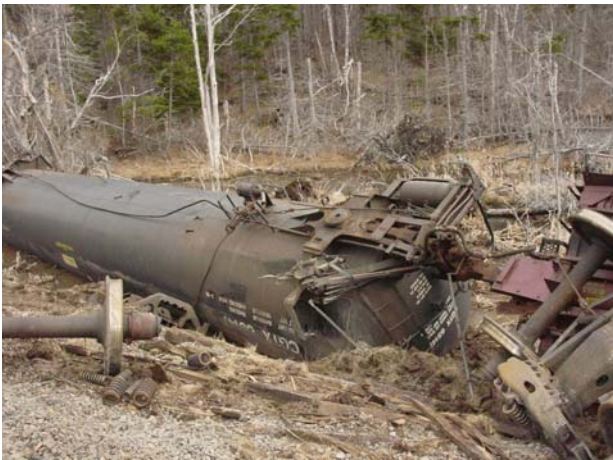
products. Eight of the LPG tank cars rolled either over onto their sides or upside down (Photos 1 and 2). Following company requirements, the crew immediately reported the accident to the CBNS Stellarton office and the rail traffic control office located in North Bay, Ontario. The rail traffic controller (RTC) notified a CBNS Operations Manager in Stellarton, the TSB in Gatineau, Quebec, and Canutec³ in Ottawa, Ontario⁴.

Photo 1. The first derailed LPG tank car upside down off the right-of-way

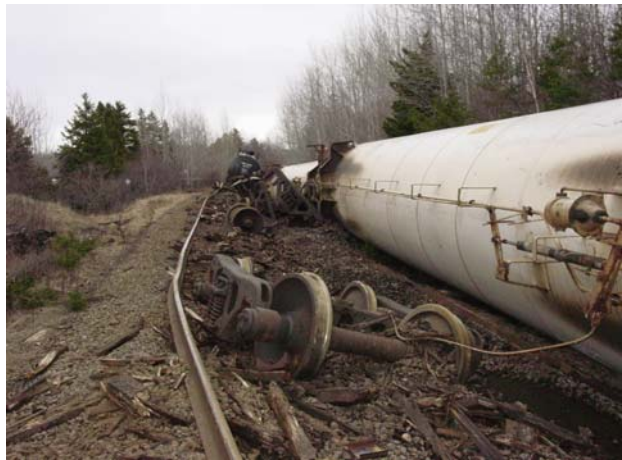
There were no injuries nor release of dangerous goods. One car was lightly damaged, eight cars were heavily damaged, and one car was destroyed. Approximately 1100 feet of track was extensively damaged or destroyed.

Photo 2. LPG tank cars rolled over on their side. Note extent of the track destruction

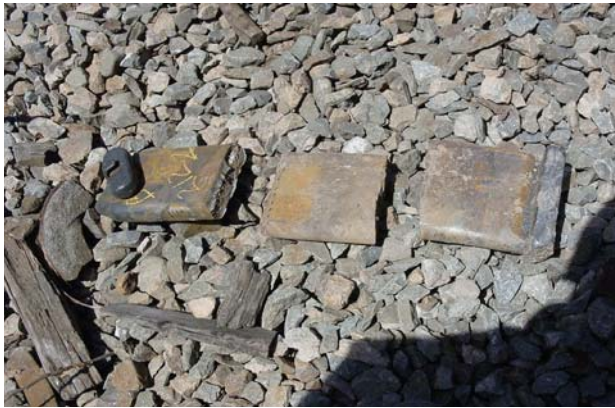
- a fractured coupler cross key on the leading end (B-end) of the third car (GATX 2122, Photo 3);
- a broken coupler shank on the leading end (B-end) of the fourth car (GATX 9138, Photo 4); and
- a broken stub sill on the trailing end of the fifth car (GATX 62822, photos 5 and 6).

Photo 3. Broken coupler cross key on leading end (B-end) of the third derailed car, LPG tank car GATX 2122

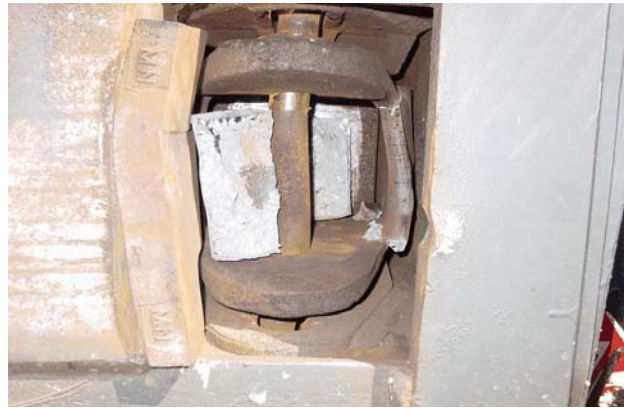
It was determined that the stub sill broke in the post-derailment sequence. The coupler cross key and the coupler shank were sent to the TSB Engineering Laboratory in Ottawa for further examination and analysis (see Appendix B). Both parts were subsequently determined to have failed in brittle overstress under torsional loads, consistent with failure as a result of the derailment. However, the mechanical properties of the material in the coupler shank were found to be outside of the Association of American Railroads (AAR) specifications, particularly as far as ductility was concerned. A TSB Engineering Laboratory report (LP 064/2004) concluded, in part, that:

- Charpy impact testing revealed the coupler material did not meet the minimum required level of energy absorption at -40°F (8.33 foot-pounds versus 20 foot-pounds prescribed);
- Tensile testing revealed low elongation, slightly below the specified minimum for Grade E coupler material (12.7 per cent versus minimum 14 per cent prescribed); and
- gas porosity in the casting, considered as being AAR severity 3, served to locate the initiation site for the overstress failure.

Although the coupler shank failure was not considered to be a contributory factor in this accident, the observations were similar to a broken coupler involved in an occurrence on the Broadview Subdivision, Manitoba, in 2002. In both occurrences, the couplers did not meet all AAR specifications, and the quality assurance system employed by the manufacturers failed to identify this shortcoming.

Photo 4. Broken coupler shank on leading end (B-end) of the fourth derailed car, LPG tank car GATX 9138

4. Although the fractured coupler shank from tank car GATX 9138 was not considered causal to this derailment, both TSB testing and external testing revealed that it had very low energy-absorbing capability, meaning that in severe cold weather it could pose a risk to safe train operations, particularly those involving dangerous goods.

In September 2004, the TSB issued a Rail Safety Information Letter (10/04), *Mechanical Properties of Coupler Casting*. This letter, which was sent to the Nova Scotia Department of Transportation and Public Works, and copied to Transport Canada (TC) and the Railway Association of Canada, highlighted the condition of the coupler casting that was broken on the fourth derailed car (GATX 9138). Subsequently, TC brought the matter to the attention of the Association of American Railroads (AAR) emphasizing how the quality assurance processes in place by the manufacturer failed to identify the shortcomings found by the TSB Engineering Laboratory. The AAR has also been requested to provide information on any follow-up corrective action that it may take as a result of this derailment.

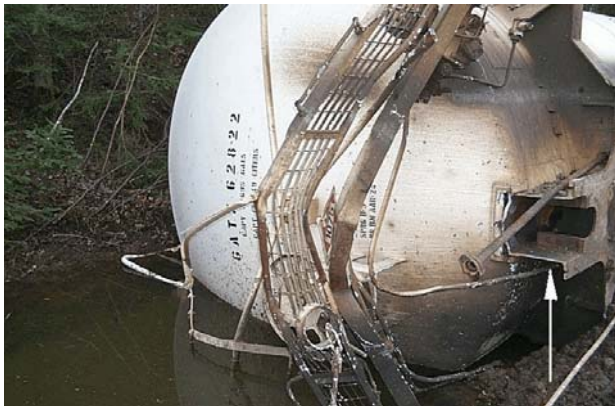
Photo 5. Arrow denotes location of broken stub sill on trailing end (B-end) of the fifth derailed car, LPG tank car GATX 62822

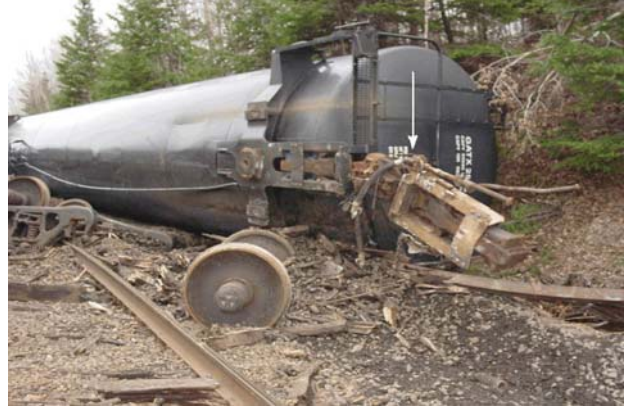
Photo 6. Broken stub sill from GATX 62822 still attached to leading end (A-end) of the sixth derailed car, LPG tank car GATX 2506

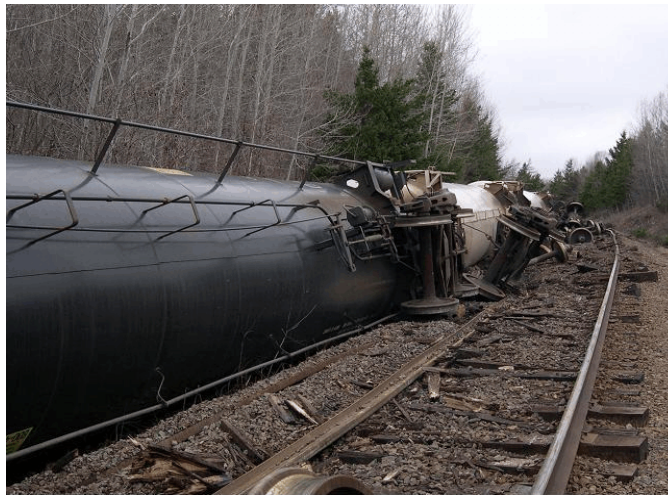
The TSR require a minimum of 10 crossties, in good condition and effectively distributed, for each 39-foot segment of rail. There were 26 defective ties (split, spike-killed, or broken) out of 93 ties between the entry of the spiral and the point of derailment, which is within TSR allowable limits. Several locations had two defective ties in a row; others had up to four defective ties in a cluster (Photo 7).

Photo 7. View of ties and rail near the initial derailment location

- In locations where clusters of bad ties exist, the ability of the track structure to restrain the gauge spreading forces exerted on it is greatly reduced. Rail fasteners need to have high stiffness in order to reduce the lateral rail deflections under load to reduce rail spreading. As there was a history of wide gauge through a third of the curve, the derailment could have occurred anywhere in a cluster of bad ties.

1. The train derailed as a result of a combination of track conditions (excessive superelevation, wide gauge, and defective ties) when rigid pressure tank cars, which are prone to derailment in areas of track irregularities, were negotiating an entry spiral of a three- to four-degree compound curve at underbalanced speed.

Cape Breton and Central Nova Scotia Railway (CBNS) has put a program in place to identify and prioritize areas where excess superelevation conditions exist. This program covers maintenance, tie installation, and curve elevation reductions. Fifty-seven curves with excess elevation were identified on the Hopewell Subdivision. Fifty-one have already been repaired, and the balance will be corrected in the 2005 Tie and Surfacing Program.

- approximately 21.4 miles of surfacing was performed;
- over 21 000 feet of gauging was performed; and
- 10 234 ties, as well as additional spikes, were installed.

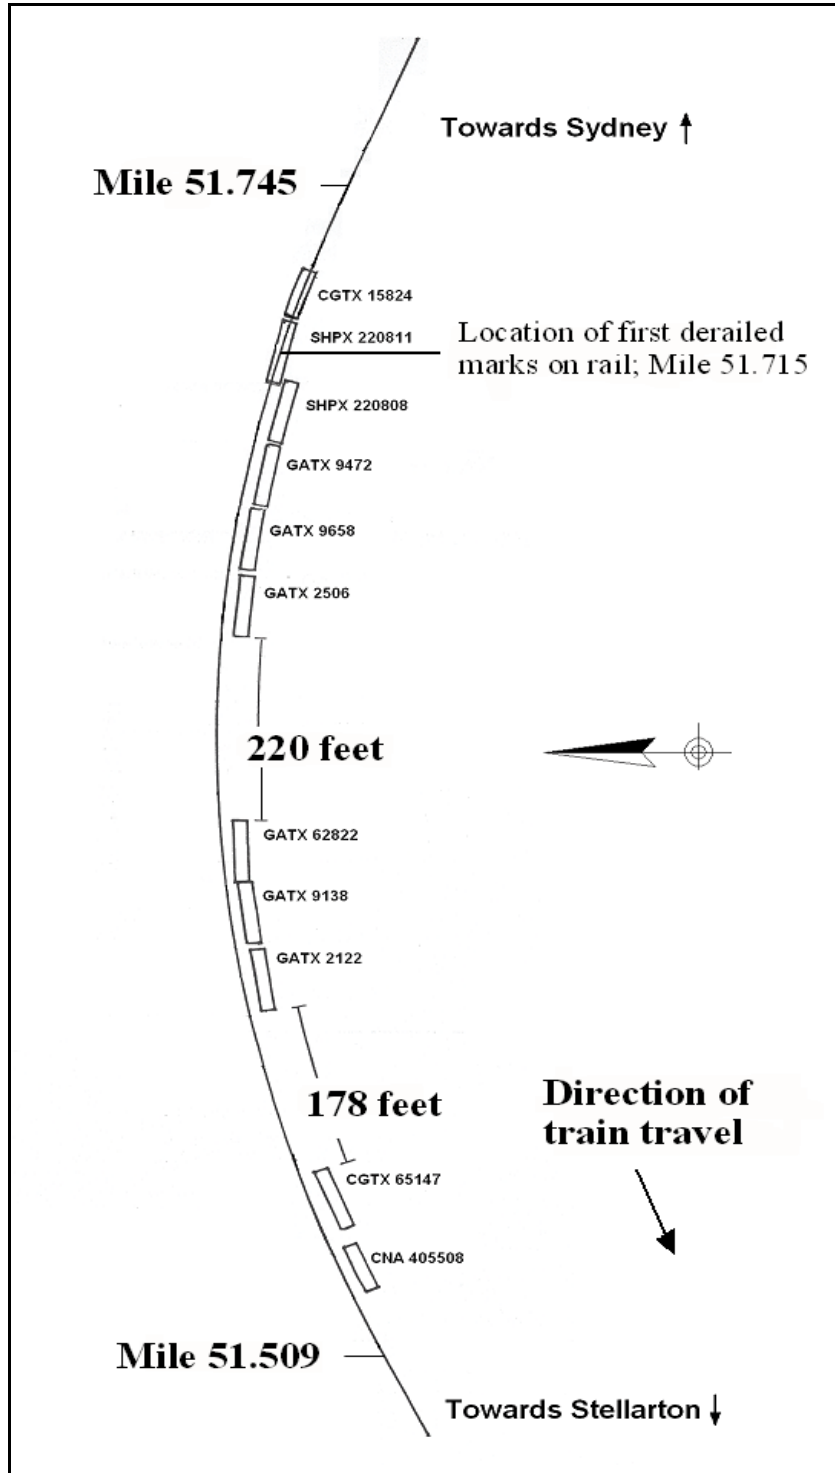
Appendix A – Schematic Identifying and Showing the Approximate Position of Derailed Cars

The derailed cars were in three groups (see Appendix A). There were several fractured car parts among the third, fourth, and fifth derailed cars. These were:
