RAILWAY INVESTIGATION REPORT

R04Q0016

MAIN-TRACK DERAILMENT

LINTON, QUEBEC

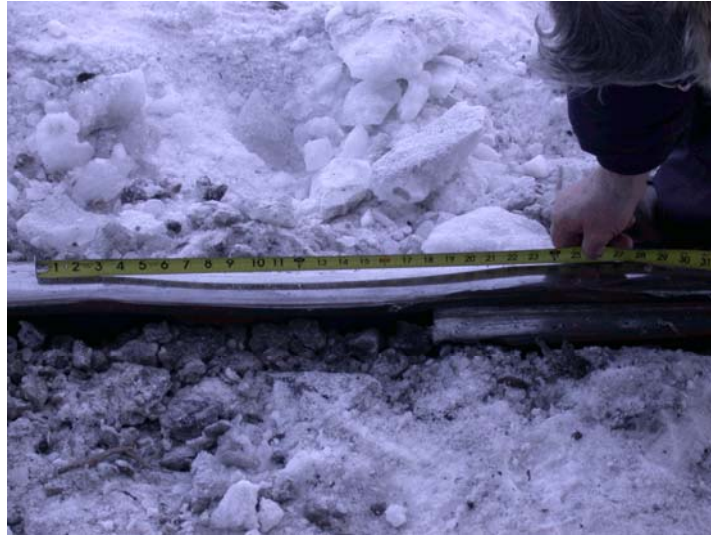
The rail was rolled in 1952, but there is no documentation indicating where it came from or when it was laid. Vertical rail wear was 9 mm and lateral wear was 5 mm, exceeding the wear limits prescribed by SPC 3200 for jointed rail, which are 8 mm for vertical wear and 13 mm for combined (lateral and vertical) wear. The rail had a crushed head (see Photo 1) 10 mm in depth located 410 mm from the north rail joint and about 1 m from the rail fracture.

The crushed rail head was not noted in the bi-weekly inspection records. The TSR do not define a crushed rail head as a defect. It is considered a defect in SPC 3207 when the depth reaches 10 mm, but no corrective action is required.

1. The west rail failed suddenly as the 28th car in the train rolled over it, causing the train to derail.
2. The failure progressed from a vertical split head on the inside of the rail.
3. The age and wear of the rail and the presence of the crushed rail head suggest that the fatigue resistance of this section of rail was exhausted.

CN has increased the frequency of the visual inspection from twice a week to three times a week. SPC 3207 has been amended; it now includes criteria for remedial action for crushed rail heads.
