RAILWAY INVESTIGATION REPORT
R05C0082

MAIN-TRACK DERAILMENT

CANADIAN PACIFIC RAILWAY

MILE 69.2, RED DEER SUBDIVISION

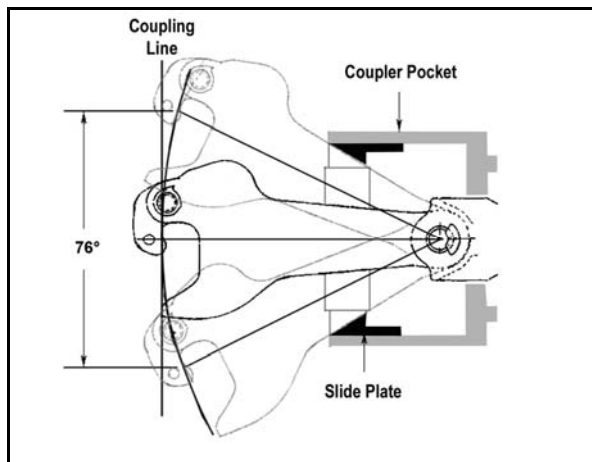
Figure 3. Coupler without alignment control

The alignment control feature on the coupler restricts the lateral movement of the drawbar when longitudinal in-train forces are in compression, or buff. A lower drawbar angle reduces the lateral forces placed on the track at the wheel-rail interface and consequently lowers the possibility of derailment from rail rollover. Couplers without the alignment control feature

provide a greater range of coupler movement while negotiating tight curves in yards and industrial spurs. Alignment control couplers, under buff conditions, can limit the drawbar angle to +/- 17 degrees, while couplers without alignment control permit a drawbar angle as large as +/- 34 degrees.⁴ The locomotive manufacturer recommends that bolster stops⁵ be installed when locomotives without alignment control features operate in consists with units capable of generating high dynamic effort.

⁴ The drawbars on the GP 9 locomotives equipped with couplers without alignment control can achieve an angle of +/- 34 degrees.

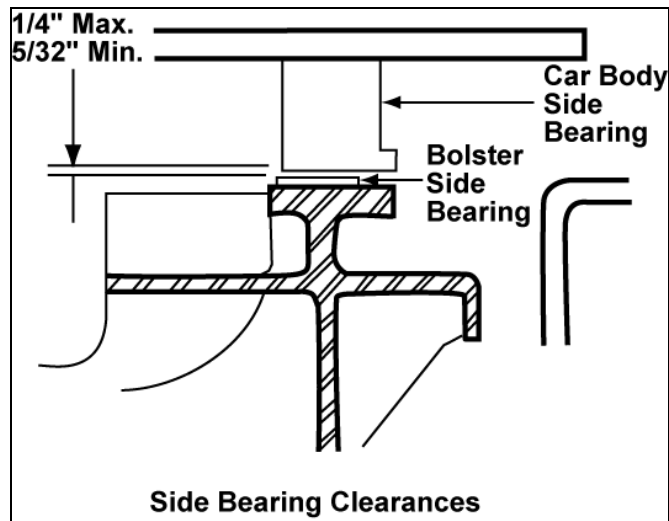
Figure 5. Diagram of side bearing clearances

- the bolster stop had broken off prior to the accident, and
- the lubricant had migrated to the centre of the truck bolster bowl and the remainder of the liner was inadequately lubricated resulting in excessive wear. The excessive wear resulted in zero side bearing clearance.

- inadequate truck bolster bowl lubrication had led to wear in the liners to create zero side bearing clearance; and
- the missing bolster stop on the left side of No. 2 truck.

Each locomotive truck has a side bearing mounted on either side of the truck bolster matching a car body side bearing on the locomotive underframe (see Figure 5). General Motors (GM) prescribed a minimum side bearing clearance of 5/32 inch; however, CPR allowed that, before the clearance decreased to 1/32 inch, the truck bolster bowl wear plate liners must be checked for wear and replaced, if necessary. No measurement of side bearing clearance was recorded on inspection reports to indicate if the locomotive side bearing clearance met the manufacturer's specifications and was in compliance with Transport Canada (TC) rules.

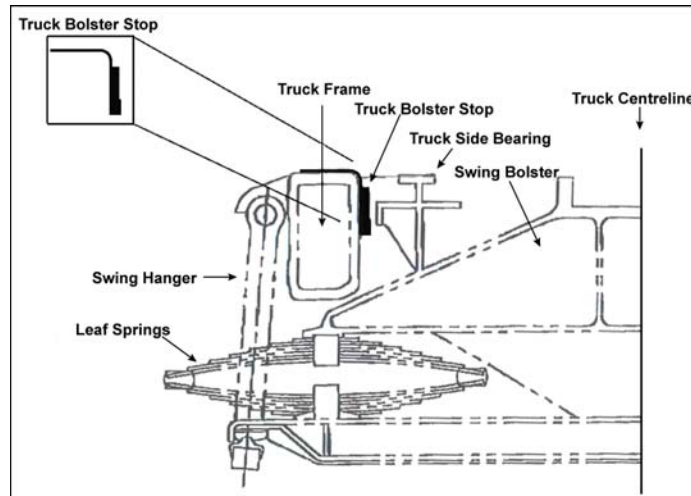
Figure 6. Diagram of truck bolster stop and side bearing

The bolster stop on the left side (east side) of the No. 2 (trailing) truck of locomotive CP 1514 was broken off. The remaining portion of the bolster stop bracket was obtained for analysis by the TSB Engineering Laboratory (report LP 062/2005). The bracket was not fastened with bolts as per the manufacturer's specifications; it was welded to the top of the truck frame. The analysis determined that the bolster stop fractured along the bent portion of the bracket. The fracture surface revealed beach marks indicating a high cycle fatigue failure mode. Each cycle would be associated with an impact between the truck's side frame and the swing bolster assembly. No metallurgical anomalies or manufacturing defects were observed that would have contributed to its failure. It did not appear to have been a recent break.

Bolster stops are used to reduce the potential of jackknifing of locomotives not equipped with alignment control couplers. The bolster stop limits the lateral movement of the locomotive car body, thus reducing the lateral force at the wheel-rail interface generated from transformed longitudinal forces, such as experienced during episodes of heavy dynamic braking and/or slack run-ins.
