RAILWAY INVESTIGATION REPORT

R05Q0010

MAIN-TRACK DERAILMENT

CANADIAN NATIONAL

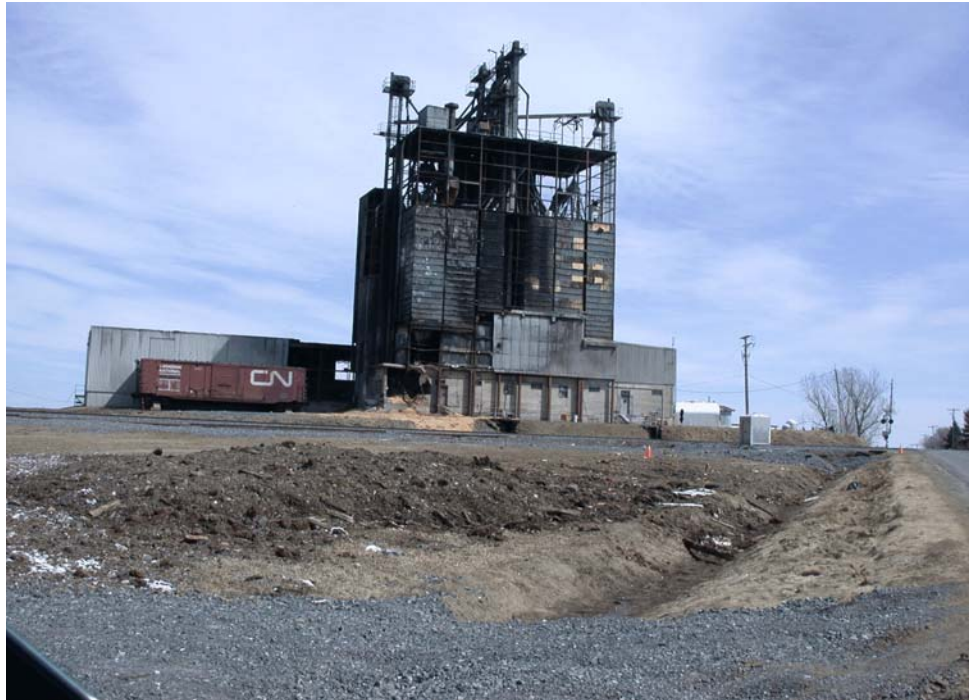
Car WC 65061 was followed immediately by three other cars loaded with scrap metal and then by tank cars CGTX 64270 and GATX 9200 carrying propane and by tank car PROX 83006 carrying chlorine. Tank car CGTX 64270 caught fire and exploded, damaging the mill, which was empty at the time of the accident (see Photo 1). Cars GATX 9200 and PROX 83006 were heavily damaged and affected by the fire, but did not lose their content. The other cars carrying dangerous goods (hydrocarbons, UN 1863) were among the last to derail. They were damaged but were not affected by the fire and did not lose their content.

Photo 1. Damaged facade of the mill (photo taken two months after the accident)

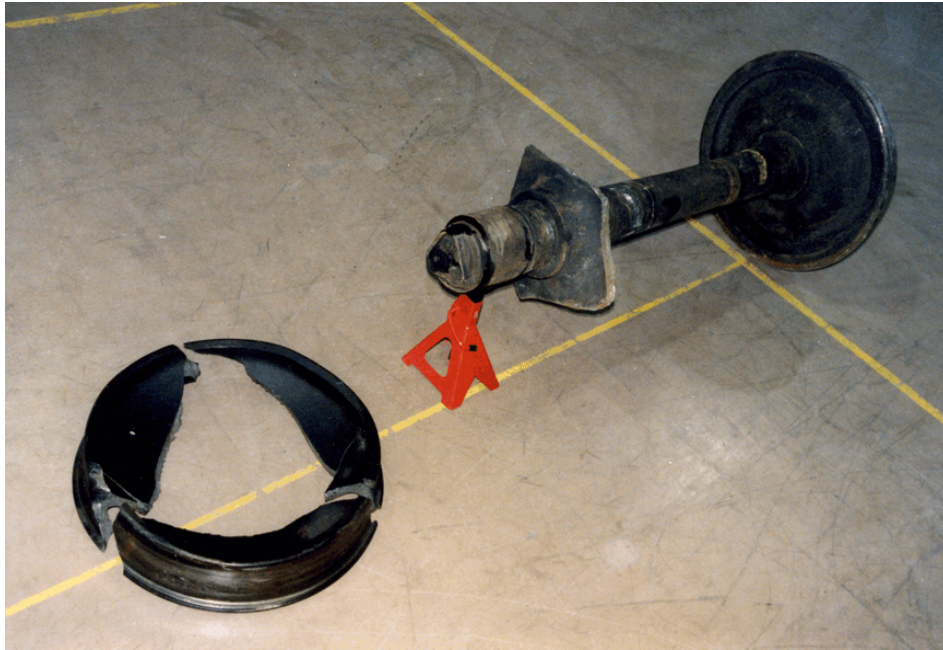
Examination of the derailed cars showed that car WC 65061 had lost its rear truck. The truck was directly westward of the pile-up of derailed cars. The wheel plate of wheel L2¹ was fractured; part of the plate remained attached to the axle and the wheel rim broke into three main pieces of equal length and a small fragment (see Photo 2).

Photo 2. Axle LR2 and pieces of wheel L2

destructive tests. The degree of porosity would not have caused the wheel to be rejected because porosity is not standardized in the industry. Three fatigue cracks 10 to 15 mm long in the external part of the wheel plate spread from voids.
