RAILWAY INVESTIGATION REPORT
R06Q0046

MAIN-TRACK TRAIN DERAILMENT

CANADIAN NATIONAL
FREIGHT TRAIN M-36921-15
MILE 137.68, LAC SAINT-JEAN SUBDIVISION
LAC BOUCHETTE, QUEBEC
15 MAY 2006

Report Number R06Q0046

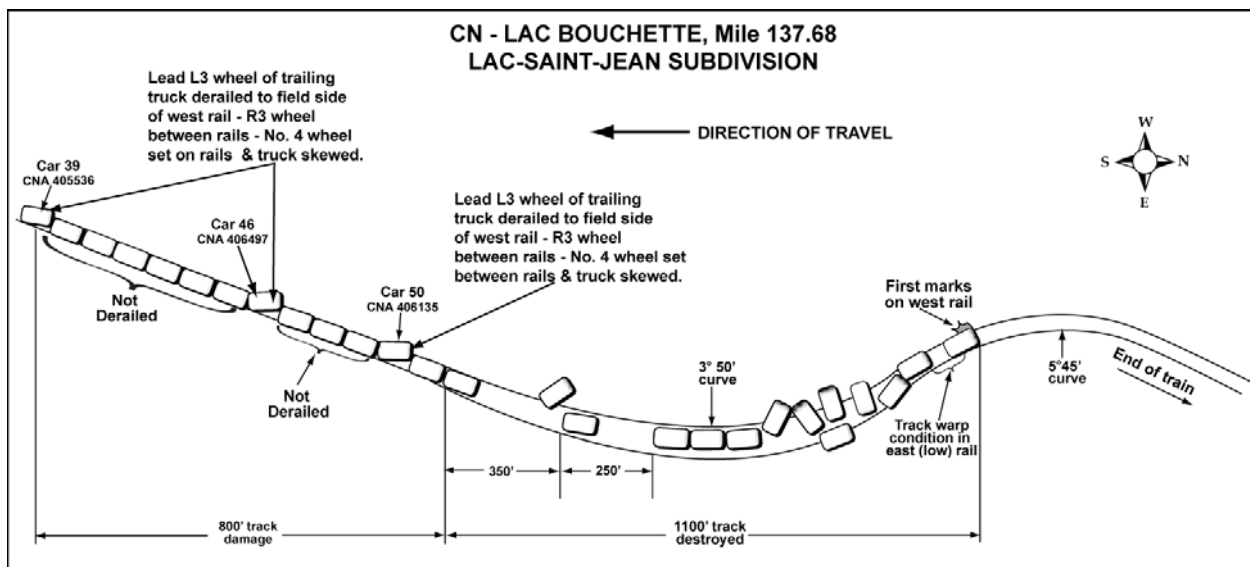
Figure 2. Accident site diagram

At the north end of the derailment site, three wheel flange marks were observed on the head of the west (high) rail. They were located at the entry of the exit spiral² of a left-hand curve, in the direction of train travel, at Mile 137.68. The marks extended southward diagonally from the gauge side over a distance of 18 inches. Three feet away, the field side spike heads and tie ends were damaged. The tie end damage extended southward for about 20 feet. Wheel marks and tie damage were observed on the gauge side of the east rail. Track damage extended 1900 feet to the south, ending at the trailing truck of the first derailed car, CNA 405536 (the 39th car from the head end). The next cars to derail were CNA 406497 (the 46th car), CNA 406135 (the 50th car) and the following 15 cars (51st to 65th).

The first three derailed cars remained upright. Their trailing trucks were skewed with their leading wheel set derailed to the field side of the west rail. The trailing wheel set of the third car had fallen between the rails. The 51st to 65th cars came to rest in various positions along the right-of-way (see Figure 2).

The track damage led back to Mile 137.68, where the three wheel flange marks were observed on the head of the west rail. The orientation of the marks and the position of the derailed leading wheel sets in the trailing trucks of the 39th, 46th and 50th cars suggest that they derailed at that location. The flange marks may have resulted from either wheel climb or wheel lift. The mechanical teardown inspection of the trucks from the first three derailed cars did not reveal any common factor that was conducive to wheel climb because the truck components exhibited different wear patterns. Furthermore, the lack of markings on the gauge face of the rail indicates that the derailment was initiated by wheel lift, which occurred as the first three cars to derail were entering the exit spiral of the left-hand curve.

The lead wheel of each trailing truck unloaded on the high rail, which resulted in wheel lift and the derailment of the wheel set. The trailing truck in each of the cars became skewed, exerting spreading forces on the rails. The trailing wheel set of the 50th car fell between the rails, leading to the derailment of the following 15 cars.
