**RAILWAY INVESTIGATION REPORT
R06V0111**

TRAIN COLLISION AND DERAILMENT

**BETWEEN ROCKY MOUNTAIN VACATIONS INC.
PASSENGER TRAIN RMV P61051-21
AND CANADIAN NATIONAL
SWITCHING MOVEMENT YKSS30
KAMLOOPS YARD
KAMLOOPS, BRITISH COLUMBIA
21 MAY 2006**

Report Number R06V0111

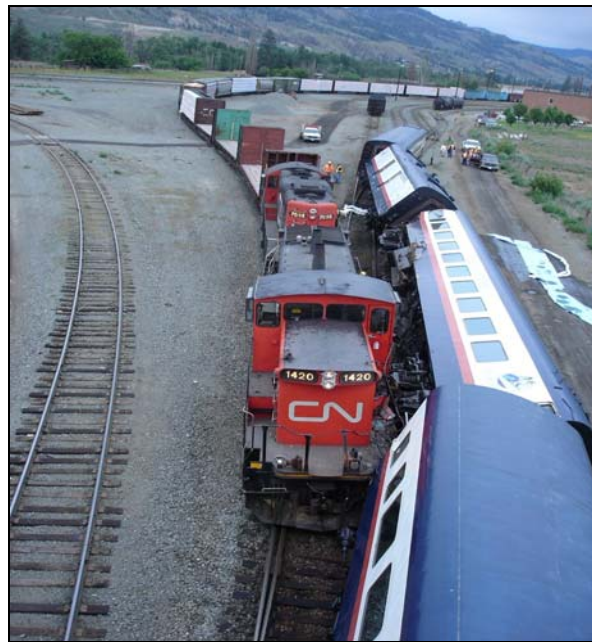
The RMV crew members heard the brakes being applied on the locomotive of the switching movement.¹ The locomotive engineer on the CN switching movement exited the cab of locomotive 1420, gestured to the two RMV employees, then re-entered the cab. No emergency brake application was made on the RMV train. The RMV locomotive had stopped, but the passenger cars at the front of the movement were still moving slowly when the CN switching movement struck RMV 9272, the second car from the leading end. The collision caused the derailment of the four leading cars of the passenger train, with the third car, passenger car 3200, derailed on its side as shown in Photo 1.

Photo 1. Derailed passenger cars

The post-derailment condition of the RMV train was as follows from tail end to head end (north to south):

RMV 3217 - Leading passenger car derailed; one wheel off the rail and in the air

RMV 9272 - Generator car derailed, leaking diesel fuel

RMV 3200 - Passenger car derailed on side

RMV 3203 - Passenger car derailed all wheels, upright

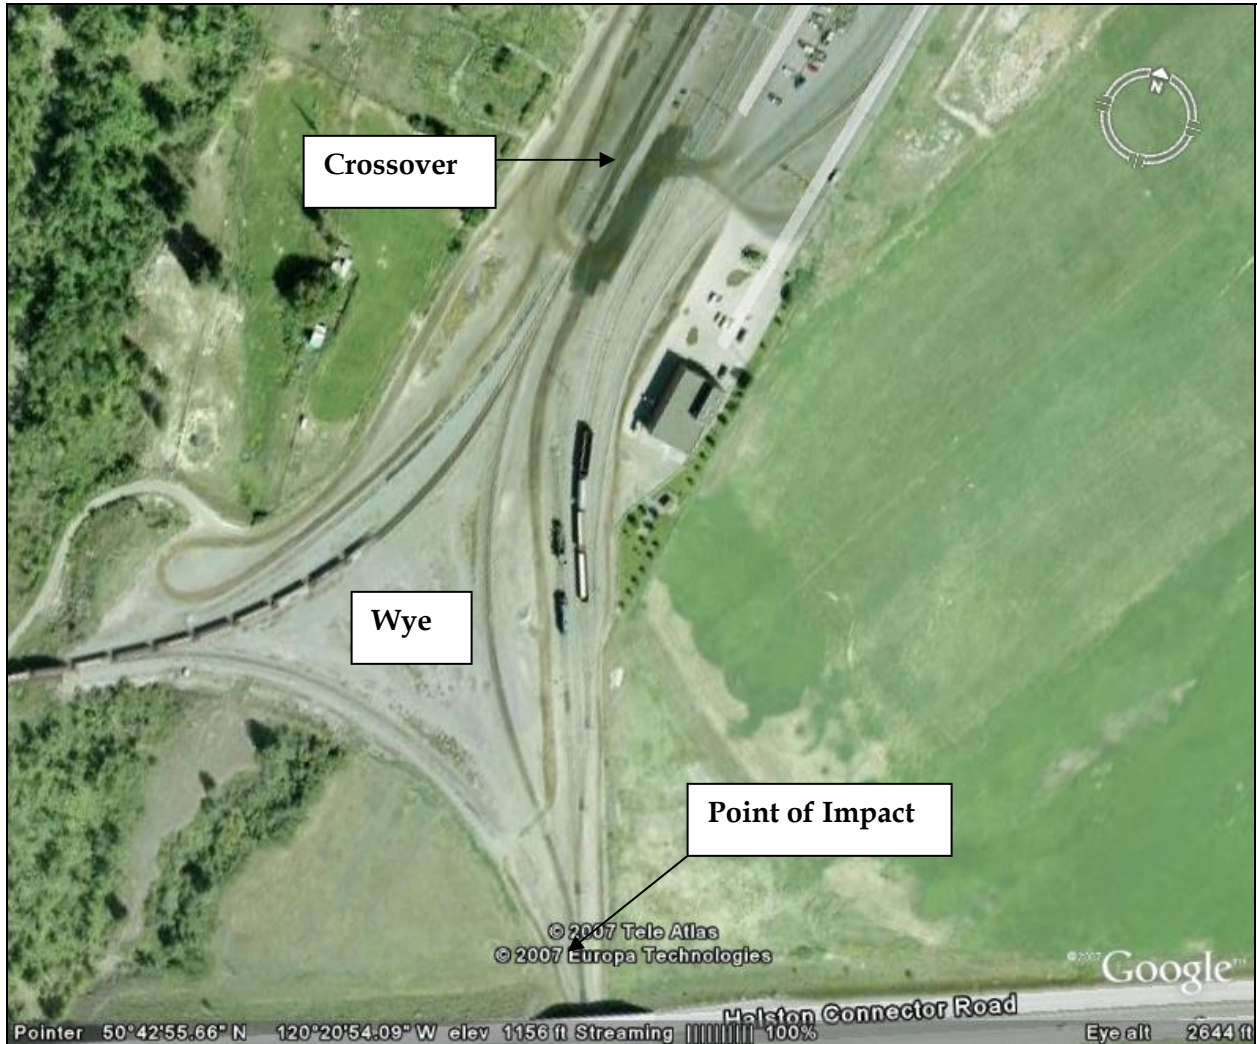
There is a wye at the west (geographic south) end of Kamloops Yard formed by the beginning of the Ashcroft Subdivision, end of the Clearwater Subdivision and the OCT. The 3.5-mile-long OCT provides RMV access to downtown Kamloops, Kelowna Pacific Railway, and Canadian Pacific Railway trackage and is used as a switching lead by CN. Northbound traffic approaching the yard on the OCT can be observed by southward yard movements from the crossover area in the yard, but as they continue southward toward the OCT on the south leg of the wye, the track curves westward and the view becomes obstructed by the Halston connector road embankment and overpass. There is a clear view from the yard west of the crossover of northbound traffic on the OCT coming into the yard once it clears the highway overpass near the OCT wye switch.

At the time of the incident, the view from the yard was also partially obscured by trees near the highway overpass west approach span. The RMV crew members indicated that, as the train backed up past the wye switch into the yard, they could see the CN switching movement coming across the crossover (see Photo 2).

Photo 2. Aerial view of Kamloops wye

Canadian National (CN) cut down the trees under the highway overpass west approach span to improve sightlines down the Okanagan connecting track (OCT). In addition, Operating Bulletin BC068 issued on 26 May 2006 advised operating employees that a sign had been erected on the OCT approximately 500 feet south of the overpass, controlling northward movements, and signs had been installed at the west end clearance points of tracks KF21, 22, 23, 24, the RMV spur and east leg of the wye, controlling movement onto the OCT. All movements must not pass these signs unless authorized by the Kamloops yardmaster. The Kamloops yardmaster must ensure that other movements using the OCT beyond the signs are reported clear before issuing permission.
