## **RAILWAY INVESTIGATION REPORT**

**R06W0079**

### **DERAILMENT**

**CANADIAN PACIFIC RAILWAY**

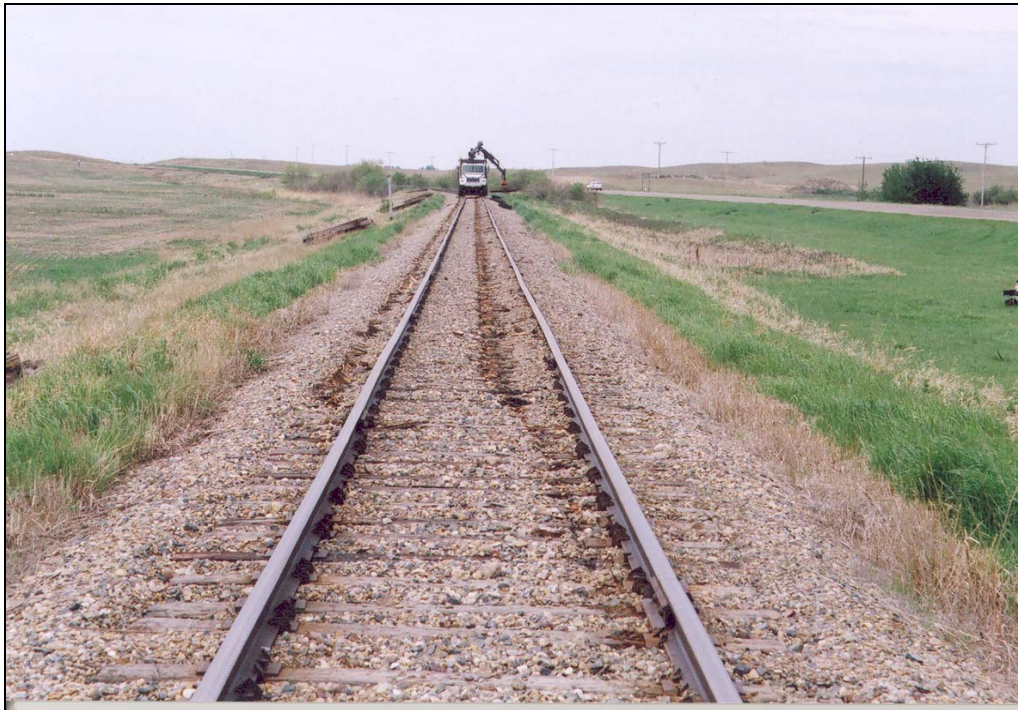
The first derailment marks found on the rail were at Mile 17.4. A second set of marks were found at the east end spiral of the curve at Mile 17.6. At both locations, the south wheel derailed to the field side of the rail, and the north wheel dropped into the gauge side of the rail (see Photo 1).

**Photo 1.** Point of derailment (Mile 17.4)

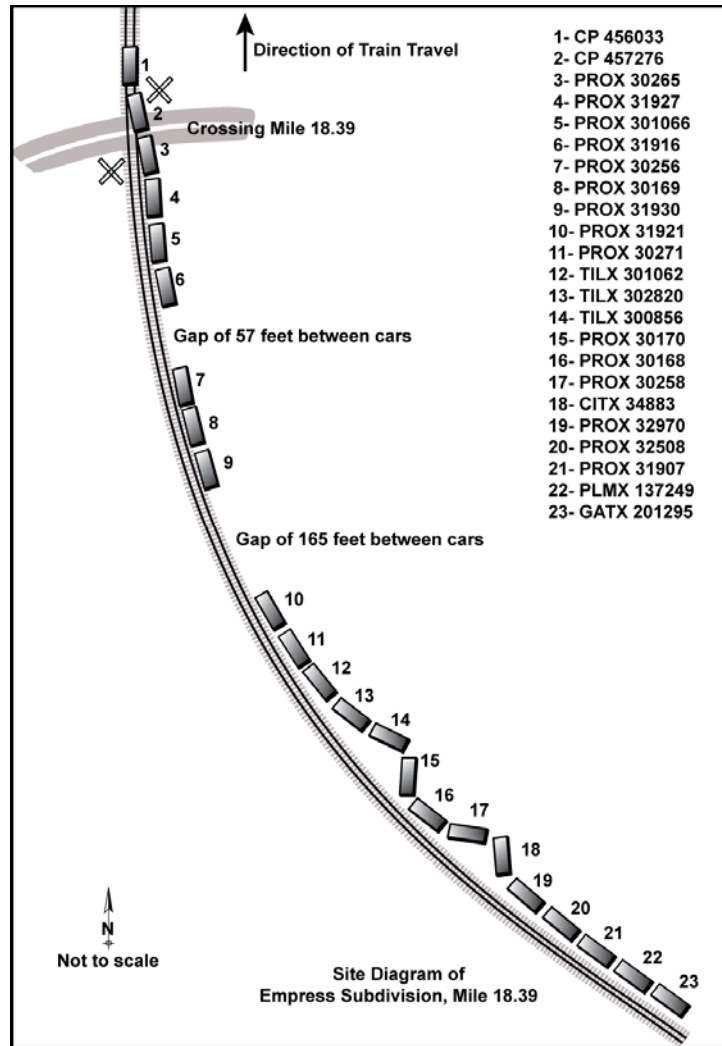
The 22 derailed cars (71st car – CP457276 to 92nd car – GATX201295) came to rest in the vicinity of Mile 18.39 (see Figure 2). The lead locomotive came to a stop at Mile 19.16.

Figure 2. Schematic of derailment site
