RAILWAY INVESTIGATION REPORT
R07W0042

NON-MAIN-TRACK TRAIN COLLISION

CANADIAN NATIONAL
HUMP ASSIGNMENT
MILE 145.20, SPRAGUE SUBDIVISION
SYMINGTON YARD, WINNIPEG, MANITOBA
13 FEBRUARY 2007

Report Number R07W0042

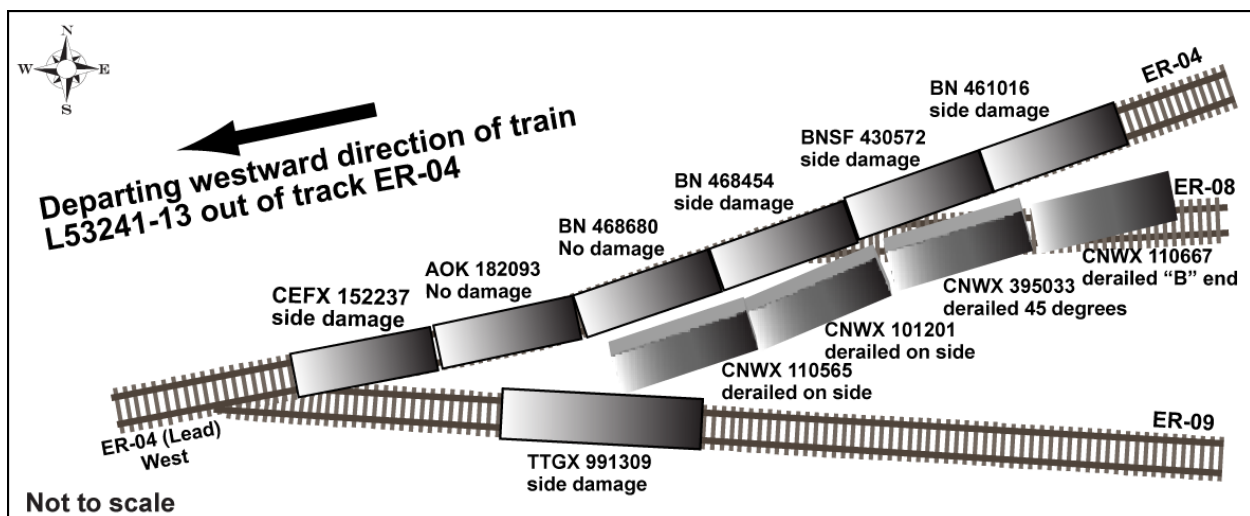
Figure 2. Accident site diagram

Subsequent inspection determined that, as a result of the train collision, four empty covered hopper cars at the west end of the assignment had derailed. The first two derailed cars (CNWX 110565 and CNWX 101201) were on their side, the third car (CNWX 395033) came to rest at a 45-degree angle and the fourth car (CNWX 110667) was upright with the “B” end derailed. On the outbound train, three covered hopper cars loaded with grain (BN 468454, BNSF 430572 and BN 461016) and one empty covered hopper car (CEFX 152237) sustained side damage during the collision. In addition, a stationary empty auto rack car (TTGX 991309), which was part of a cut of cars stored in adjacent track ER-09, was damaged (see Figure 2).

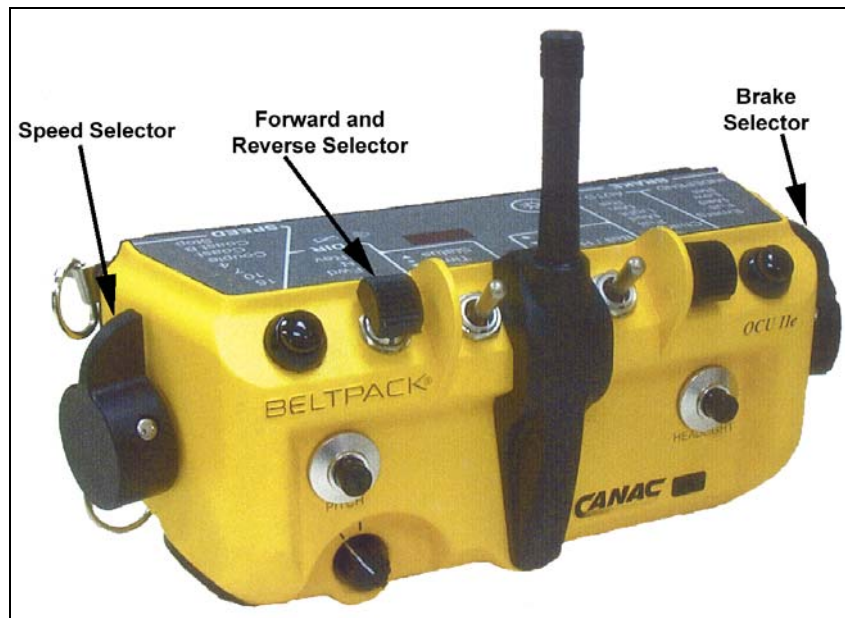
Photo 1. Beltpack operator control unit

During Beltpack® operations, the operator uses an OCU, which is a small three- to five-pound box attached to the operator's safety vest (see Photo 1). By transmitting radio commands to the locomotive, the OCU permits the operator to remotely activate a number of locomotive controls. The commands are received and processed by a computer on board the locomotive that initiates the appropriate response. The Beltpack® OCU is equipped with a speed selector, a reverse selector and brake selector, which includes an emergency brake feature.

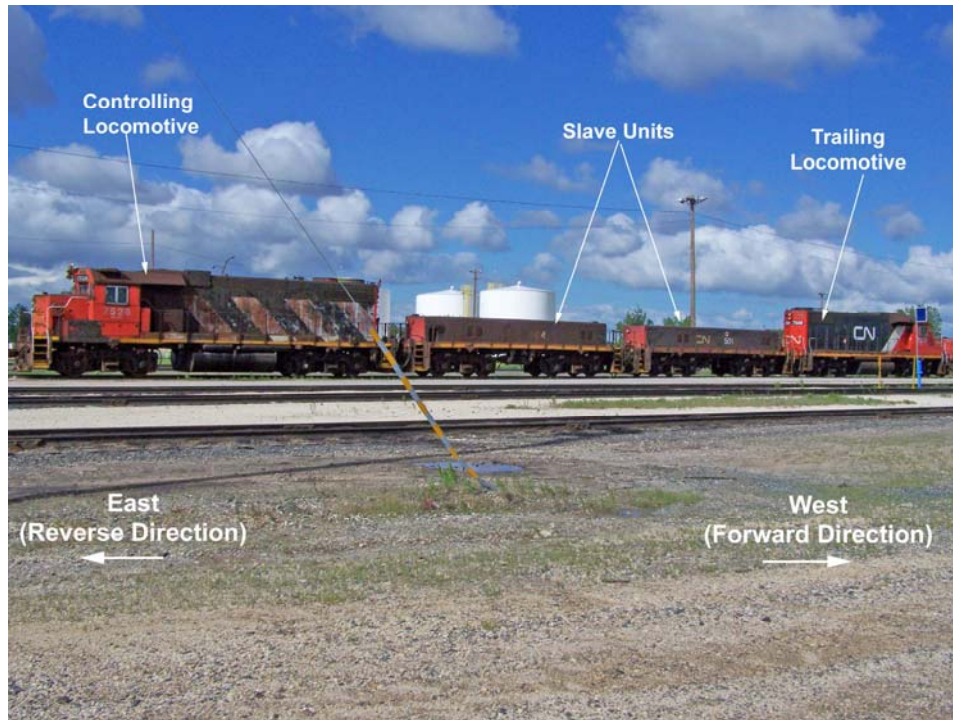
Photo 2. Normal hump set configuration at Symington Yard

The locomotive consist for the assignment was arranged in the hump set configuration normally used at Symington Yard (see Photo 2). In a hump set, the locomotives are set up as follows:

- The east locomotive (controlling unit) has the long nose trailing.
- The middle two units are slave units (that is, traction motor units with no locomotive cab).
- The west locomotive (trailing unit) has the long nose leading. (Note: In this occurrence, this locomotive was coupled to the cars in track ER-08.)

At Symington Yard, the east direction is designated as reverse and the west direction is designated as forward. Therefore, the Beltpack® OCU is configured such that, for the hump set to travel eastward, the reverse direction is selected on the OCU. Similarly, for the hump set to travel westward, the forward direction is selected on the OCU.

This hump assignment configuration, which has a symmetrical visual appearance, does not allow one to visually determine the direction of travel based only on the physical appearance of the hump set.
