RAILWAY INVESTIGATION REPORT
R09Q0030

DERAILMENT

CANADIAN NATIONAL
YARD ASSIGNMENT YLUS-30
MILE 14.80, BRIDGE SUBDIVISION
LIMOILLOU YARD
QUÉBEC, QUEBEC
17 JULY 2009

Report Number R09Q0030

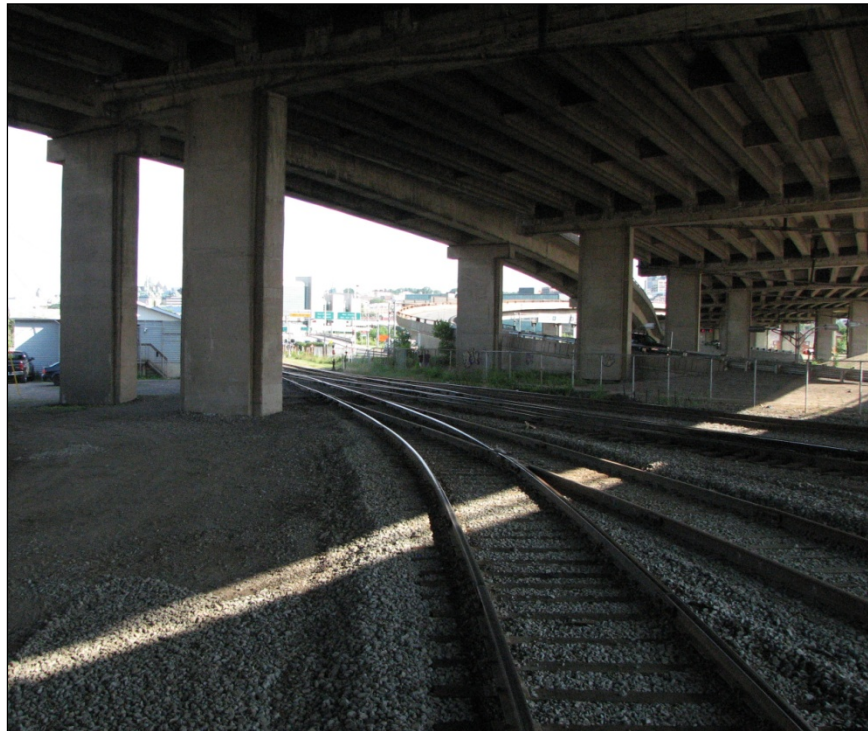
The TSB carried out a simulation in conditions similar to those prevailing on the day of the accident to determine the visibility distances of the yellow target on the switch stand mast. It was found that, from the helper's position, for a westbound movement on track EL02 approaching turnout EL18, the target on the switch stand mast remains hidden by a column of the Dufferin-Montmorency Highway viaduct structure for almost the entire distance (see Photo 1). It becomes visible only at a distance of 100 feet.

Photo 1. View to the west of the approach to turnout EL18

Based on the simulation done in conditions similar to the ones prevailing on the day of the accident, it was found that, from the helper's position, the target on the switch stand mast became visible only at a distance of 100 feet because it remained hidden behind a viaduct column throughout most of the time. Since the braking distance at a speed of 6 mph is 140 feet, the assignment could not be stopped before the turnout and would have trailed through the switch, even if the helper had observed the target and applied the brakes.
