RAILWAY INVESTIGATION REPORT
R10D0077

MAIN-TRACK DERAILMENT

CANADIAN PACIFIC RAILWAY
FREIGHT TRAIN 159-23
MILE 22.2, WINCHESTER SUBDIVISION
SAINT-LAZARE, QUEBEC
23 SEPTEMBER 2010

Report Number R10D0077

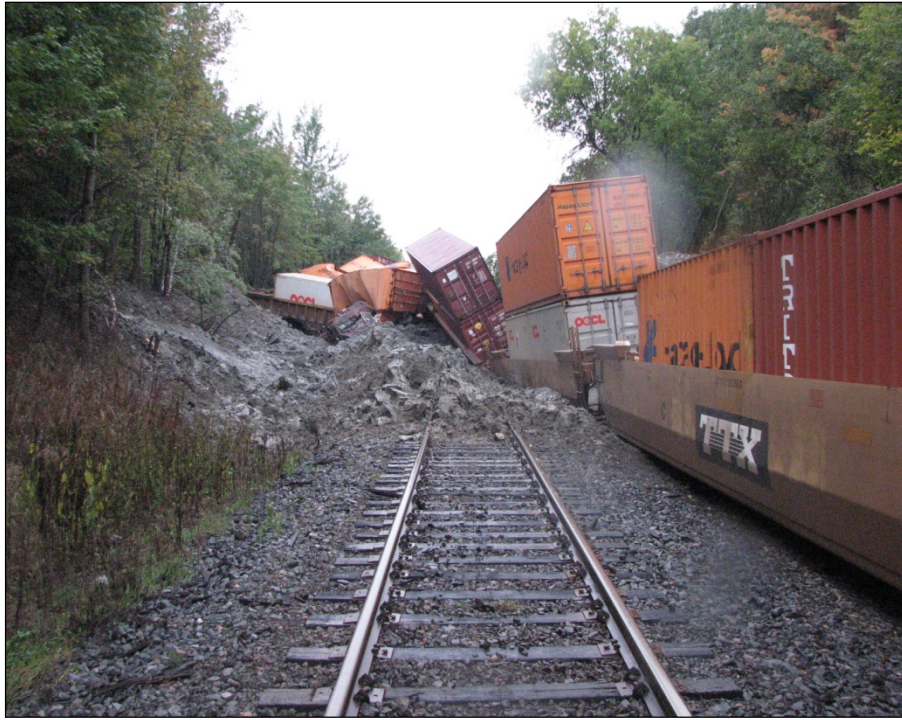
Around 2330,¹ the train left Dorion, Quebec using the north main track. While the train was travelling at 50 mph, it passed the 221 signal (Mile 22.1), which was showing a clear indication, and the crew noticed that the track ahead was obstructed by debris. The engineer reduced the throttle and initiated an emergency brake application. The train was unable to stop before hitting the debris and derailling (see Photo 1).

Photo 1. Clay on the tracks – looking westward

The train derailed when it struck a thick layer of sensitive clay that had slid down from the terrain north of the track. The analysis will focus on the factors that contributed to the landslide, inspection of the track and adjacent area, and applicable legislation regulating non-railway activities in areas adjacent to the railway right-of-way.

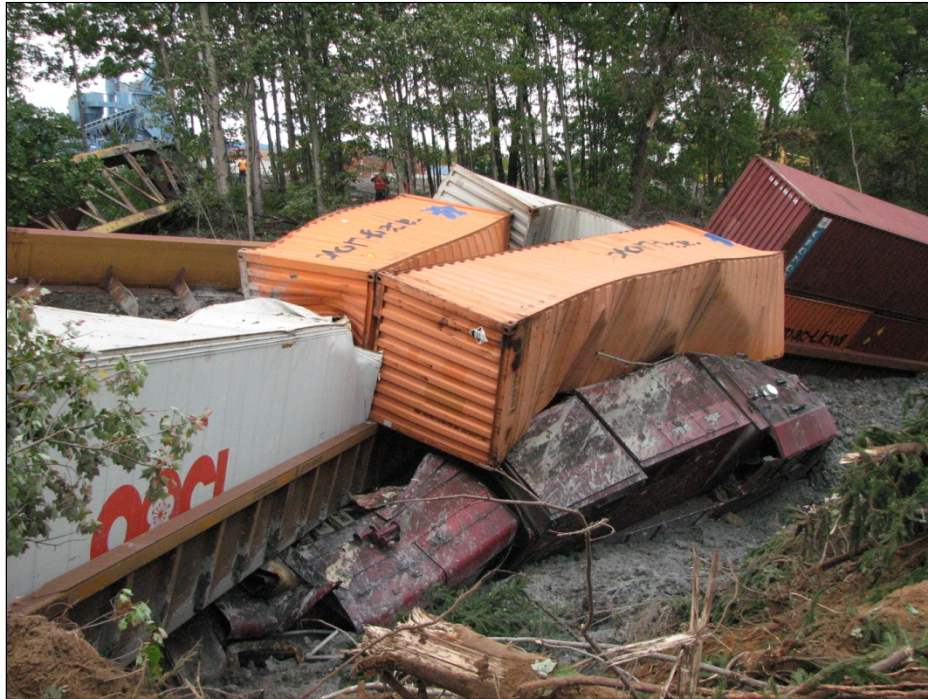
The double-stack container cars (1st to 9th car) had lost their trucks, derailed and piled up on the track, with some cars on top of the locomotives (see Photo 2). The 10th and 11th cars, which were multi-platform container cars, derailed. The 10th car climbed up and derailed on the south side, and the 11th car stayed upright on the roadbed.

Photo 2. Cars piled up on top of locomotives

Once the crew saw that the track was obstructed by debris, the locomotive engineer initiated an emergency brake application. However, the train was not able to stop before hitting the debris. Upon impact, the locomotives and the first 11 cars derailed and piled up.

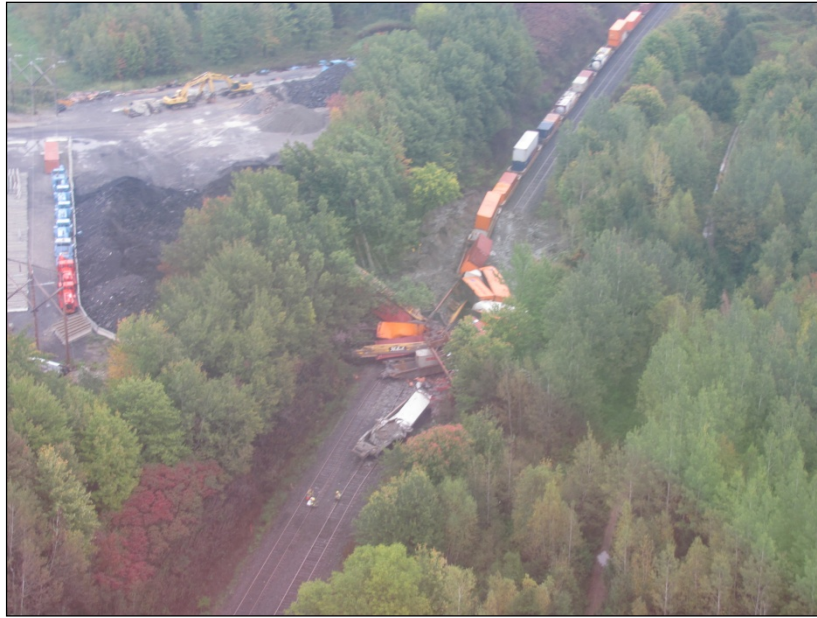
The derailment zone is bordered on the north side by an asphalt plant (lot 1 673 921 on Rue du Plateau, in the municipality of Vaudreuil-Dorion) that produces asphalt mix (see Photo 3). In the wooded area between the plant grounds and the track, the trees were tilted northward, and there were cracks in the ground several feet deep and wide. At the edge of the wooded area, concrete Jersey barriers enclosed a storage area for scrap asphalt mix. The storage scrap pile was approximately 15 feet high. The soil had failed under the storage scrap pile, causing the formation of shear cracks and the collapse of the storage scrap pile.

Photo 3. Aerial view of the derailment zone and the storage scrap pile

In the wooded area between the plant grounds and the railway right-of-way, the ground collapsed under the storage scrap pile and slid towards the track. The trees were tilted northward, and there were cracks in the ground several feet deep and wide. These characteristics suggest that the rupture was a deep circular surface rotational motion triggered by the overload imposed by the storage pile for scrap asphalt mix. When the ground slid, the soil mass broke apart, causing cracks to appear and the ground in the affected area to collapse.

The two stability analyses conducted independently by the TSB and CP determined that the higher the storage scrap pile, the more likely the slope will experience a deep rupture. For a 15 feet high storage scrap pile, the safety factor for a landslide is less than 1, meaning that the slope is likely to slide. The asphalt scrap storage pile rendered the terrain unstable, causing a thick layer of sensitive clay to slide and obstruct the tracks.
