RAILWAY INVESTIGATION REPORT

R10Q0037

MAIN-TRACK DERAILMENT

MILE 165.80, SAINT-MAURICE SUBDIVISION

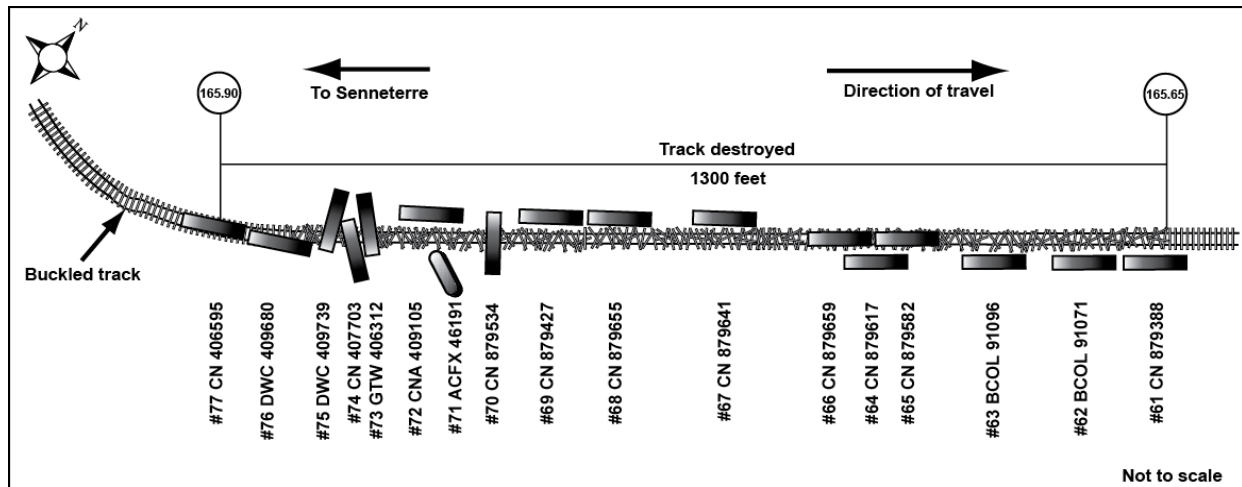
The derailment zone covers a distance of approximately 1300 feet (see Figure 2). The derailed equipment consisted of 10 gondola cars loaded with wood chips, 1 empty covered hopper car (residue of sodium cyanide UN1689), and 6 covered cars carrying newsprint.

Figure 2. Schematic of accident site

The first 4 derailed cars, the 61st to the 64th, were tipped on their side on the south side of the track. The next 2 cars (cars 65 and 66) came to rest upright on their trucks in the centre of the platform. Cars 67, 68 and 69 were tipped on their side on the north side of the track. The next cars, the 70th to the 75th, were piled up near the derailment point. The last 2 derailed cars remained upright on the track, the 76th with both trucks derailed and the 77th with only the leading truck derailed.

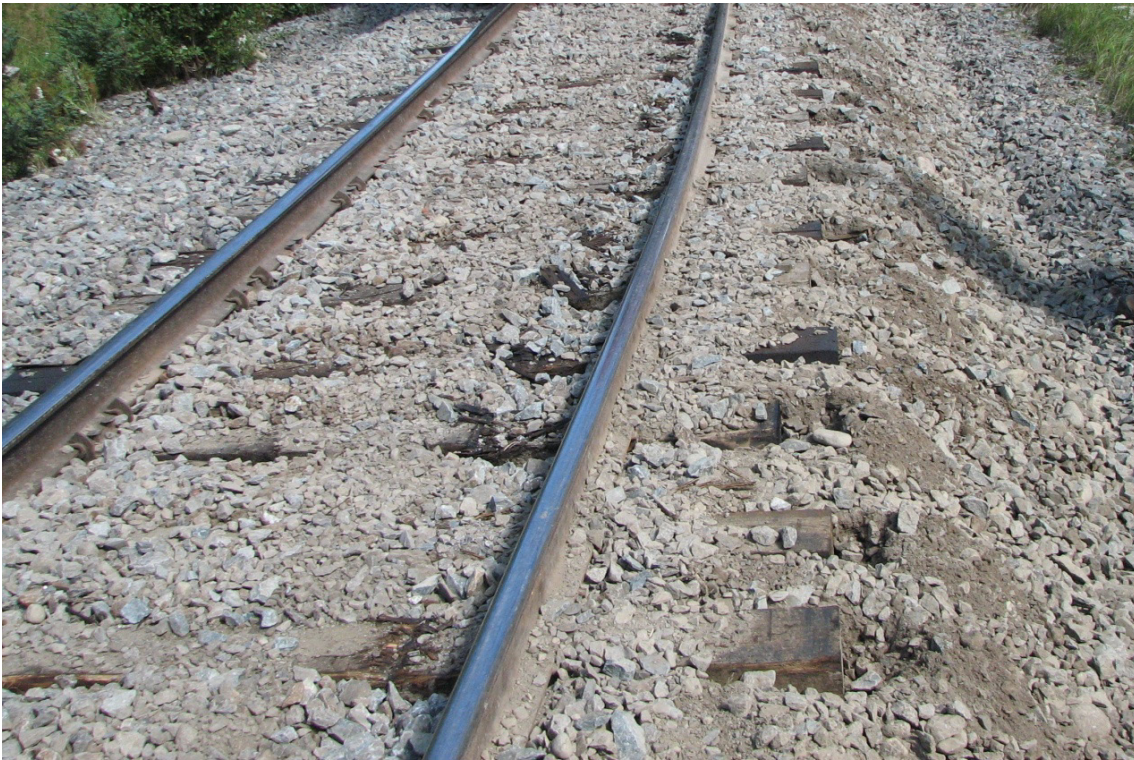
In the eastern part of the curve, about 75 feet behind the last derailed car, the track had shifted laterally about 12 inches toward the outside of the curve (south side of the track). The ballast consisted mainly of crushed rock, was in good condition and showed no signs of fouling. The ballast was disturbed and the shoulder was only about 6 inches wide (see Photo 1). Over 50% of the ties had been replaced recently.

Photo 1. Disturbed ballast at ends of ties

1. The derailment occurred when the track shifted laterally as the train was passing.
2. Since the rail-neutral temperature in the derailment area was lowered due to the work, the track became more susceptible to buckling.
3. Track levelling, tie replacement and the narrow shoulder, which was not detected during the quality control performed at the end of the work, weakened the track structure and reduced its capacity to resist lateral loads generated by the cars.

On 31 August 2010, Canadian National issued new procedures concerning the action to be taken after ties are laid and the dynamic stabilizer is used. Before normal train speed is resumed following work, a 10 mph slow order must be in place for the first 2 trains and 30 mph for the next 2 trains, and the track must be inspected after the passage of each of those trains.
