**RAILWAY INVESTIGATION REPORT
R10T0213**

MAIN TRACK DERAILMENT

**CANADIAN NATIONAL
TRAIN M31451-28
MILE 144.19 BALA SUBDIVISION
FALDING, ONTARIO
01 OCTOBER 2010**

Report Number R10T0213

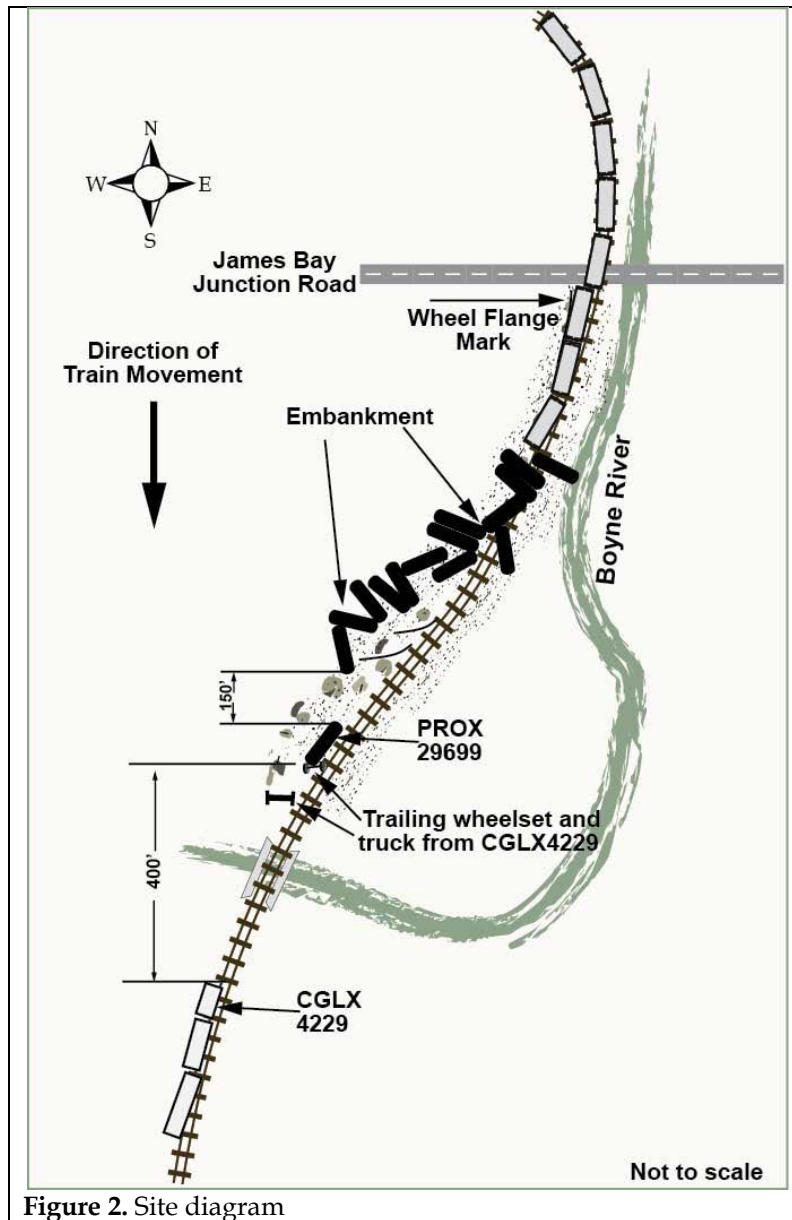
Figure 2. Site diagram

The derailed cars came to rest at the bottom of a sag ⁴ in curving, undulating territory. ⁵ Eleven feet south of the James Bay Junction Road crossing, in an exit spiral of a 5° right-hand curve (in the direction of travel) where there were flange marks on the head of the west rail (5 ties long). The marks dropped off the field side of the rail where the first wheel flange marks were observed on the ties between the rails and just beyond the tie plate ends on the field side of the west rail. The flange marks continued south into an area of destroyed track. No wheel flange marks were observed on the east rail head. About 105 feet south of the crossing, the west rail had rolled to the field side and the east rail was canted to the field side. Approximately 1 500 feet of track was destroyed.

The following 15 loaded tank cars (52nd to 66th) had rolled and jackknifed in various orientations predominantly to the west of a 350 foot portion of elevated tangent track. In this area, the west rail had rolled and shifted to the west. The derailed tank cars slid down an embankment and came to rest in a swampy area where the track entered a 2° left-hand curve. The 66th car came to rest upright on the bank of the Boyne River east of the tracks. The 67th to 69th cars had derailed upright on the web of the canted west rail, and on the ties between the rails (see Figure 2).

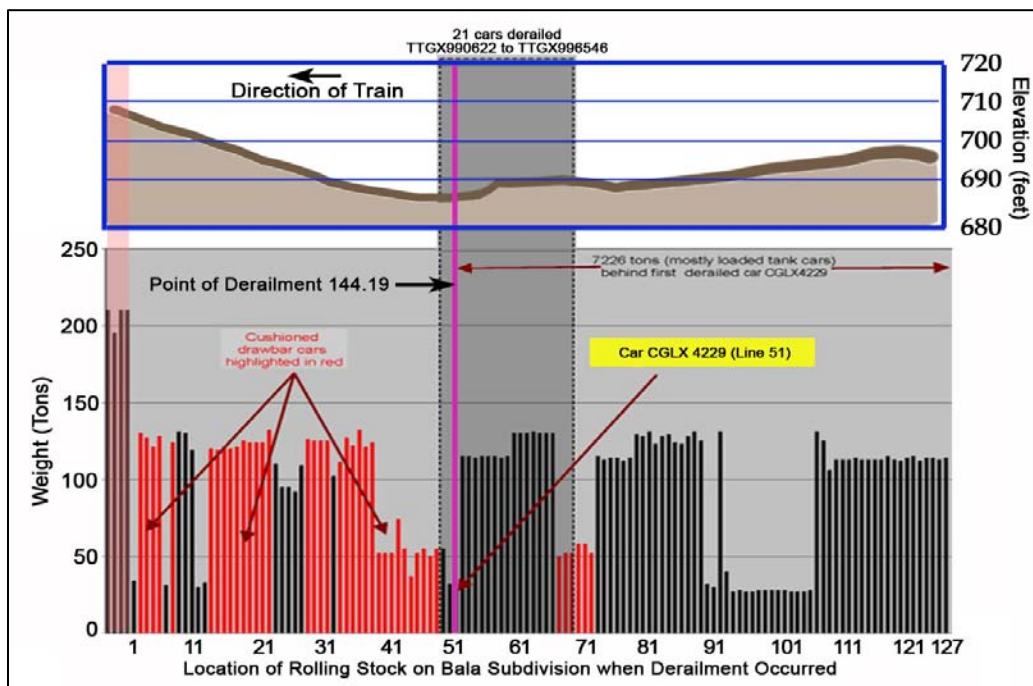
It also notes that cars with extremely low tare weights can be problematic when placed ahead of heavier cars. Specifically, short light cars are known to be susceptible to string-lining and jack-knifing when placed ahead of significant trailing tonnage. When empty, the low vertical forces acting on such cars magnify L/V ratios when coupler jack-knifing is induced by high longitudinal buff forces. Under these circumstances, these cars are susceptible to wheel climb type derailments on curves when coupled ahead of significant trailing tonnage. The position of the occurrence consist in relation to trailing tonnage and track gradient is presented in Figure 3.

Figure 3. Tonnage profile and track gradient in derailment area. EOCCD cars highlighted in red
