**RAILWAY INVESTIGATION REPORT
R11T0161**

EMPLOYEE FATALITY

**VIA RAIL INC.
TRAIN VIA 051
MILE 314.4 KINGSTON SUBDIVISION
DURHAM JUNCTION, ONTARIO
14 JULY 2011**

Report Number R11T0161

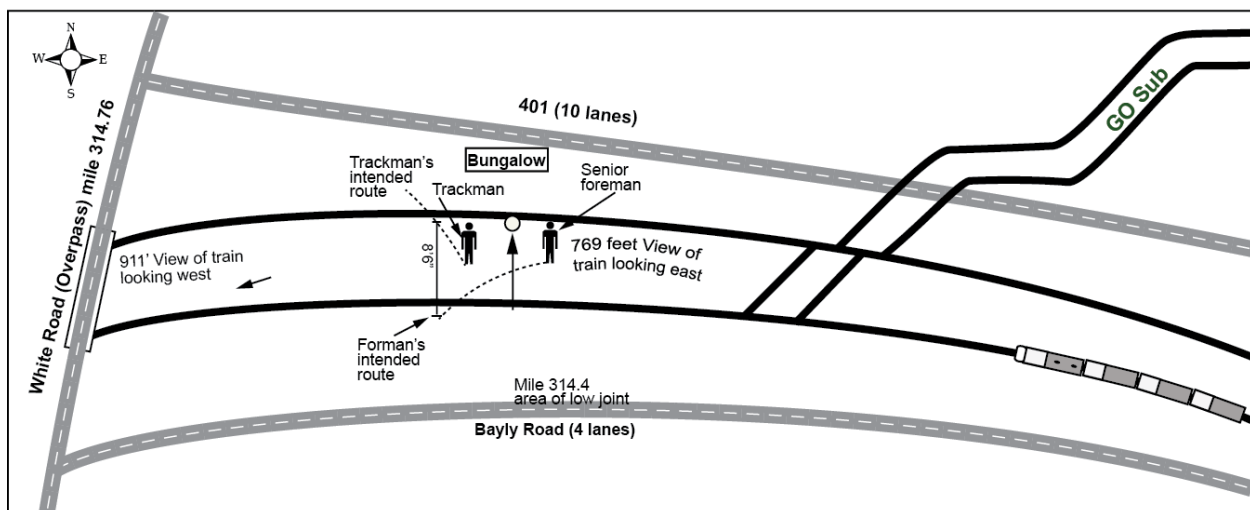
Figure 2. Accident Site Diagram (diagram not to scale)

At Mile 314.4, the trackman, who was providing the safety watch, was also actively engaged in the work. To help lift the insulated joint, the trackman jacked the track and placed his weight on the lining bar, allowing the senior track foreman to tamp slag under the ties at the low joint. During this work, neither track worker was dedicated to watching for trains. The sightline to the east of the accident location was 769 feet and the sightline to the west was 911 feet.

The accident occurred just east of the White Road overpass (Mile 314.76). Highway 401 is situated to the north and Bayly Road is situated to the south (Figure 2).
