RAILWAY INVESTIGATION REPORT
R11V0039

MAIN-TRACK TRAIN DERAILMENT

CANADIAN NATIONAL
TRAIN C 751-51-11
MILE 93.45, NECHAKO SUBDIVISION
FORT FRASER, BRITISH COLUMBIA
12 FEBRUARY 2011

Report Number R11V0039

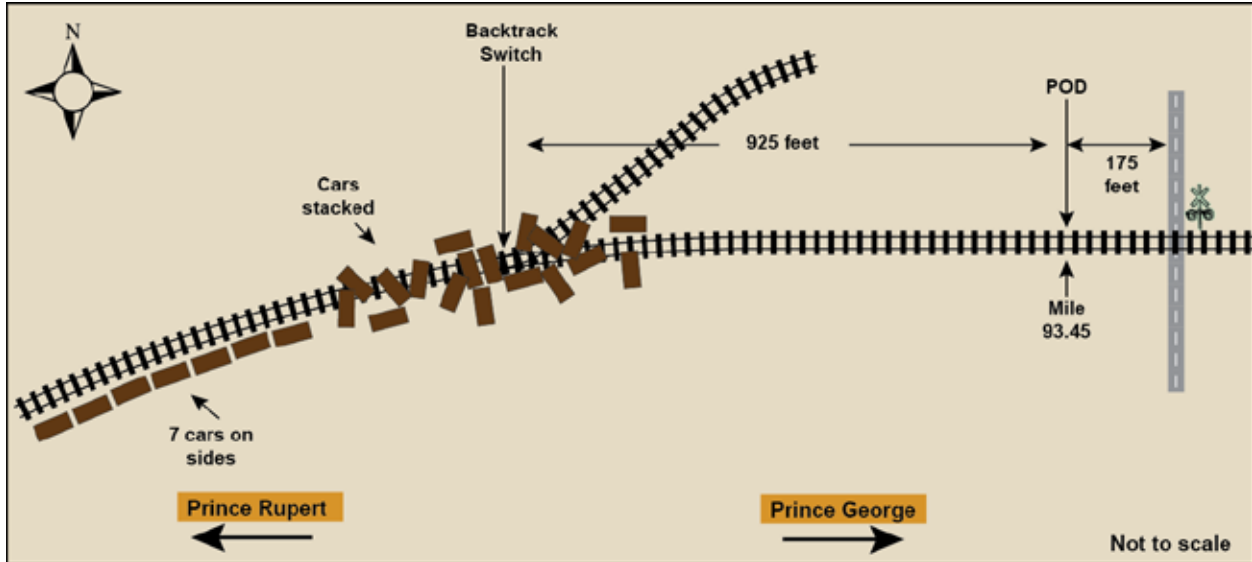
It was determined that the L2 wheel on the 62nd car, BCNE 900534, had broken and derailed to the field side of the north rail. The car then travelled approximately 925 feet where it encountered a track switch for a backtrack, precipitating the main derailment. In addition to the 62nd car, 19 cars in front (west) and 16 cars behind (east) derailed (Figure 2). The 19 cars ahead (west) derailed in a string-line fashion with 7 cars (that is, 43rd to 49th) on their sides in the body of the curve and the remaining 12 in various positions behind them.

Figure 2. Site sketch. Note: The site sketch is a schematic representation of the derailment site, and not of actual car location and quantity.

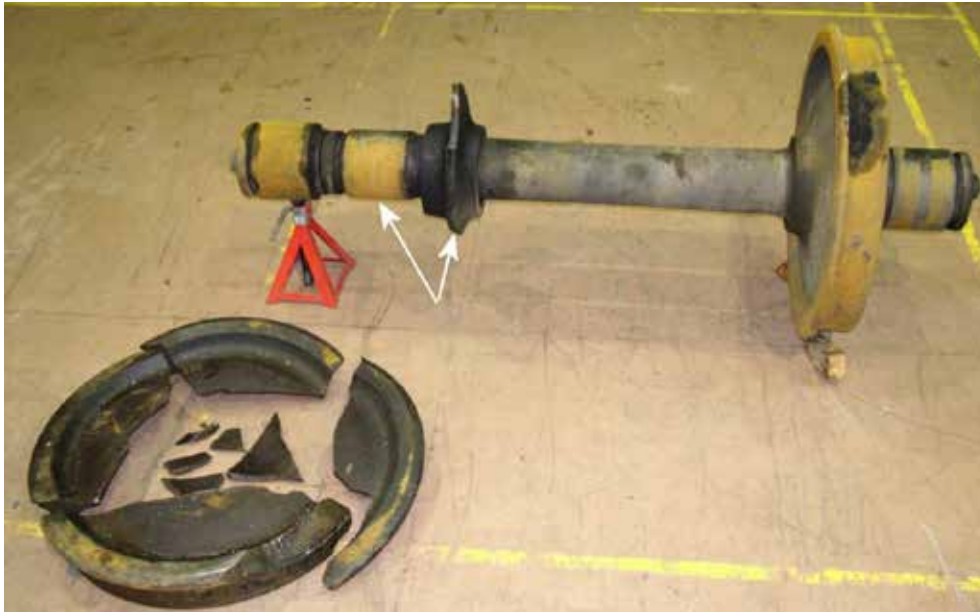
- The rim had fractured in four places.
- The hub of the fractured wheel was still on the axle (see arrows in Photo 1), but it had been forced inboard off its seat.
- The bearings adjacent to the fractured wheel and the non-fractured mating wheel were examined visually and they did not exhibit any indications of damage.
- The fractured wheel did not exhibit a rust-coloured band around its perimeter to suggest it had been overheated.
- The tread of the fractured wheel exhibited a large number of shells extending all around the circumference of the wheel. The larger shells were very close to the Association of American Railroads (AAR) maximum allowable limit, but did not exceed it.

- The shelling damage at the origin of the progressive fracture did not appear to be significantly worse than elsewhere on the tread. The tread surface of the L2 wheel also exhibited small surface cracks inclined at 45°.
- On the mate wheel, shelling was limited to a region approximately 12 inches long. This shelling did exceed both the AAR and Transport Canada's (TC) allowable limits.
- Apart from the shelling, the treads of both wheels were otherwise undamaged and they did not exhibit thermal cracks.

Photo 1. Broken L2 wheel and mate wheel

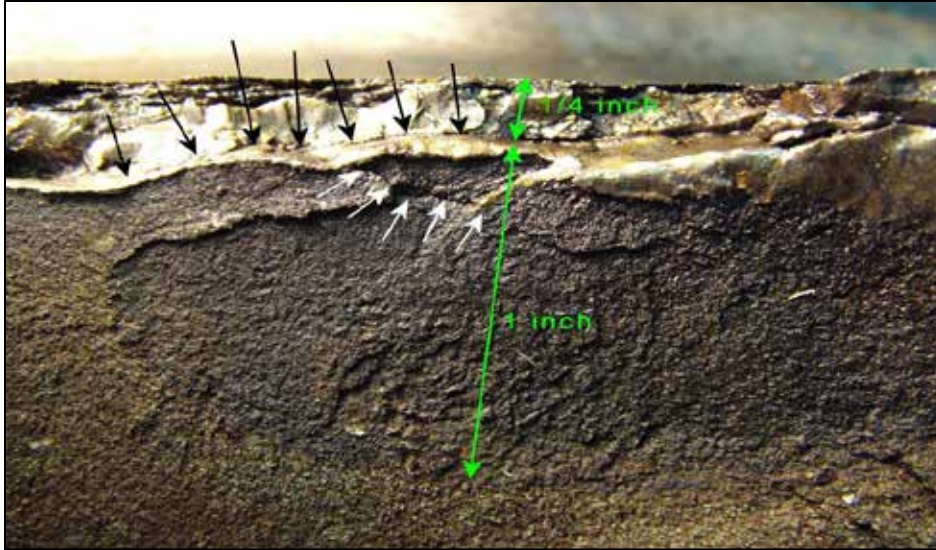
· The wheel fractured due to a VSR that extended around approximately 1/4 of the wheel circumference. The VSR originated approximately 1/4 inch below the tread surface along the bottom of a shell (Photo 2).

Photo 2. Origin of the vertical split rim. The black arrows show a crack approximately 1/4 inch below and parallel to the tread surface that was associated with the formation of the shell. White arrows show a secondary crack running down into the wheel.

- The subsurface crack parallel to the tread that caused the shell was visible. There was also a secondary crack extending from the bottom of the shell, perpendicular to the tread, downward into the wheel.
- The L2 wheel was shelled all around its circumference and exhibited multiple surface and subsurface cracks, indicating significant rolling contact fatigue crack growth activity (Photo 3). The VSR had originated at the base of such a shell. The shelling was not considered to be condemnable under AAR standards.

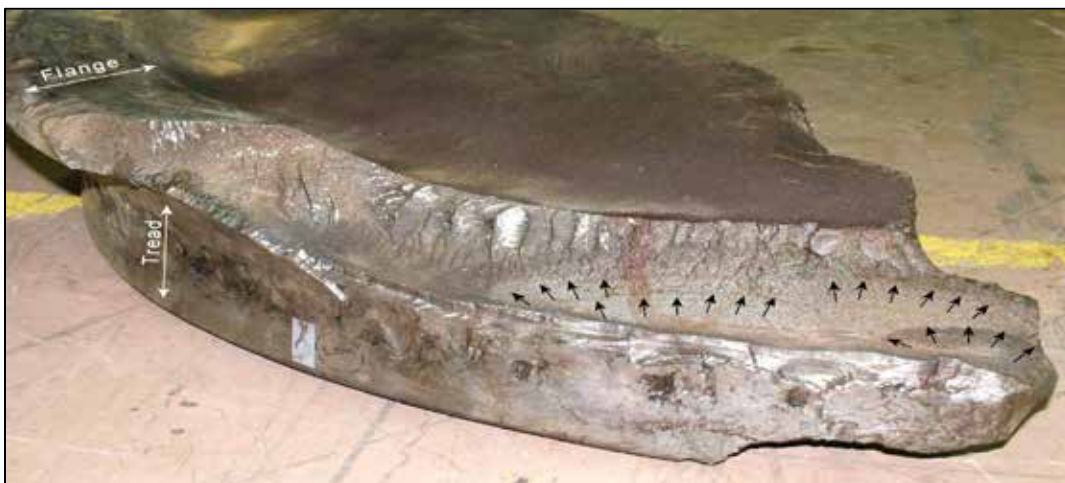
Photo 3. Arrows show the beach marks indicative of a progressive fracture.
