**RAILWAY INVESTIGATION REPORT
R13E0142**

NON-MAIN-TRACK DERAILMENT

**CANADIAN NATIONAL
FREIGHT TRAIN M30151-18
MILE 57.25, EDSON SUBDIVISION
GAINFORD, ALBERTA
19 OCTOBER 2013**

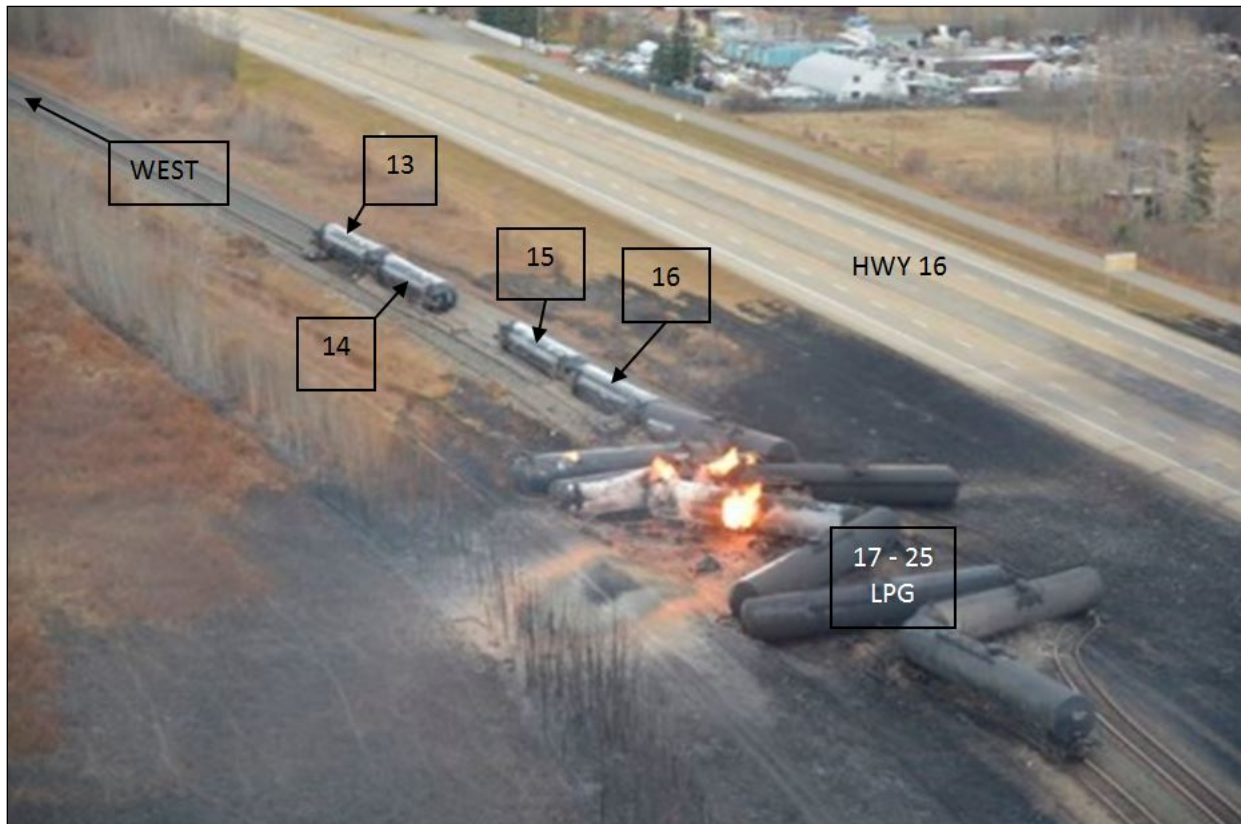
Figure 2. Aerial view of derailment site

As a result, 13 tank cars derailed (cars 13 to 25). The first 4 derailed cars (cars 13 to 16) were loaded with petroleum crude oil (UN 1267). The following 9 derailed cars (cars 17 to 25) were loaded with liquefied petroleum gas (LPG)² (UN 1075) (Figure 2).

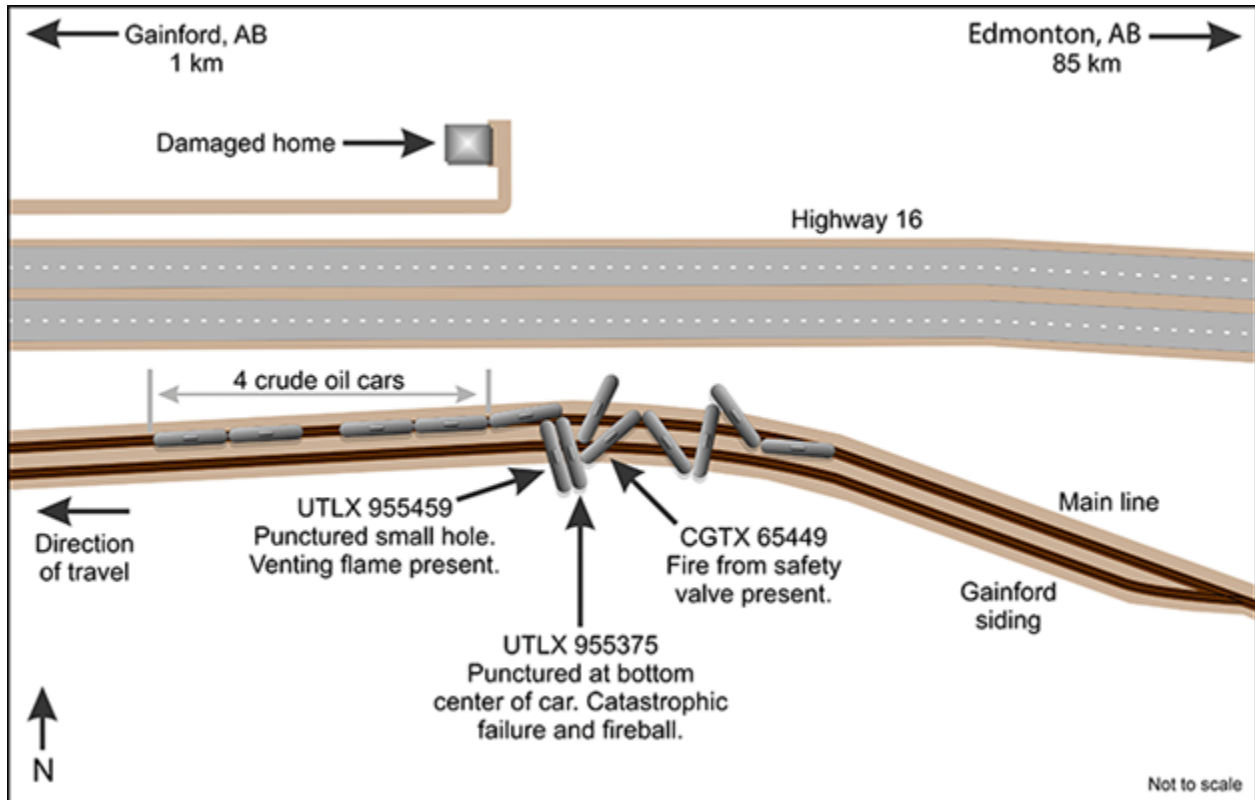
Figure 3. Accident site diagram - Damage to UTLX 955375 (18th car), UTLX 955459 (19th car) and CGTX 65449 (21st car)

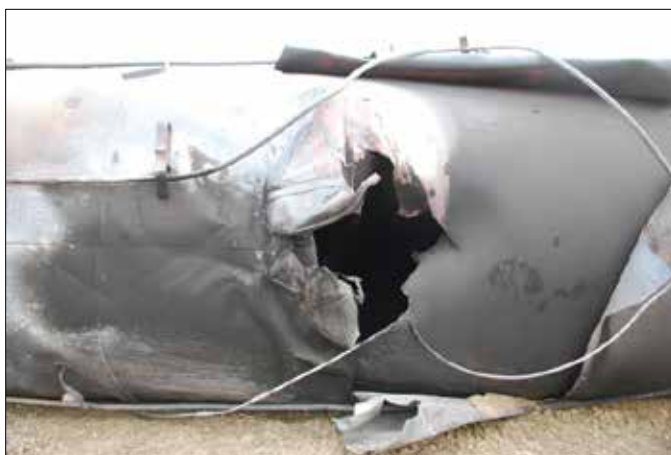
- The 19th car (UTLX 955459) sustained a small puncture, releasing product (LPG) that ignited and began flaring itself off.
- The 21st car (CGTX 65449) was not breached but was subjected to flame impingement on the exterior jacket. The product (LPG) was heated sufficiently to activate the safety valve. This prevented a build-up of pressure inside the car as the vaporized product was released. Once the product releasing from the safety valve reached an ignition source, it began to burn. When the pressure reduced inside the car, the safety valve closed until the next internal build-up of pressure. This occurred a number of times until the rubber O-ring within the safety valve was compromised by the fire. As the safety valve would no longer reseal upon closing, product was flared continuously.

Photo 1. Puncture in the underside of UTLX 955375

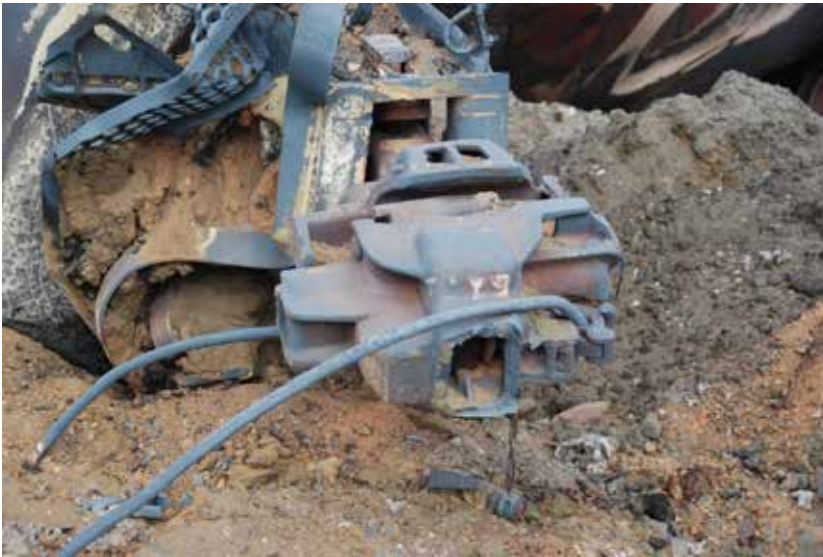
The 13 derailed tank cars were equipped with double shelf couplers as required under CGSB 43.147/TP14877, specifically Type E or Type F. These couplers are designed to restrict upward and downward movement so that they do not disengage when subjected to forces that can occur during train derailments. If the couplers are kept engaged, it is less likely that a coupler punctures another tank car. However, if cars are prevented from disengaging in a derailment, the torsional forces of a derailing car can be transferred to other cars, resulting in the derailment of the adjacent cars. When the forces caused by the derailing cars exceed the design specifications of the couplers, the couplers can disengage, or a coupler shank failure can occur (Photo 4).

Photo 4. Coupler shank failure with the double shelf couplers still engaged

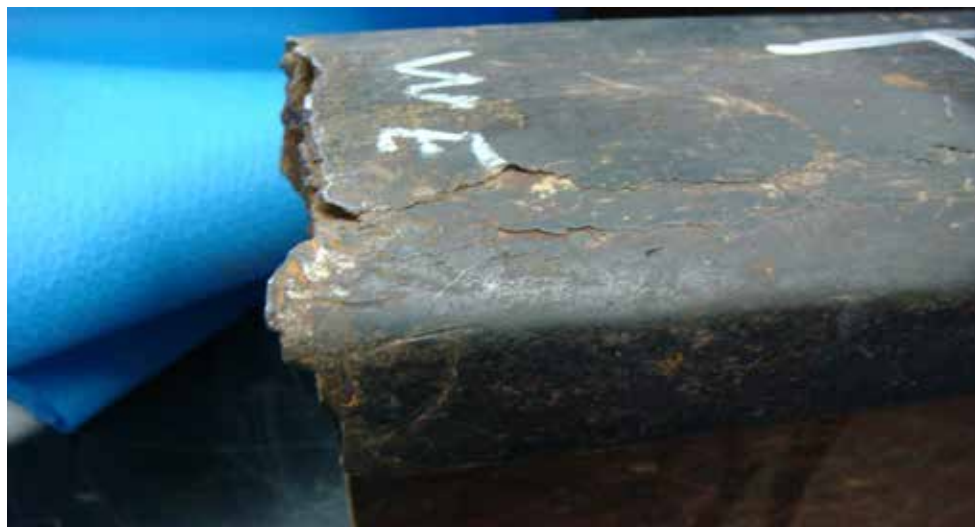
- One rerun had to be conducted due to loss of expected response of the ultrasonic signal. There was no loss of expected response on the test rerun.
- Some high rail gauge surface conditions were noted within Gainford siding and confirmed by system-generated vision photos of the rail.
- Based on the vision photos, the operator attributed the system response to the rail fatigue conditions (Photo 5 and Photo 6). Since there had been no loss of expected response on the test rerun, the operator considered the test to be valid, and no further action was taken.¹⁶

Photo 5. Rail surface conditions

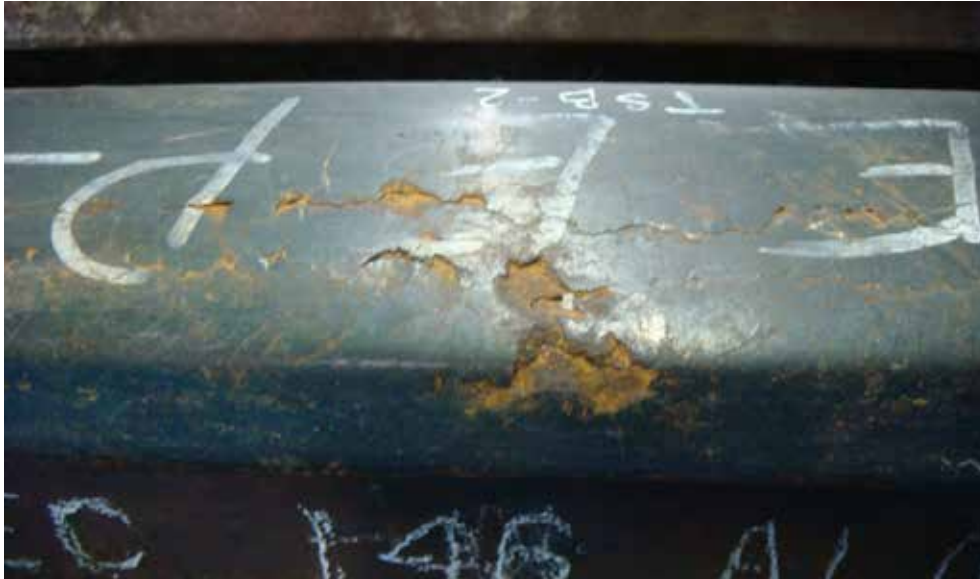
Photo 6. Rail surface conditions

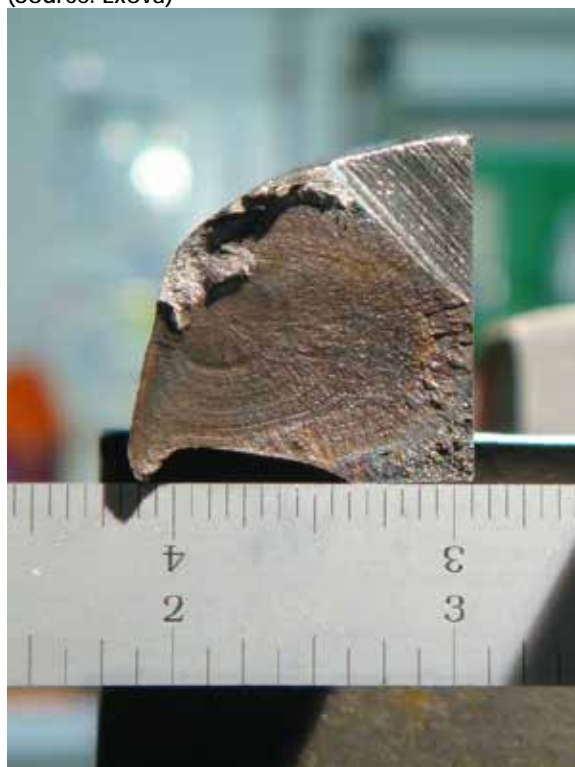
Embedded fatigue cracks on rail specimen TSB-1

Photo 7. Defect beach marks or growth rings
(Source: Exova)

- A total of 16 fatigue TDDs were revealed on 8 pieces. The largest detail fracture was equivalent to 30.8% of the worn rail head cross-sectional area (Photo 7 and Photo 8).
- The largest total flange and head wear of 19.5 mm was observed on specimen TSB-3.
- The east end of TSB-3 was the only fracture surface with top front head wheel impact damage. A large shell-out fracture was observed on the flange side. This piece of rail was the likely origin of the catastrophic rail failure (Photo 9).

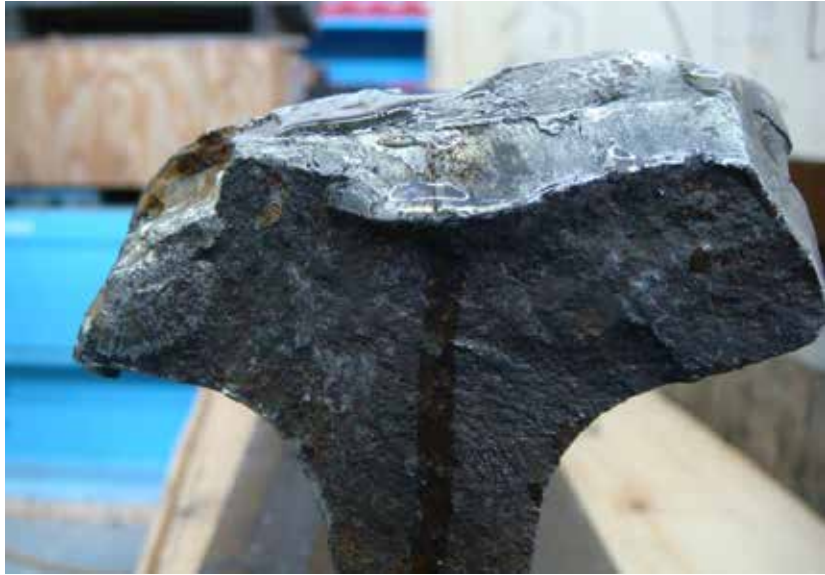
- The presence of pre-existing internal transverse defects caused the rails to break.
- The transverse defects initiated in areas of shelling that resulted from long-term heavy traffic levels.
- Rail surface damage such as shelling and cracks seem to have significantly impeded the detection of the defects, reducing the performance of ultrasonic equipment used to detect internal defects.

Photo 9. Wheel impact damage on rail specimen TSB-3 (Source: Exova)

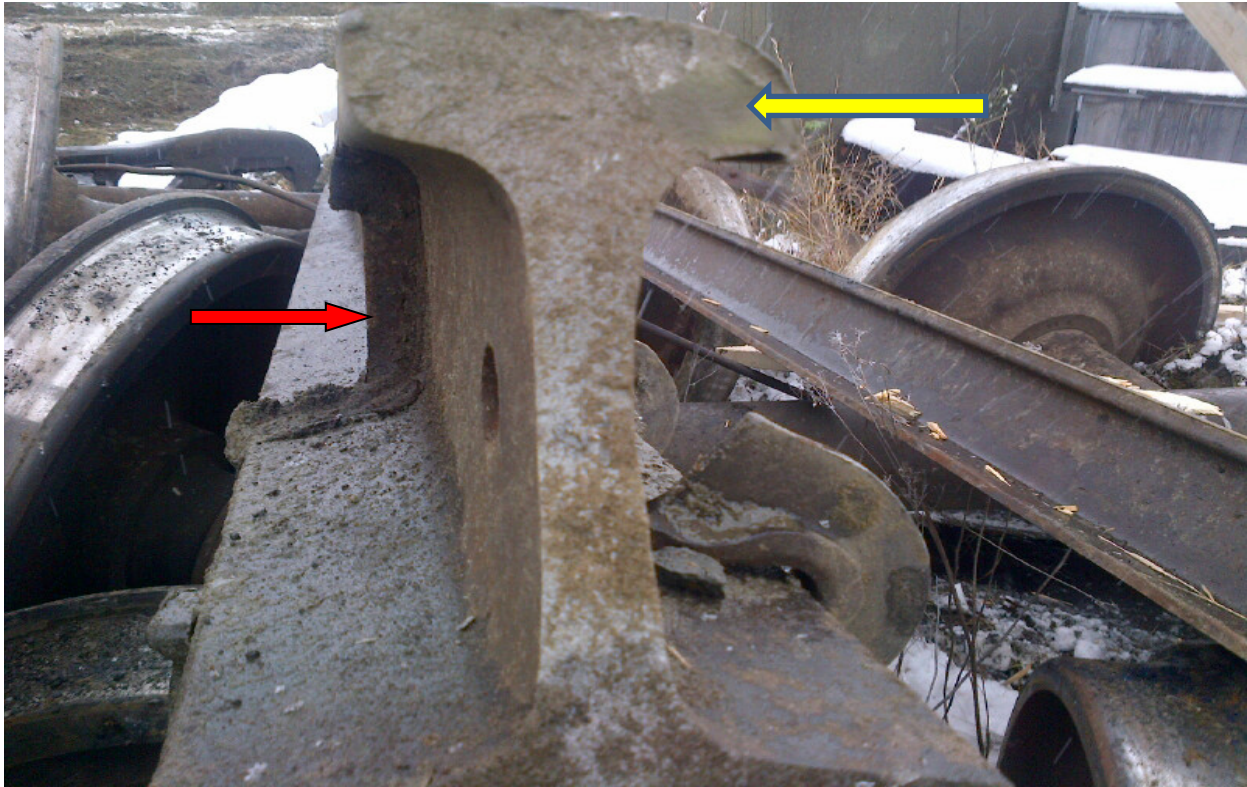
Peers siding is 1 of 7, 25-mph sidings on the Edson Subdivision. During site examination, a piece of 1996 Bethlehem rail with a TDD was identified, approximately 12 inches away from a thermite weld (Photo 10). The rail had 18-mm head wear and 5-mm flange wear. Another TDD was found nearby in a separate piece of the same rail. Both rail pieces were battered, indicating that the rail had broken and remained in track until the passage of wheels broke more pieces out. The rail was from a plug rail³⁰ located in the south (high) rail of the siding near the tangent-to-spiral point of a curve leading to the east switch. The parent rail was 1987 Sydney carbon steel with 18-mm head loss and 1-mm flange wear. All of the rail involved was 136 pounds with little shelling and gauge corner cracking.

Peers siding had been tested for rail flaws on 26 August with no defects detected. Review of the SRS test, which was performed with the same operator and truck that had tested Gainford siding 2 days later, revealed indications of near-surface ultrasonic and induction responses. The operator interpreted the cause of these responses to be surface fatigue on the centre/gauge portion of the rail head. There was no indication on the B-scan³¹ test tape of a TDD.

Photo 10. Transverse detail defect (TDD) in gauge corner of high rail (east end of plug [yellow arrow]) in Peers siding (note location of thermite weld [red arrow])

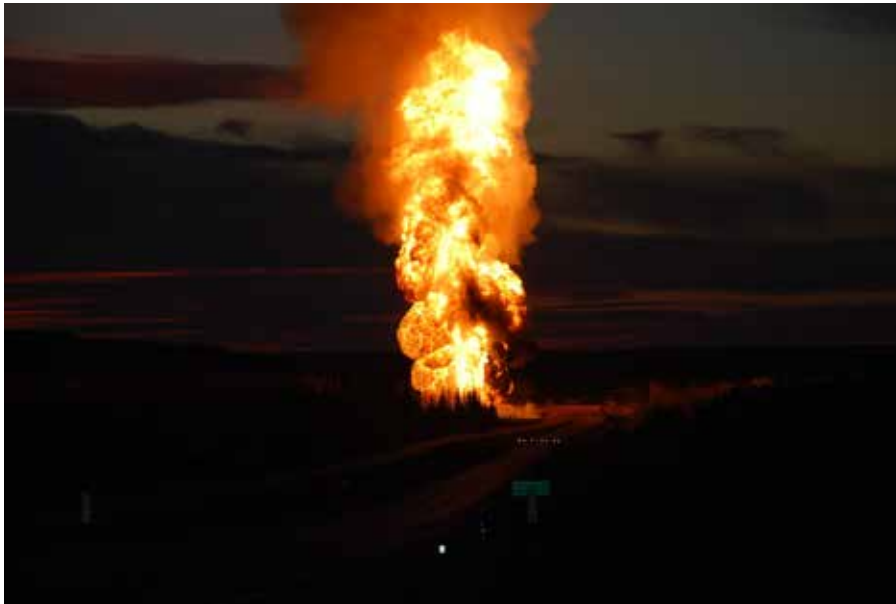
On 20 October, a specialized explosives contractor was on site to conduct the vent and burn operations on 8 loaded LPG tank cars (Photo 11). Following the first vent and burn operation, product was still inside 5 of the tank cars. A second vent and burn operation was conducted on 21 October.

Photo 11. Initial vent and burn operation
