RAILWAY INVESTIGATION REPORT

R16D0073

Misaligned switch and derailment

Acton Vale, Quebec

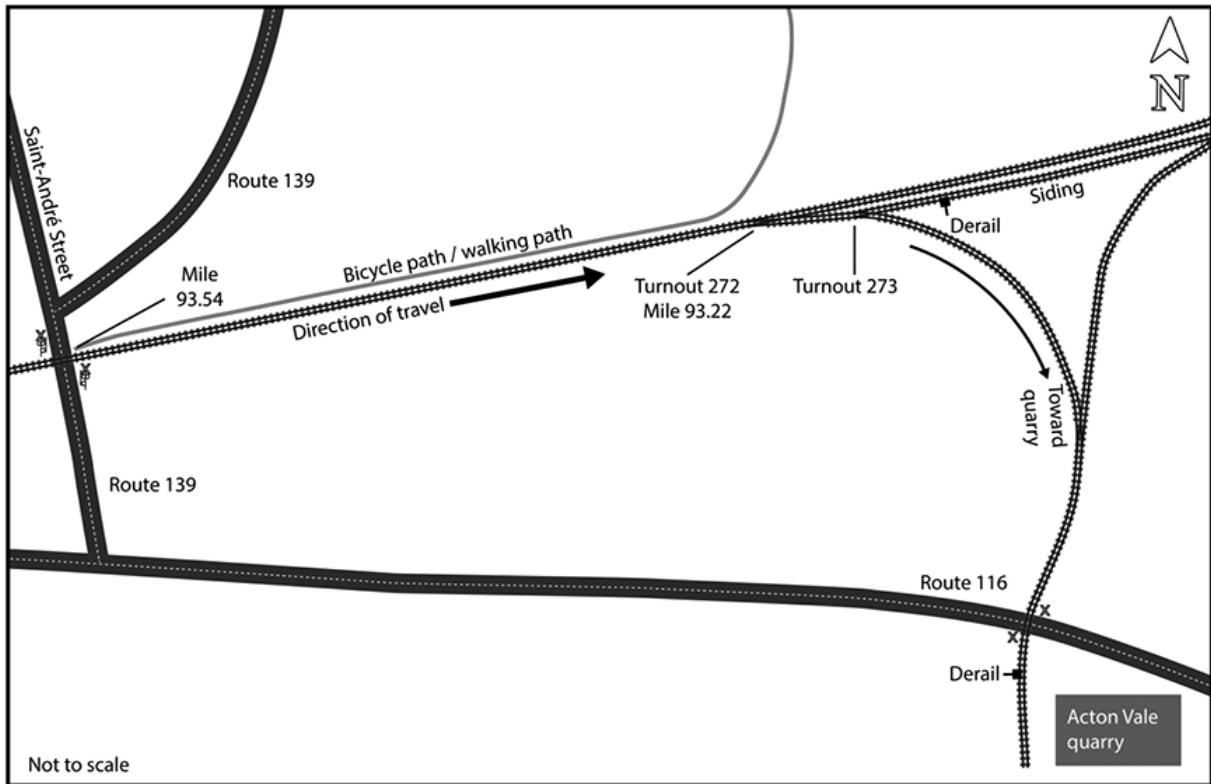
From the siding, the wye track and the Acton Vale quarry are accessible via turnout 273. Switch 273 was in the normal position and locked with a high-security lock.⁵ A hinged derail was positioned on the track leading to the quarry (Figure 3).

Figure 3. Diagram of tracks at Acton Vale
