RAILWAY INVESTIGATION REPORT

R16D0092

Crossing collision

Passenger train No. 600

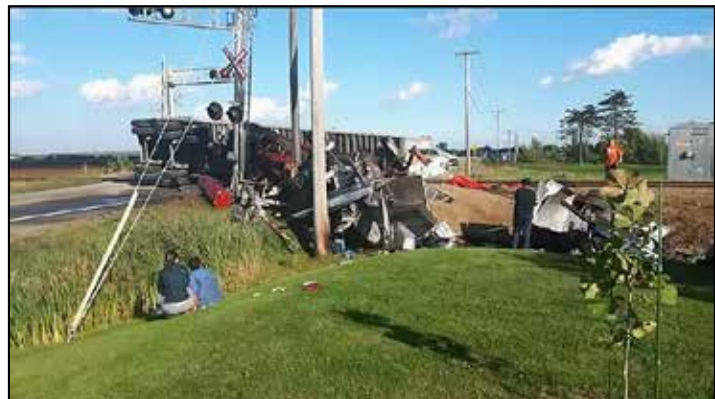
Figure 3. The tractor and the trailer after the collision (Source: Transport Canada)

The tractor-trailer was destroyed (Figure 3). The tractor cabin, the engine and the axles were ripped from the frame and thrown into the ditch along the railway track. The fuel tanks ruptured and spilled approximately 60 gallons of fuel. The trailer, which detached from the tractor, came to rest on its side, parallel to the track and blocking the road. The tarp that covered the trailer was ripped off and the load of sand spilled onto the track. The trailer frame was twisted and its upper lateral stiffeners were torn.

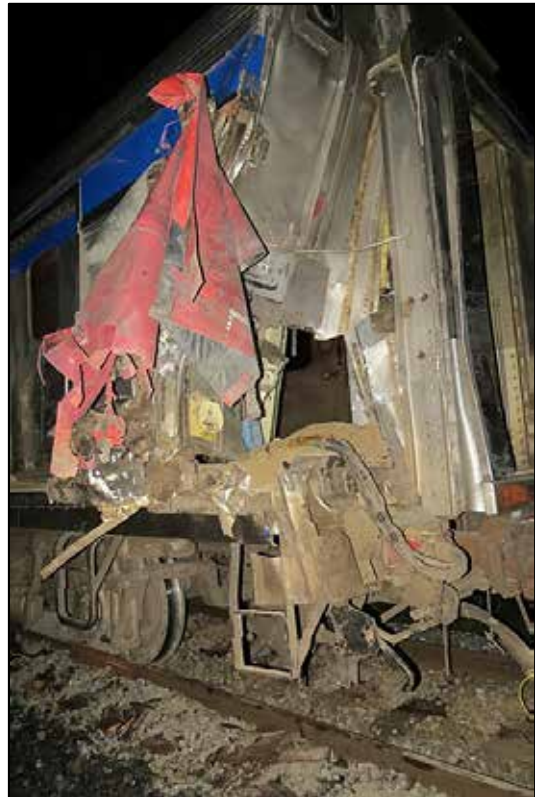
Figure 4. First baggage car

Both trucks of the first coach derailed; the rear truck was damaged and the right side of the car body was bent in the middle. The front right corner of the first baggage car was deformed and its vertical support was dented (Figure 4). The engine access panels on the second locomotive (VIA 6413) were torn off (Figure 5). The fuel tank of the second locomotive was ruptured, and braking system and suspension components were damaged (Figure 6). The second baggage car and the second coach were slightly damaged. Approximately 1800 gallons of fuel from the locomotives spilled along the track.

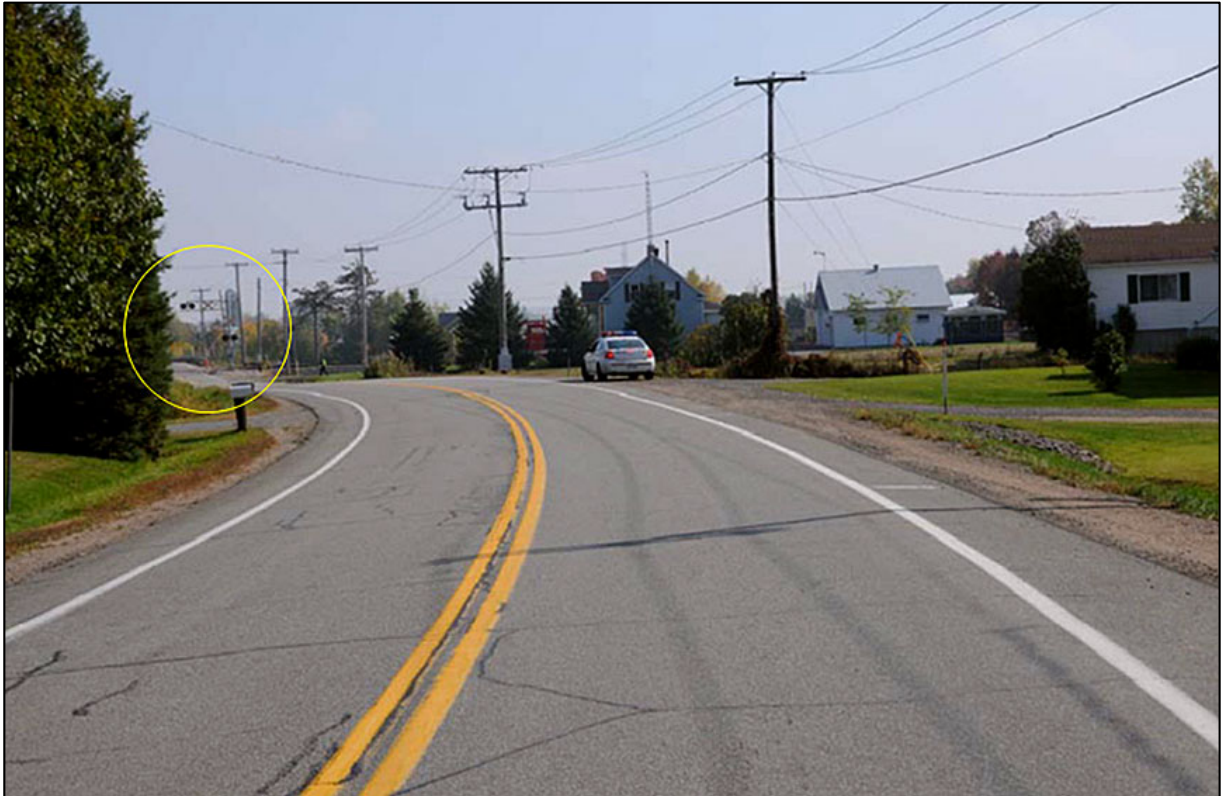
Figure 7. View from a distance of approximately 800 feet from the crossing (Source: Sûreté du Québec)

Vehicles coming from the west on Highway 348 must negotiate a left-hand curve before they reach the crossing. The trees along the road interfere with the visibility of the crossing warning system, which only becomes partially visible approximately 800 feet before the crossing (Figure 7).

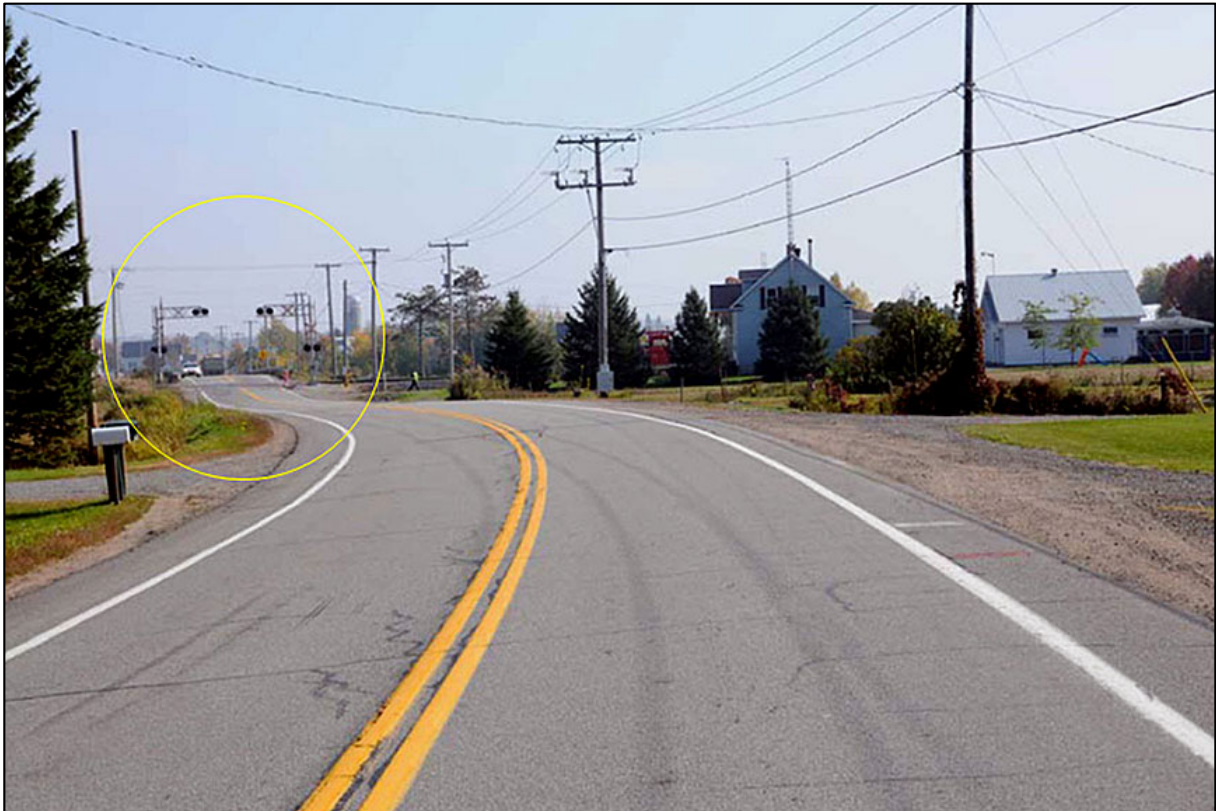
Figure 8. View from a distance of approximately 730 feet from the crossing (Source: Sûreté du Québec)

The warning system becomes completely visible at a distance of approximately 730 feet from the crossing (Figure 8). From that point on, the curve continues over a distance of approximately 230 feet, at which point the road becomes straight for 500 feet up to the crossing.

In this occurrence, the curve west of the crossing obstructed the visibility of the warning system, which only became completely visible at a distance of 730 feet. From that point, a tractor-trailer equipped with ABS and approaching at 90 km/h could theoretically stop before the crossing, whereas a similar vehicle with no ABS travelling on a damp roadway would require 909 feet (distance equal to the stopping sight distance [SSD]). Therefore, the visibility of the crossing warning system must enable the drivers of approaching vehicles to see the warning devices at a distance at least equal to the SSD. If the warning system cannot be perceived at a distance at least equal to the SSD, motor vehicle drivers may not be able to stop before the crossing, thereby increasing the risk of accidents.

The previous regulations did not specify any standard regarding SSD nor any condition where a "Prepare to Stop at Railway Crossing" sign had to be installed. However, Transport Canada's (TC's) new *Grade Crossings Regulations* requires that, by 2021, an active "Prepare to Stop" sign be installed when the crossing lights are not clearly visible within the limits of the SSD. The SSD for vehicles coming from the west on Highway 348 is 909 feet, whereas the crossing warning system is visible from 730 feet. Given that the visibility of the lights of the grade crossing warning system is less than the SSD, an active "Prepare to Stop at Railway Crossing" sign connected to the crossing warning system will be required at that location by 2021 in accordance with TC's new *Grade Crossings Regulations*.

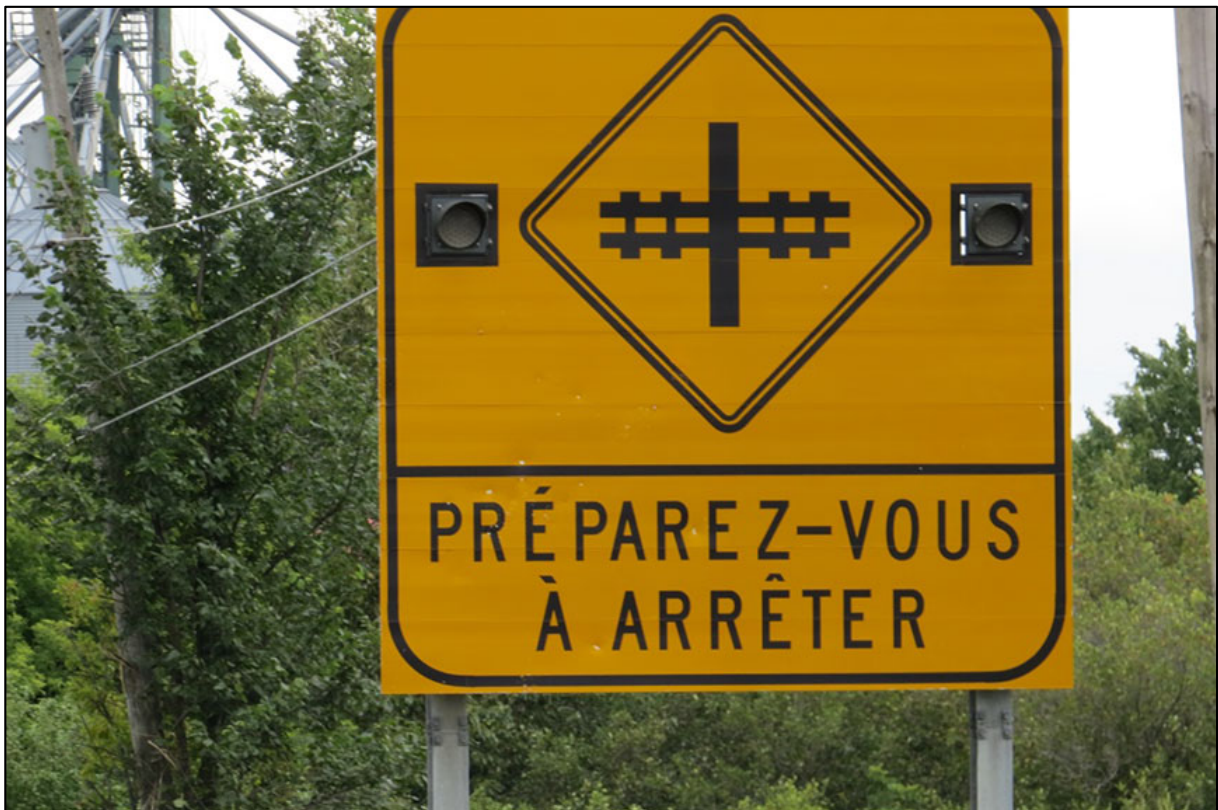
Figure 9. A “Prepare to Stop at Railway Crossing” sign” with flashing lights on Highway 347 in Saint-Norbert, Quebec

Research on advanced warning signs¹⁸ indicates that, in locations where yellow flashing lights were added to a slightly larger advanced warning sign and where the lights were activated by a train, drivers were much more likely to recognize the signals and slow down. These signs alert drivers to the presence of a train at the crossing approximately one quarter of a mile ahead of the crossing. There is such a sign at the Highway 347 crossing in Saint-Norbert, Quebec, at Mile 90.61 of the Joliette Subdivision (Figure 9).
