Railway Transportation Safety Investigation Report R17C0074

MAIN-TRACK DERAILMENT

Canadian Pacific Railway
Freight train 603-230
Mile 26.4, Maple Creek Subdivision
Antelope, Saskatchewan
03 October 2017

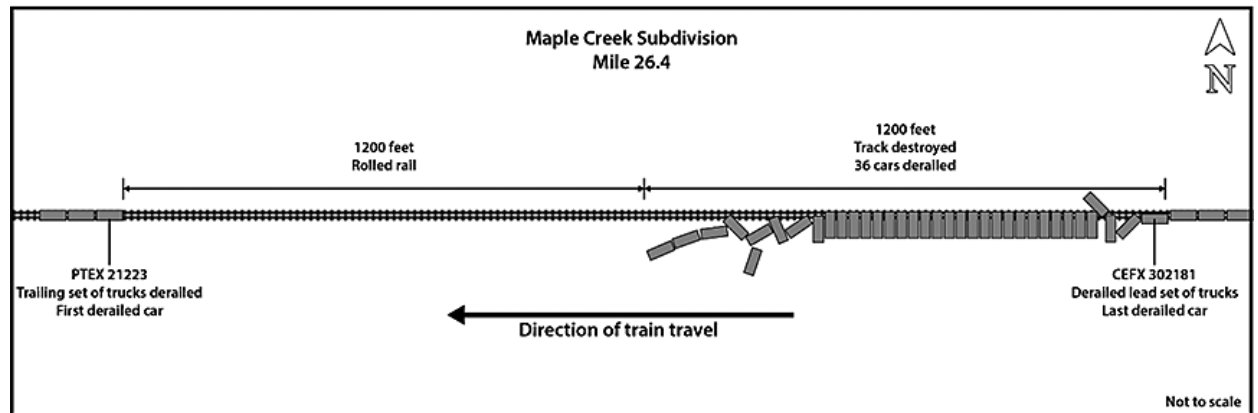
Figure 2. Derailment site

Leading up to the occurrence site, there were no wheel marks on the track infrastructure. The first derailed car (with the trailing set of trucks derailed) was PTEX 21223, the 107th car from the head end. The following 36 derailed cars came to rest in various positions on the right-of-way. The last of the derailed cars (with the lead set of trucks derailed) was CEFX 302181, the 142nd car from the head end (Figure 2).

Many of the derailed cars were breached and had released potash. About 2400 feet of track was destroyed or damaged, including about 1200 feet of rolled rail. There were no waterways in the vicinity, and there was no significant impact to the environment.

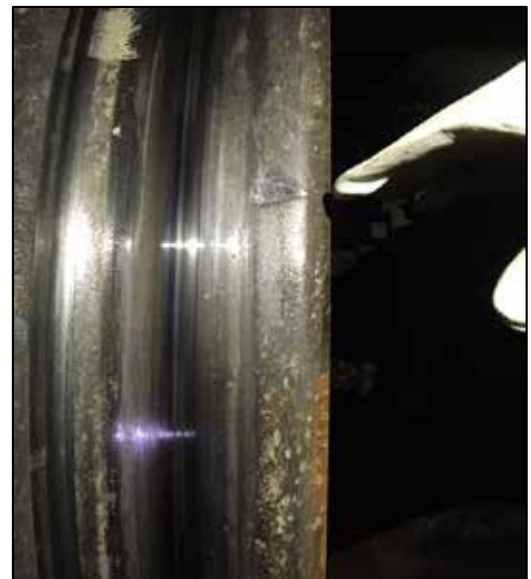
An examination of the head-end portion of the train was performed, up to and including the first derailed car. This car (the 107th) as well as the 105th and 106th, had impact marks on the treads of the wheels on the north side (Figure 3).

Figure 3. Impact marks on the north-side wheel of CNPX 3795, the 105th car (Source: Canadian Pacific Railway)

Marks that were present on the north wheel treads of the 105th car to the 107th car indicated that these wheels had hit a broken rail. The rail had likely broken when the head-end portion of the train passed over it.

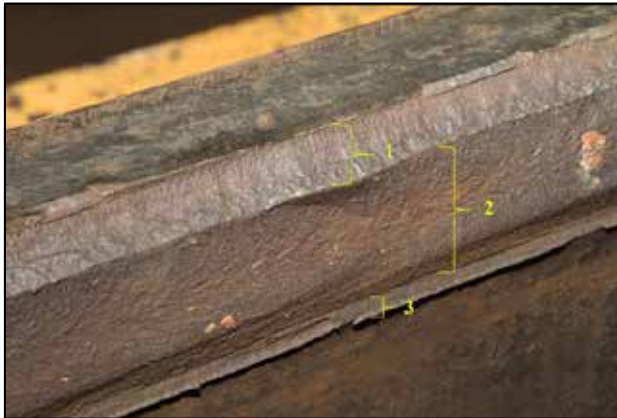
The laboratory examination determined that most of the fractures in the rail were due to overstress as a result of the derailment. However, the gauge side of the rail head was missing on one of the rails. There were indications of a vertical split head (VSH) on this rail. The approximately 2-inch-wide fracture was relatively uniform with a ½-inch band of fatigue cracking along the top edge (zone 1), a ⅛-inch band of fatigue/shear along the bottom edge

(zone 3), and an overstress rupture along the 1 $\frac{3}{8}$ -inch centre portion (zone 2) (Figure 4). The fatigue cracking along the top of the fracture surface indicated that the overstress portion had been partially separated for an extended period of time. The pre-existing VSH on this rail section had likely progressed to a complete separation during the derailment sequence. Shelling was also present on the running surface at one end of the same rail section (Figure 5), but the VSH fracture passed by the shelling.

Figure 4. Close-up of gauge-side head fracture showing 3 zones

It was not possible to determine precisely the role of the recovered rail sections in the derailment, as their exact location (pre-derailment) was unknown. Nonetheless, the VSH and the shelling on one of the rail sections showed that there were pre-existing conditions in the rail.

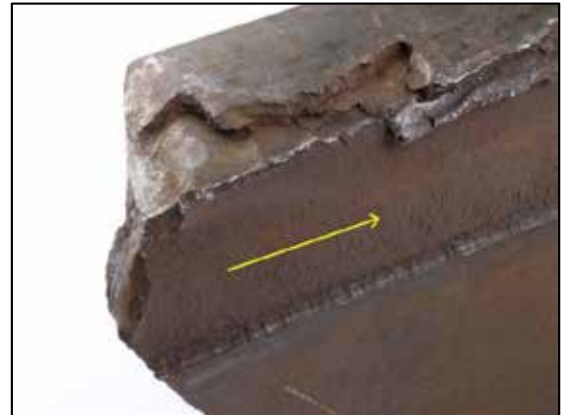
Figure 5. Shelling on the running surface at one end of the rail section
