## **RAIL TRANSPORTATION SAFETY INVESTIGATION REPORT R18D0069**

### **MAIN-TRACK TRAIN DERAILMENT**

Canadian Pacific Railway  
Freight train 142-14  
Mile 36.6, Winchester Subdivision  
Saint-Polycarpe, Quebec  
16 July 2018

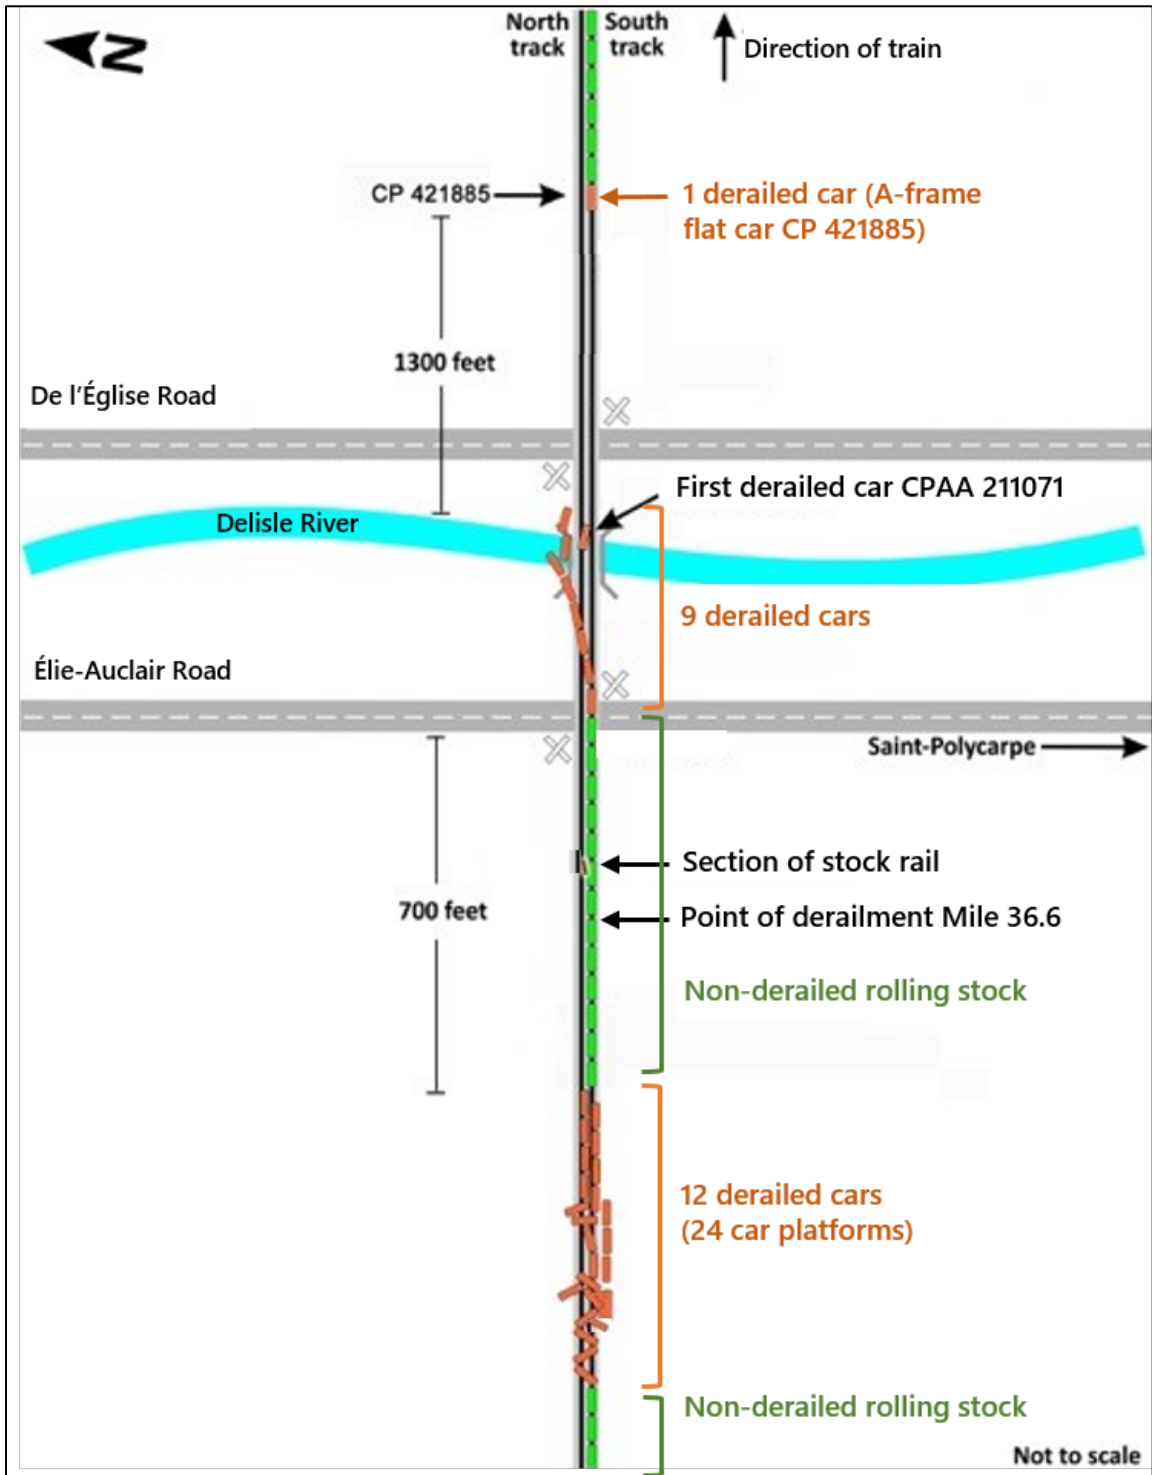
The 22 cars that had derailed came to rest at 3 separate locations (Figure 2). The 37th car, CP 421885, came to a stop about 1300 feet west of the 38th car and was still coupled to the head end of the train. Nine cars (38th to 46th) came to rest near the crossing (Figure 3). Twelve cars (60th to 71st), comprising 24 car platforms, came to rest about 700 feet west of the crossing (Figure 4).

Figure 2. Diagram of the occurrence site (Source: TSB)

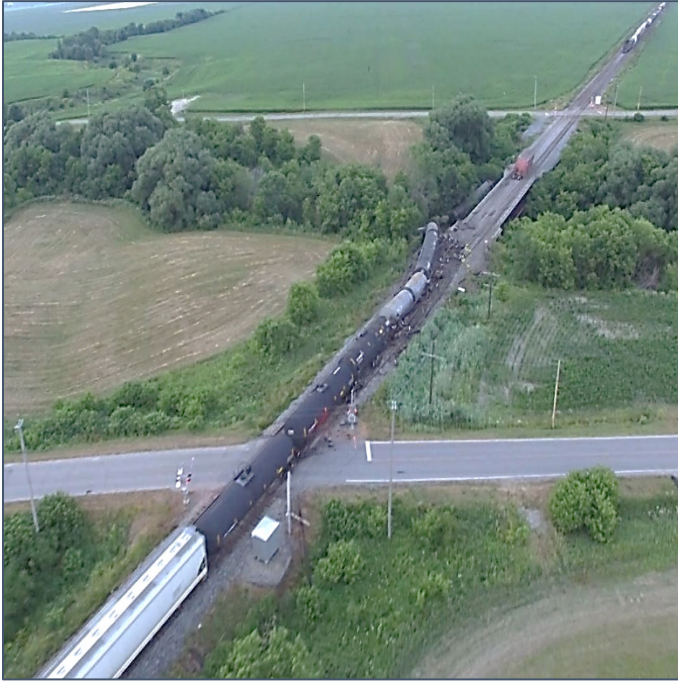
Figure 3. The nine cars that derailed near Élie-Auclair Road crossing, looking northeast (Source: Third party, with permission)

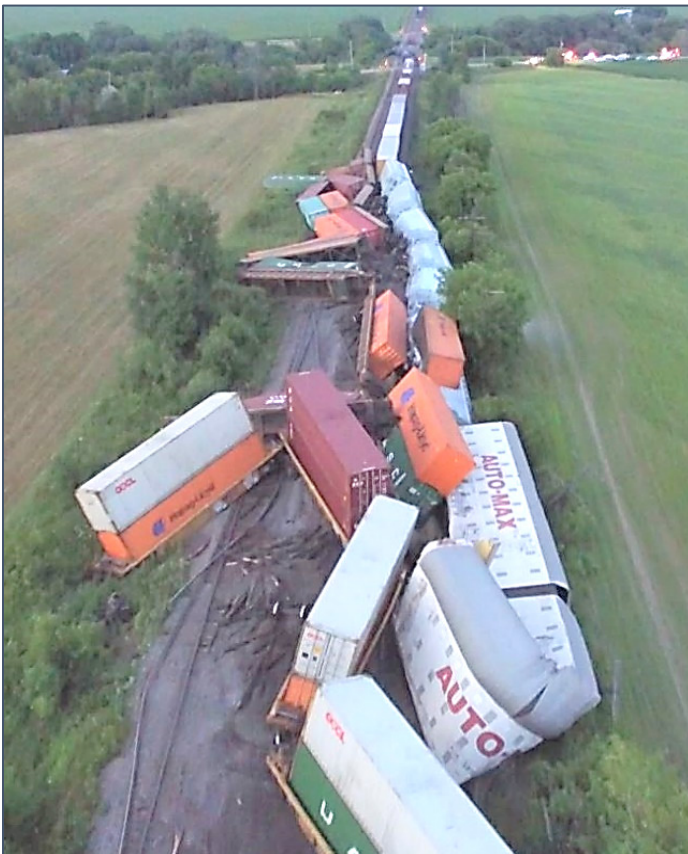
Figure 4. The 12 cars (24 platforms) that derailed about 700 feet west of Élie-Auclair Road crossing, looking east (Source: Third party, with permission)

Approximately 700 feet west of the crossing, another 12 derailed cars (60th to 71st) had come to rest. These cars, comprising 24 car platforms, consisted of 7 empty hopper cars, an articulated auto carrier car, and 4 multi-platform intermodal cars. The remaining 25 cars at the tail end of the train did not derail.

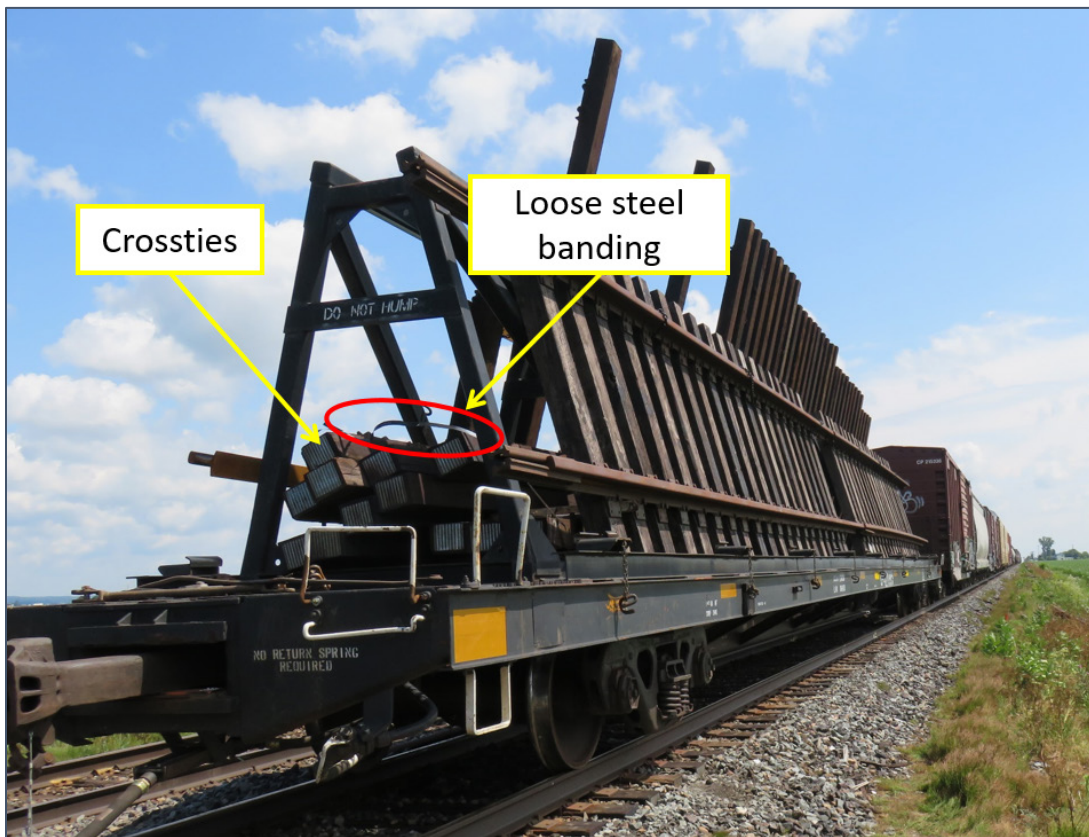
The first car that derailed, CP 421885, was a flat car equipped with a permanent A-frame structure (a type of car known as an A-frame flat car<sup>3</sup>). It had been carrying pre-built track panels, stock rail, crossties, and associated supplies (Figure 5). The trailing truck (B-end) had derailed, and one of the 2 steel bands securing the crossties was broken. Some of the crossties had shifted laterally and fallen over. The stock rail was missing from the car. There were signs of abrasion and damage to the A-frame, lading, deck, and appurtenances of the car, as well as damage to the underside and trailing truck of the car. Track damage extended from just east of the Élie-Auclair Road crossing, where the track had been destroyed, eastward to where the trailing truck of CP 421885 stopped.

Figure 5. Shifted crossties and loose steel band on car CP 421885. The photograph was taken after the car had been moved and re-railed. (Source: TSB)

This securement technique did not provide a sufficient lateral restraint. Over the 2400 kilometres (1500 miles) travelled by the car under normal train operation, the load of crossties with the heavier stock rail on top gradually shifted laterally and fell over, allowing the 2 loops of steel banding to come loose.

The rough surface of the ties limited longitudinal movement while they were stacked on the A-frame flat car. However, because it was not adequately secured, the smooth stock rail was able to slide back and forth longitudinally on top of the ties. The loosened stock rail, rubbing back and forth against the banding, progressively weakened it. Eventually, 1 of the 2 loops of steel banding broke and, as the train approached Élie-Auclair Road, the stock rail slid toward the trailing end of the car, tilted up, and fell off the end of car CP 421885 under the following car, CPAA 211070.

In addition, CP inspected and modified its A-frame cars to include a steel material containment box for securement of palletized or loose items and close-out panels on the A-end and B-end of the cars.

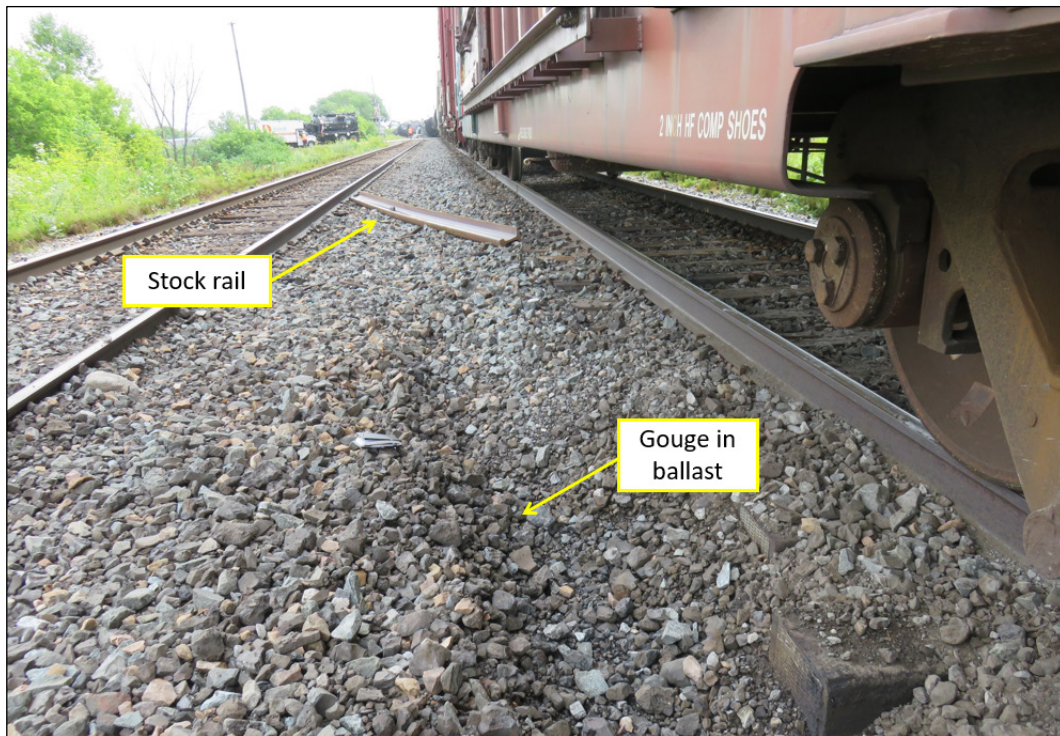
A 21-foot stock rail was lying between the north and south tracks (Figure 6), near a long gouge mark in the ballast. The gouge mark started approximately 60 feet east of the first flange marks.

Figure 6. Stock rail near gouge mark in the ballast (Source: TSB)

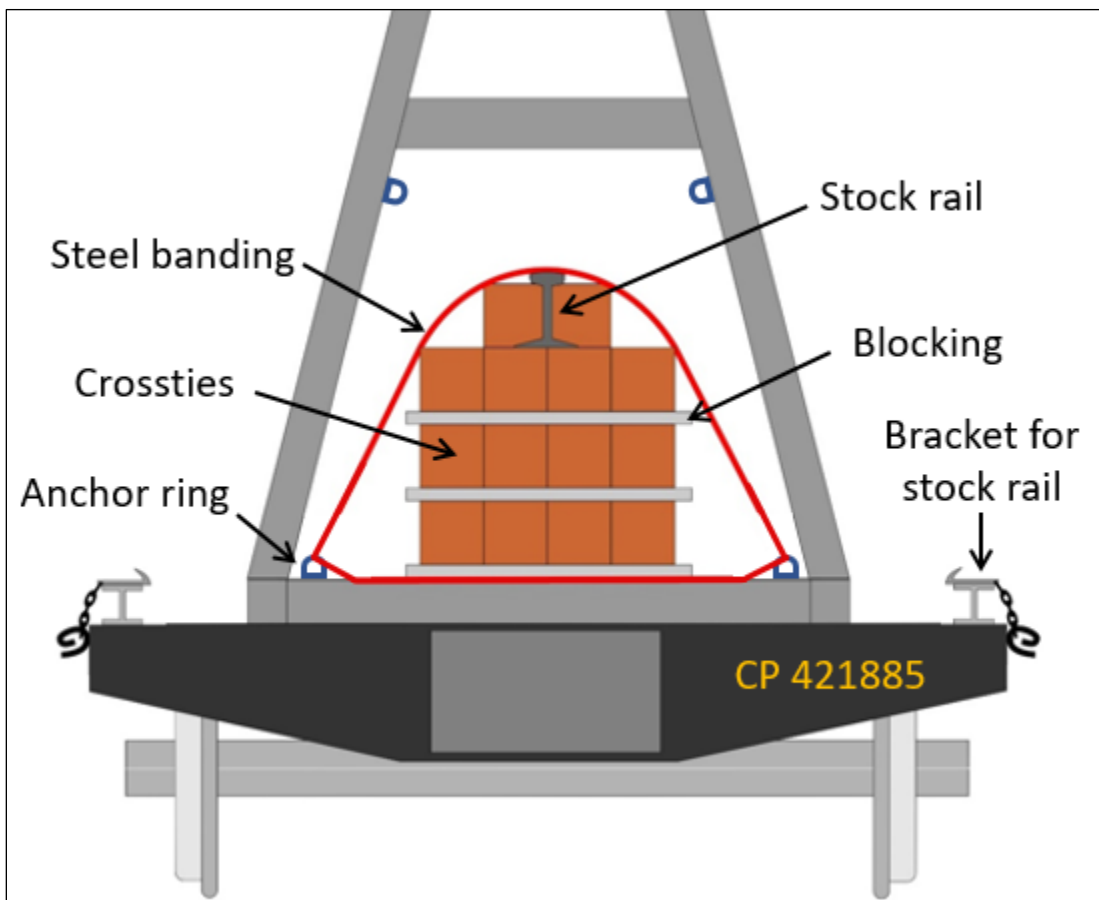
- The track panels were secured to the A-frame using chains. The load under the A-frame, consisting of the stack of 14 crossties and the stock rail on top, was secured using 2 loops of steel banding routed through the anchor rings (Figure 10).

Figure 10. Loading and securement of track materials on car CP 421885 (Source: TSB)

6. The securement technique did not provide a sufficient lateral restraint.
7. Under normal train operation, the load of crossties with the heavier stock rail on top gradually shifted laterally and fell over, allowing the 2 loops of steel banding to come loose.

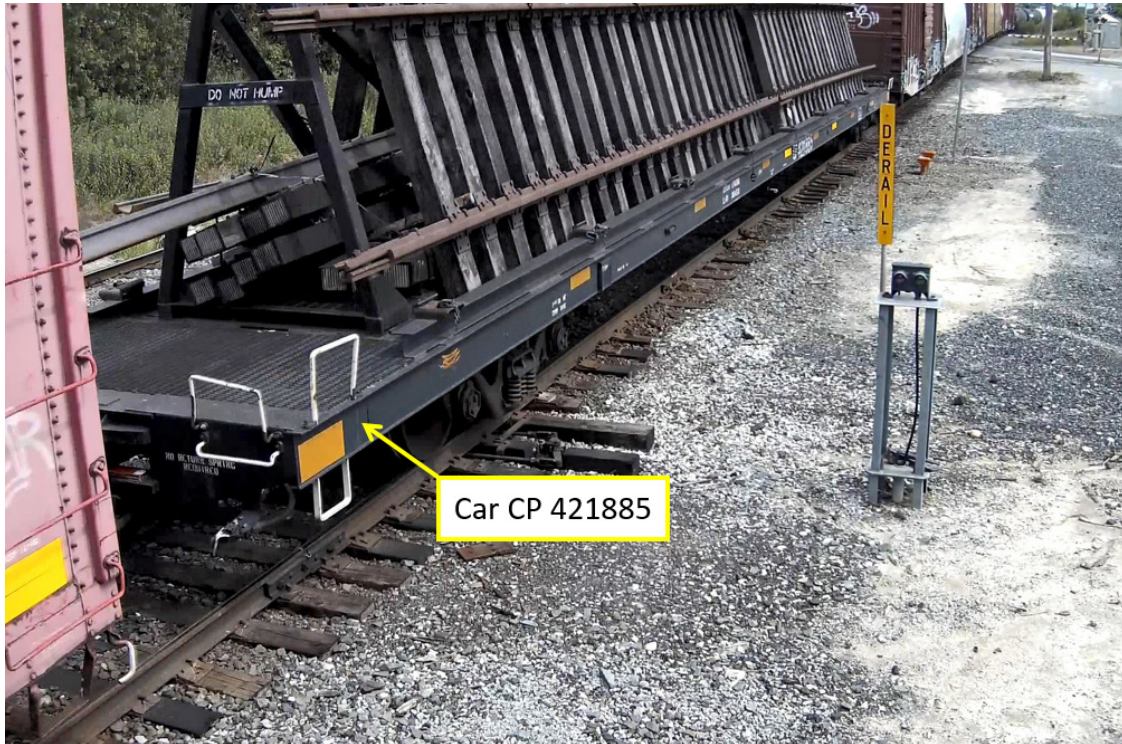
bad-ordered and subsequently removed from train 420-13. No exceptions were reported for car CP 421885 (Figure 11).

Figure 11. Car CP 421885 leaving Toronto on 16 July 2018 (Source: Canadian Pacific Railway, with TSB annotations)

shifted condition when the car was at White River, after having travelled approximately 1080 kilometres (670 miles) on train 420-13. There were other visual cues of a shifted load on video camera images upon the car's arrival in Toronto on 15 July 2018, as well as upon its subsequent departure on train 142-14 on 16 July 2018.
