RAIL TRANSPORTATION SAFETY INVESTIGATION REPORT R18M0037

EMPLOYEE FATALITY

Canadian National Railway Company
Assignment L57211-04
Mile 1.03, Pelletier Subdivision
Edmundston Yard
Edmundston, New Brunswick
04 December 2018

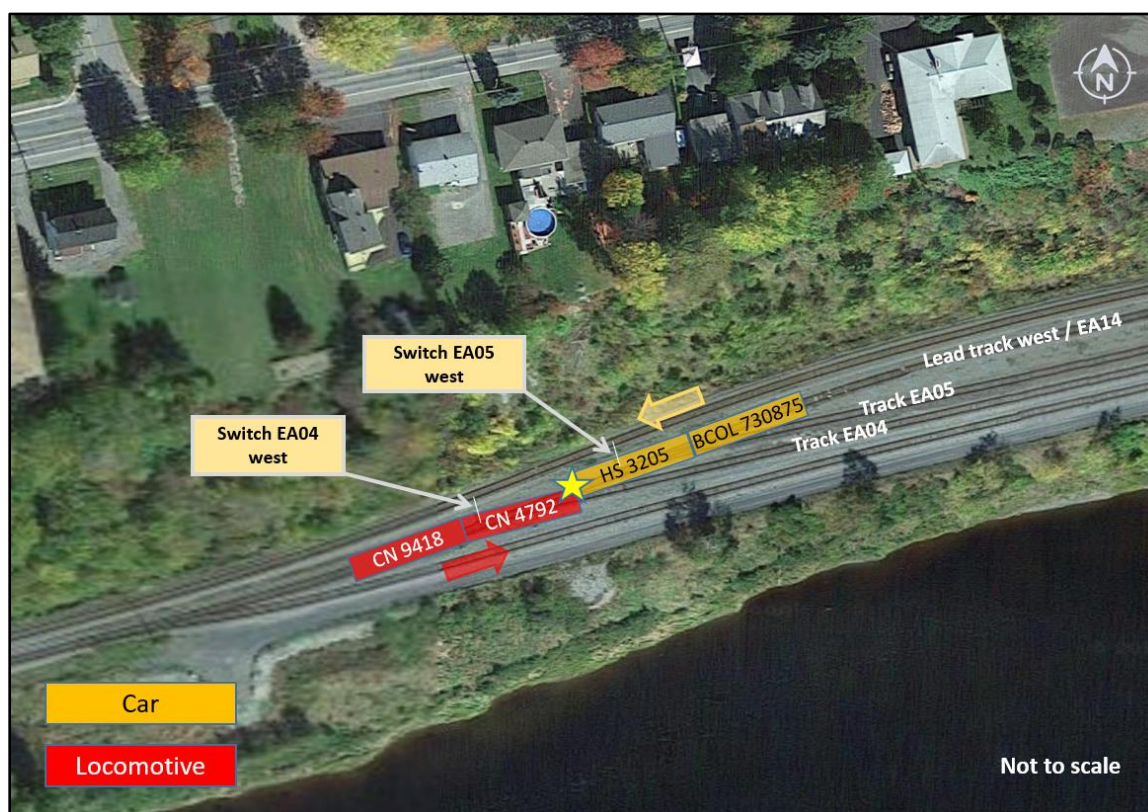
Figure 3. Position of rolling stock after the accident (Source: Google Maps, with TSB annotations)

Trailing locomotive CN 4792 was facing east, had entered track EA04, and was stopped on the EA04 West turnout frog. It was approximately 10 feet from car HS 3205. At the northeast corner of the locomotive, damage was observed on the locomotive pilot, the safety railings, the ladder, and the footboard.

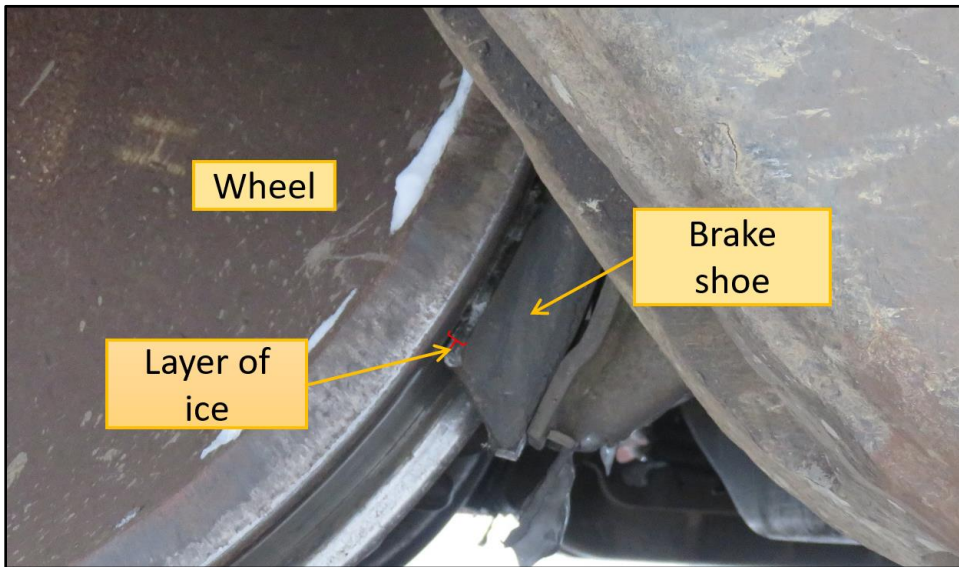
There was snow and ice around the brake shoes on all of the trucks of car HS 3205. The brake cylinder pressure on the car⁸ was approximately 70 psi, and the brake piston was extended. All brake shoes were applied against the wheels. A layer of ice was visible between the brake shoes on 7 of the 8 wheels of the car (Figure 4).

Figure 4. Layer of ice between a wheel and a brake shoe on car HS 3205 (Source: TSB)

Visual inspection of the brake shoes on car HS 3205 revealed that some of the shoes were unevenly worn. In addition, a layer of ice with an average thickness of approximately 4 mm covered 7 of the 8 brake shoes. It may be difficult to remove such a layer of ice through brake conditioning over a short handling period at low speeds.

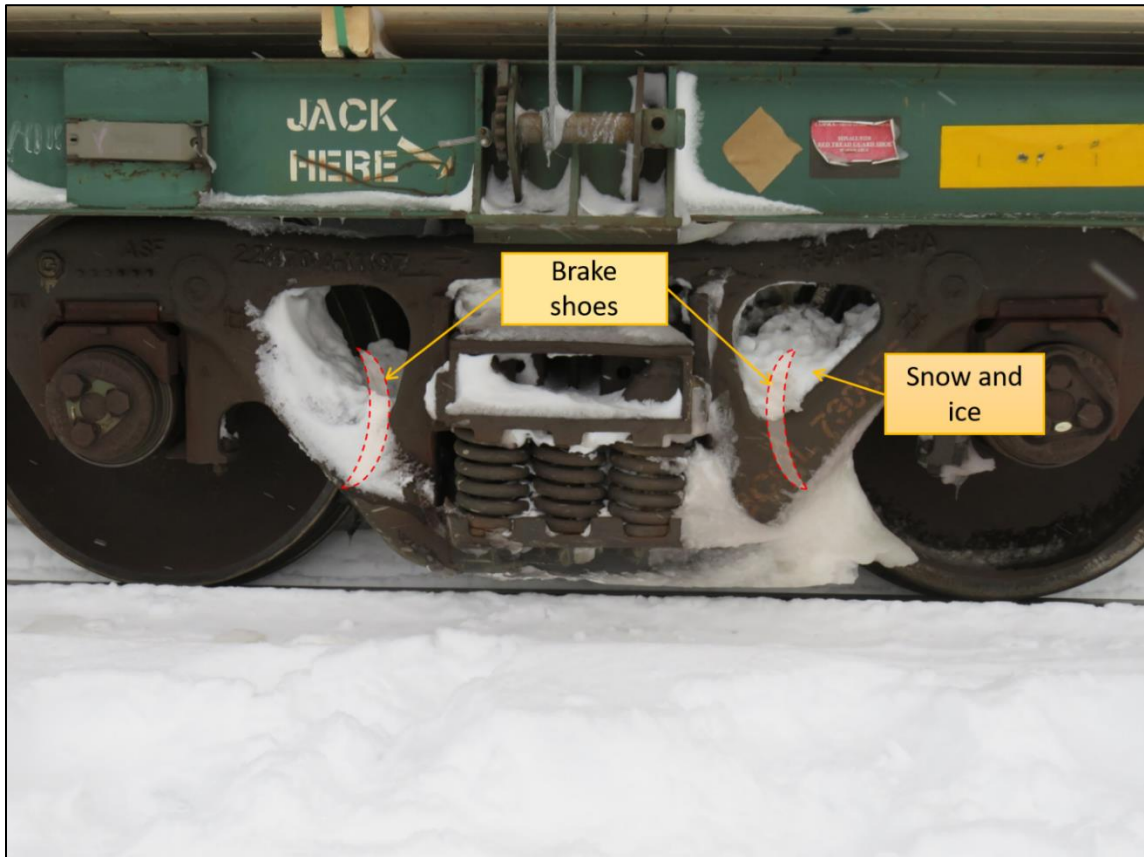
Car BCOL 730875 was stopped east of the EA05 West turnout frog. No damage was visible on this car. There was a significant buildup of snow and ice on all of the car's trucks and around the brake shoes (Figure 5).

Figure 5. Truck of car BCOL 730875, with dotted lines showing brake shoes hidden by snow and ice (Source: TSB)

Visual inspection of the brake shoes on car BCOL 730875 did not reveal any defects. However, the brake shoes were damp, and there was a significant buildup of snow and ice on the car trucks and around the brake shoes.

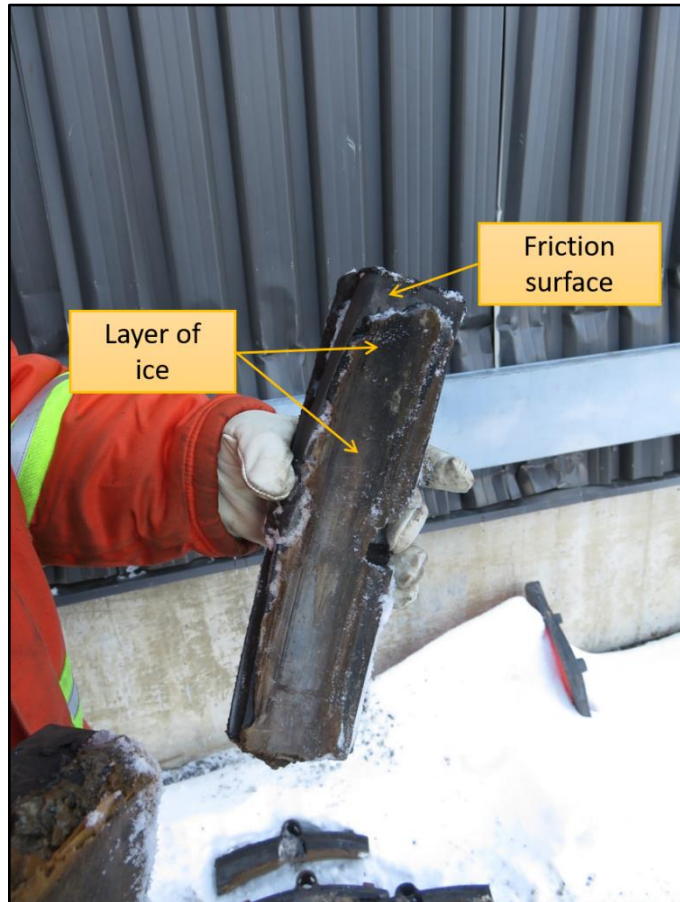
Visual inspection of the brake shoes on car HS 3205 revealed that some of the shoes were unevenly worn between the top and bottom pads of the friction material. In addition, a layer of ice with an average thickness of approximately 4 mm covered 7 of the 8 brake shoes (Figure 7).

Figure 7. Layer of ice on a brake shoe of car HS 3205 (Source: TSB)

6. Because the brakes of the 2 cars had not been conditioned when the cut of cars was moved over a distance of approximately 4380 feet, snow and ice had built up between the brake shoes and the wheels. Consequently, the total retarding force generated by the brakes of the 2 cars was insufficient to prevent the cut of cars from rolling uncontrolled on a descending grade of about 0.7%.
