# Rail Transportation Safety Investigation Report R19E0150

## MAIN-TRACK TRAIN DERAILMENT

Canadian National Railway Company  
Freight train G86341-28  
Mile 80.45, Vegreville Subdivision  
Chipman, Alberta  
29 September 2019

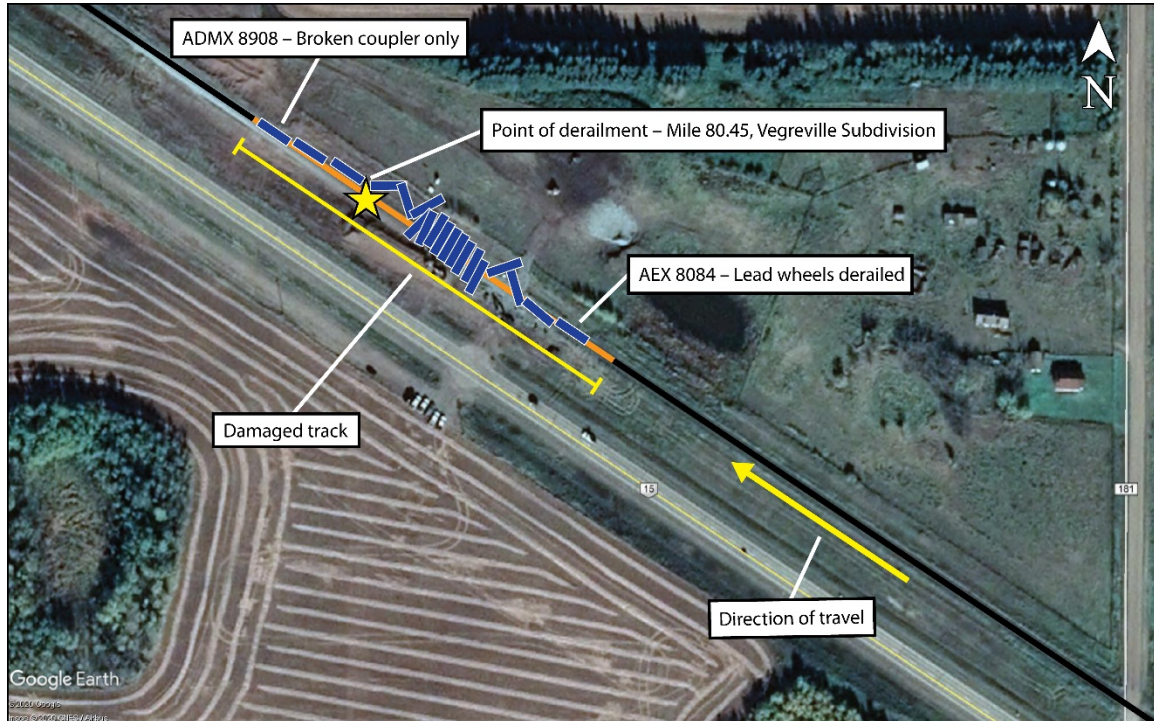
Most of the derailed cars were in a jackknife position, consistent with a sudden, catastrophic rail failure. The point of derailment was determined to be about Mile 80.45 of the Vegreville Subdivision. Approximately 600 feet of track was damaged or destroyed, with repairs needing to be made an additional 20 feet beyond both ends of the derailment site (Figure 2).

Figure 2. Satellite image of derailment location (Source: Google Earth, with TSB annotations)

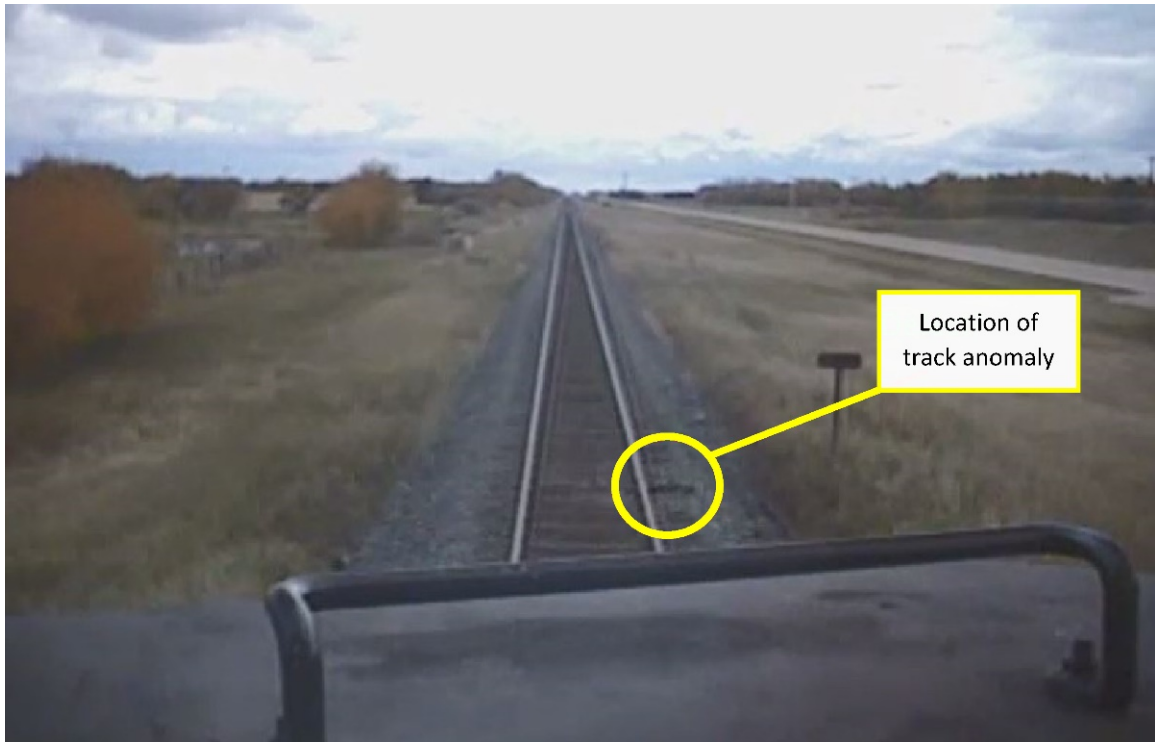
The lead locomotive was equipped with a forward-facing video camera,<sup>8</sup> but it was inoperative at the time of the occurrence. Forward-facing video footage from a previous train passing this location was obtained.<sup>9</sup> Based on a review of this recording, a track anomaly was visible, but the details of the defect were indiscernible (Figure 3). In addition, a sound was detected as the locomotive passed the point of derailment, corroborating the existence of a track anomaly.

Figure 3. Forward-facing camera view of the point of derailment from a previous eastbound train, showing the track anomaly (Source: Canadian National Railway Company, with TSB annotations)

Audio and video footage from the forward-facing video camera on a previous train supports the suspected presence of a track anomaly. It is therefore possible that a wheel impact at the location of the track anomaly caused the rail to break.
