RAILWAY OCCURRENCE REPORT

R95T0259

BETWEEN CANADIAN NATIONAL
AND VIA RAIL CANADA INC.
PASSENGER ROLLING STOCK DAMAGE
KINGSTON SUBDIVISION
15 AUGUST 1995

Report Number R95T0259

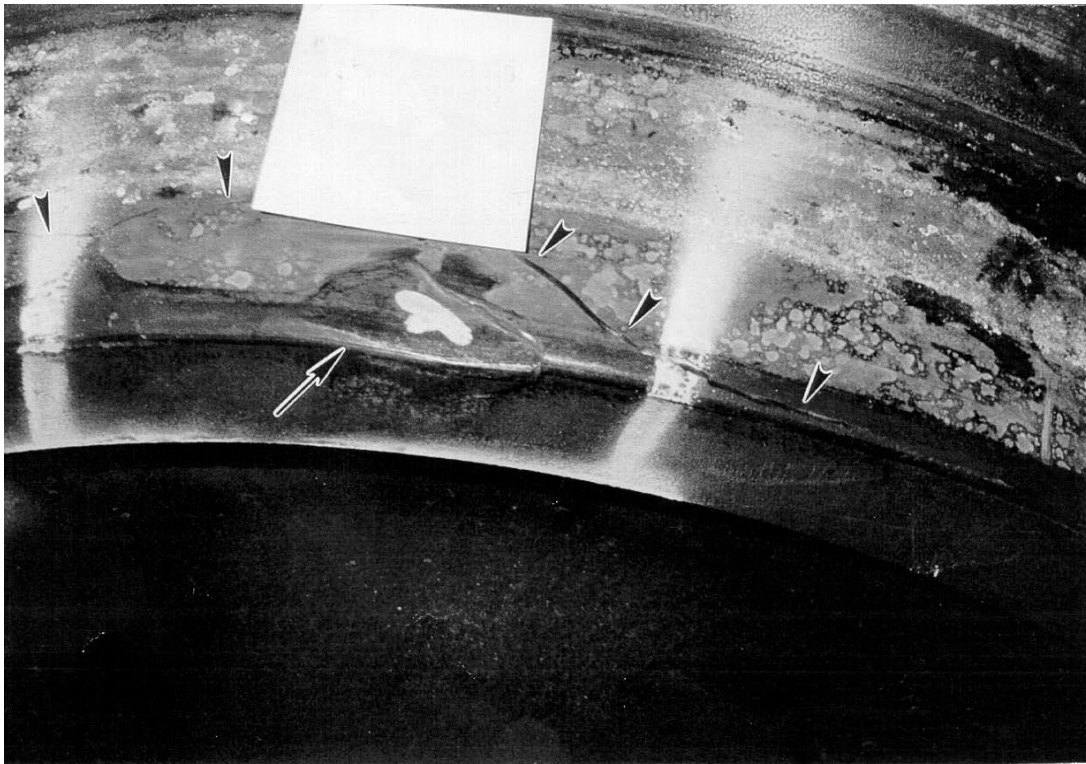
On 15 August 1995, VIA Rail Canada Inc. (VIA) train No. 65 made an uneventful trip from Montreal to Toronto. No operating exceptions were noted by the train crew during the trip, most of which was on the Canadian National (CN) Kingston Subdivision (approximately 320 miles) at speeds of up to 100 mph. After the passengers detrained at Union Station, the train was moved to the Toronto Maintenance Centre for a trip inspection. During the trip inspection, 24 wheels, on what had been the south side of the train during the trip, were observed to have impact damage. The impact marks were all roughly the same size and were located on the wheel tread near the face of the rim; the severity of the damage varied (see Figure 1).

1. Marks consistent with high-pressure impact were observed on the lip of the wheels at the outboard edge of the tread.
2. The impact marks and metallurgical findings observed on the wheels were consistent with damage resulting from the interaction with frogs in poor condition.
3. The subjective nature of the inspection criteria listed in Standard Practice Circular (SPC) 3500 and the CN Manganese Trackwork Welding Training Guide may be a factor that influenced the poor maintenance observed on the subject frog. Quantitative criteria would reduce the subjective nature of the inspection.
4. A load analysis showed that wheel speed is the most significant factor influencing the severity of impact when wheels traverse cavities in damaged and spalled out frogs.

CN promptly commenced inspections of track structures on the LRC corridor to identify the frogs suspected of causing wheel damage, and repaired or replaced all frogs having spalled manganese wings. VIA inspected all LRC equipment, and renewed or repaired all wheels that were identified as damaged.

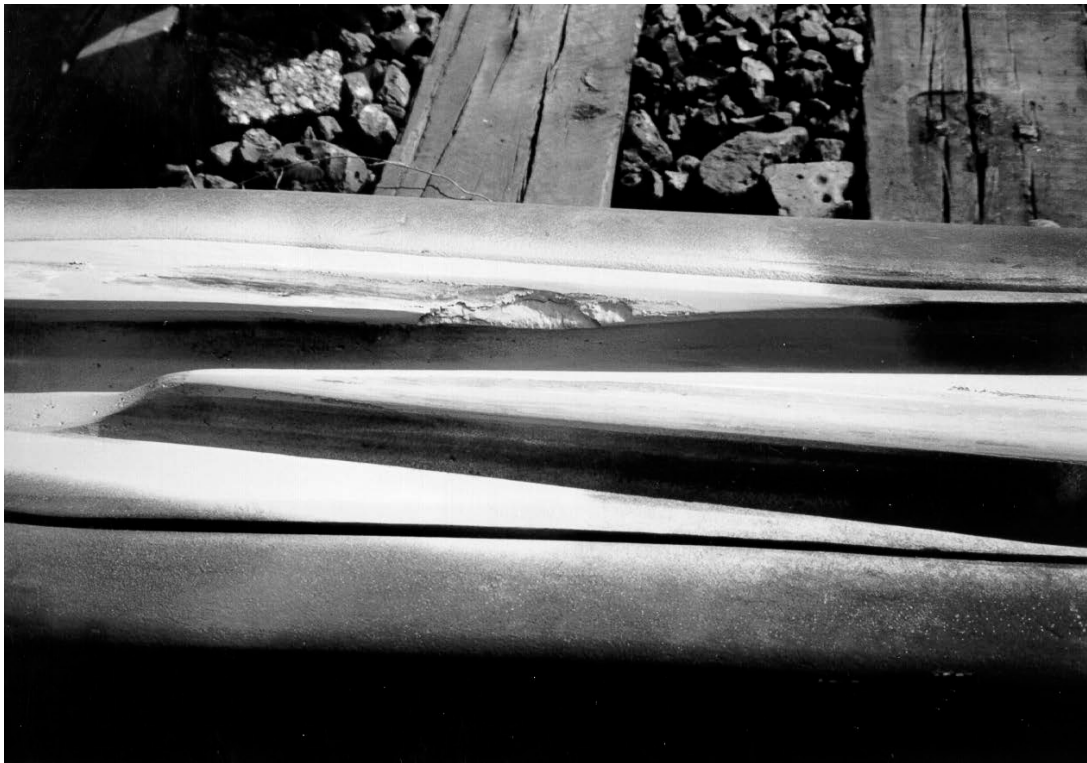
On 25 October 1995, TSB investigators and CN personnel observed a track frog with a spalled manganese wing at Mile 270.6 near Port Hope, Ontario. The spall, located at the weight transfer point of the frog, was about 1½ inches wide, 8 inches long and ¾ inch deep (see Figure 2).

Frog spalling is the result of rolling contact fatigue between the wheels and the frog. A horizontal crack develops below the surface of the wing. Continued service results in vertical fatigue cracks propagating from the ends of the horizontal crack, and eventual separation of a large piece of the manganese wing. The sharp-edged cavity created in the running surface imparts the most serious damage to the very next wheel to traverse it, and then the wheel damage subsides as the continuous traffic action pounds and blunts the edge of the cavity.

1. A VIA LRC wheel set was placed over the spalled area.
Result: the edge of the wheel tread contacted the base of the spall.
2. The spall cavity was sprayed with paint just before a VIA LRC train passed over, at about 10 mph.
Result: the wheel tread did not contact the base of the spall.
3. The spall cavity was sprayed with paint and a VIA LRC train passed over at the authorized timetable speed of 45 mph.
Result: the wheel tread contacted the base of the spall, marking the wheel tread with paint.

Spall damage to frogs is repaired by weld-filling the spall and grinding the weld smooth. The repair is not as resilient as the original material. Wheel impact can cause the repair to chip out.
