RAILWAY OCCURRENCE REPORT

DERAILMENT

VIA RAIL CANADA INC.
VIA PASSENGER TRAIN NO. 60
MILE 301.4, KINGSTON SUBDIVISION
OSHAWA, ONTARIO
21 MARCH 1996

REPORT NUMBER R96T0095

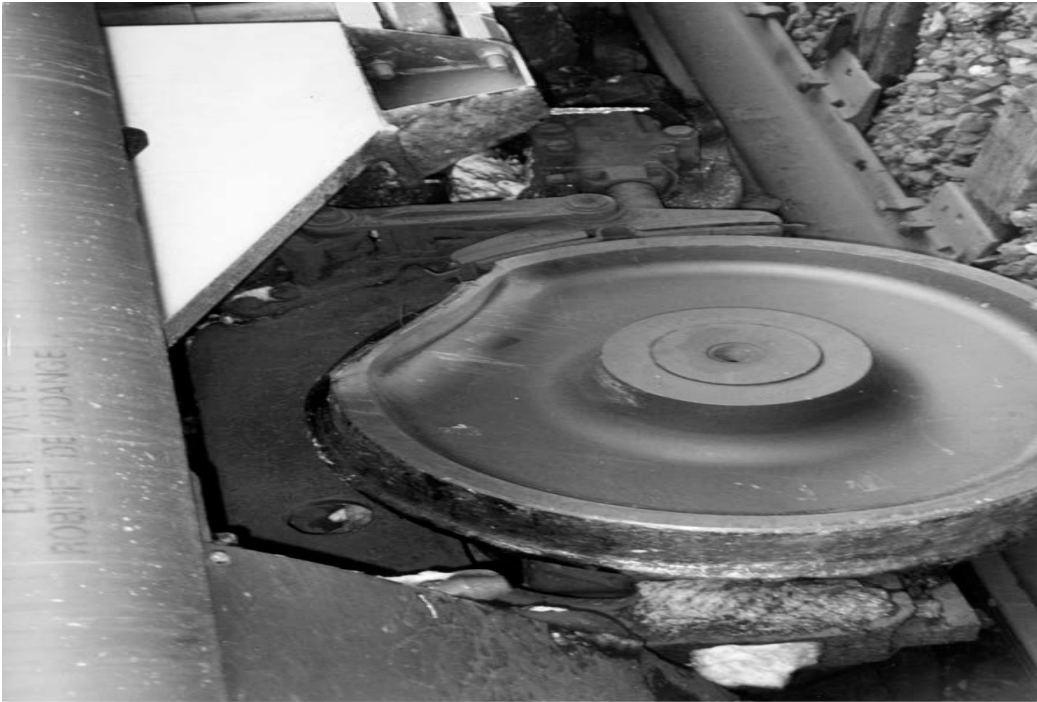
After conducting the necessary emergency procedures, the crew determined that the leading truck (No. 3 and No. 4 wheel sets) of the first car behind the locomotive, Light, Rapid, Comfortable-2 (LRC-2) coach No. 3336, had derailed.

The tread surface of each wheel of the leading wheel set (No. 4 location) of coach No. 3336 had a 15½ -inch flattened area.

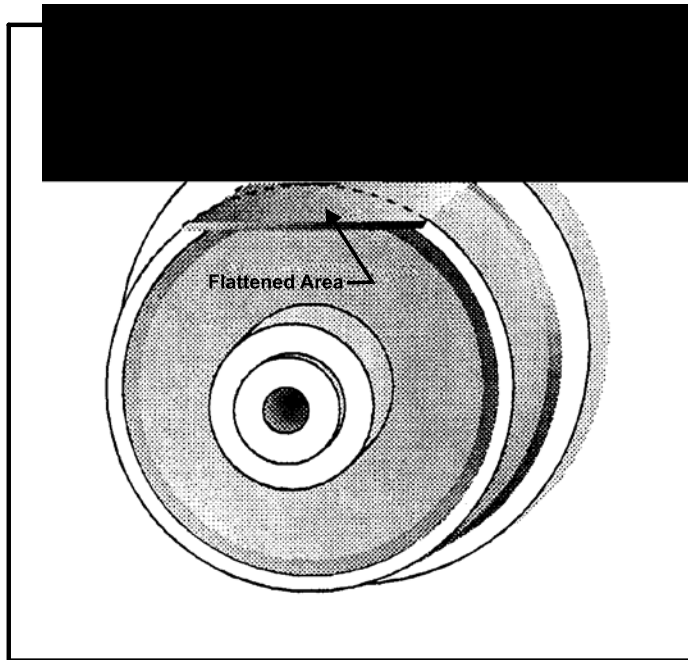
Damage to rolling stock included extensive damage to the No. 4 wheel set on coach No. 3336.

1. The leading wheel on the leading truck of coach No. 3336 derailed as a result of a slid-flat wheel condition.
2. The disc brake actuator at the L-4 location had seized with the brake applied, preventing the No. 4 axle from turning.

The derailment was caused by undetected slid-flat wheels on the No. 4 axle of coach No. 3336. Moisture had entered the disc brake actuator and frozen, causing the disc brakes to seize and preventing the wheels from turning for over 240 miles. Contributing factors included: a disc brake actuator design that did not resist moisture intrusion; inadequate supervision of mechanics to ensure that instructions with respect to draining disc brake actuators were followed; inadequate inspection practices/equipment to detect slid-flat wheels; and the lack of emphasis placed on safety inspections of passenger train brakes.

This occurrence identified the limitations of the disc brake actuator design in resisting moisture intrusion. Therefore, VIA (VIA Rail Canada Inc.) implemented modification M-82622-B which requires the raising of the breather vent away from the converter top and the application of pipe sealant on the threads of both the extension adaptor and the breather plug. This is being implemented to improve the resistance of the breather to water ingress.
