RAILWAY INVESTIGATION REPORT

R99H0009

COLLISION AT CROSSING

VIA RAIL CANADA INC.

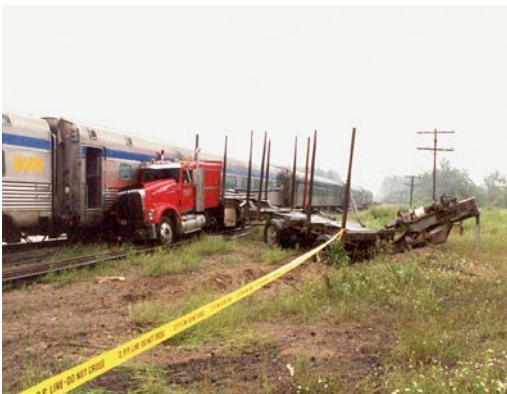
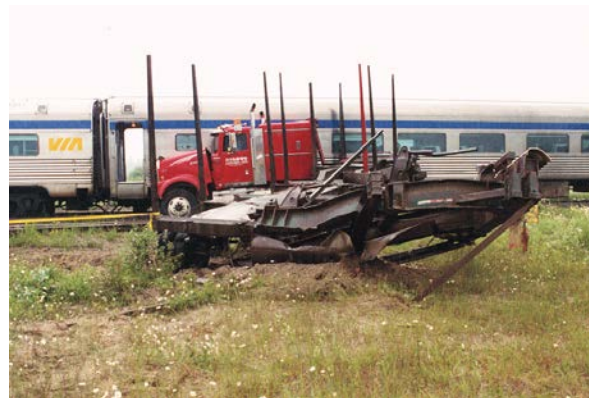
As the road and crossing were rough, the driver maintained a low rate of speed (approximately 15 km/h). There was a stop sign to the right of the road approximately 3 m before the crossing. The driver was aware of the sign and the requirement to stop. The driver elected not to stop at the stop sign as he believed that his truck could stop if he saw a train approaching and, through habit, never stopped at that crossing. The driver indicated that, at this time, he looked in both directions and did not see or hear a train. The driver stated that, once on the crossing, he again looked in both directions and did not see or hear a train. A few seconds later, as VIA 2 hit the trailer 15.85 m from the front of the truck and 14.02 m from the driver's location, the truck was thrown in an easterly direction and spun around, colliding with the first passenger car behind the three locomotives. The truck came to rest against the seventh passenger car (see Figures 1 and 2).

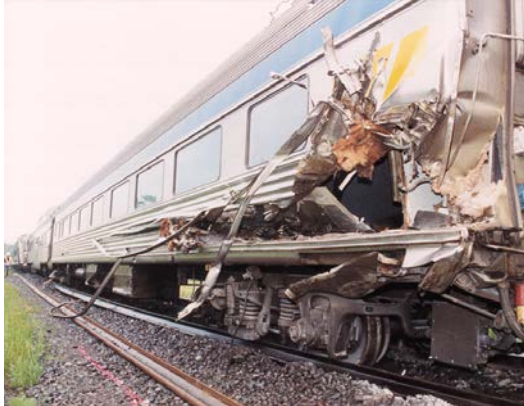
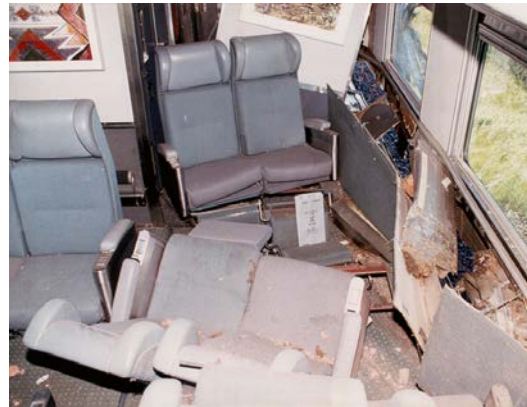
The first car behind the locomotives (8118) sustained significant damage to the south leading-end corner (see Figures 3 and 4). The damage extended to the inside of the car, tearing three sets of seats from their anchors in the floor, damaging the floor and baseboard heater and the overhead luggage rack, and destroying the end-of-car luggage rack and storage locker. The power junction box and cables were also damaged.

No. R99S0100). Given the amount of damage suffered by the first car behind the locomotives and the conclusions of Engineering Laboratory study LP 110/2000, it is evident that passenger cars are not sufficiently protected against lateral damage, such that serious injuries to passengers are likely when the cars are struck by a heavy vehicle.

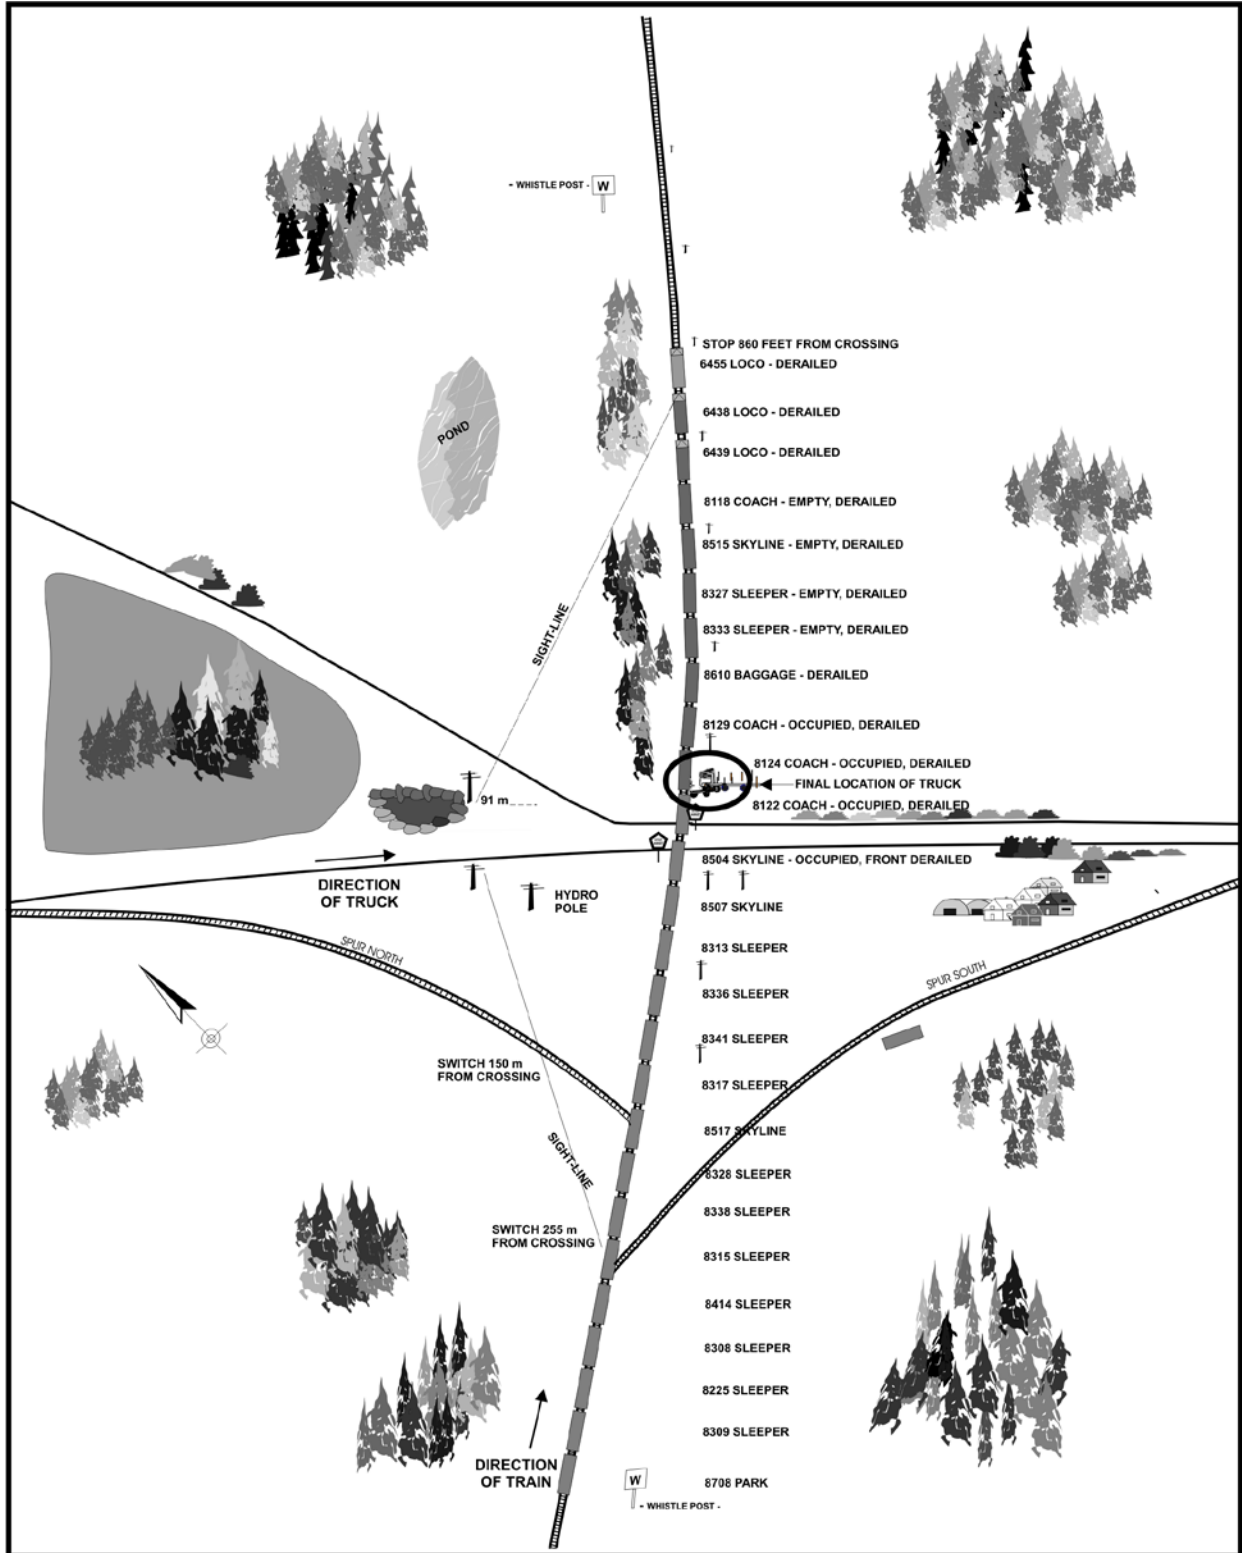
The CN Ruel Subdivision consists of a single main track. It links Capreol to Hornepayne, a distance of 296 miles. The maximum allowable track speed was 70 mph for passenger trains and 60 mph for freight trains. In the accident area, the maximum allowable speed was 60 mph for passenger trains and 55 mph for freight trains. At Mile 290.5, there is a 0.5 per cent descending grade in an eastward direction and there is a slight curve (one degree) beginning approximately 98 m west of the Becker crossing. There is a large pond immediately east of the Becker crossing just north of the main track (see Figure 5).

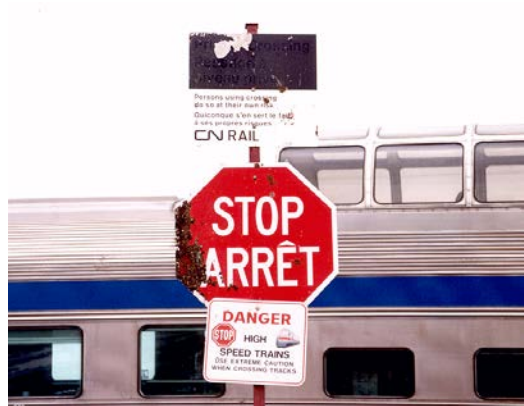
The Becker crossing was a private crossing at grade on a gravel road located at Mile 290.5 and was owned by Donahue. The Becker crossing was equipped with “maximum 30 km/h” signs, stop signs, and additional warning signs indicating “Danger High Speed Trains” on both approaches (see Figure 6). The road was straight and flat.

The Ontario Ministry of Natural Resources concluded that the crossing was unrestricted and had been used by the public for more than 50 years and that the Ministry would be the road authority for what is a de facto public crossing. The Ministry installed approach signs alerting drivers of the approaching crossing and replaced the stop signs with stop signs of higher reflectivity.

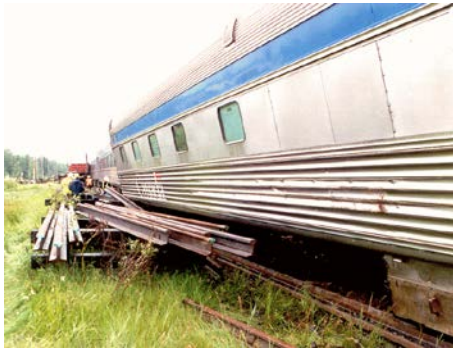
Track material, consisting of ties stacked approximately 1.2 m high, pieces of rail of various length either resting on the ground or placed on top of the ties and piles of rail anchors and tie plates, was stored adjacent to the main track immediately east of the Becker crossing and on the south side of the main track. The track material had been placed at that location several months before the accident. Because of its proximity to the main track, this material was struck by the derailed train and the truck as it was being pushed along the track.
