RAILWAY INVESTIGATION REPORT

R99H0010

DERAILMENT AND COLLISION

MONT-SAINT-HILAIRE, QUEBEC

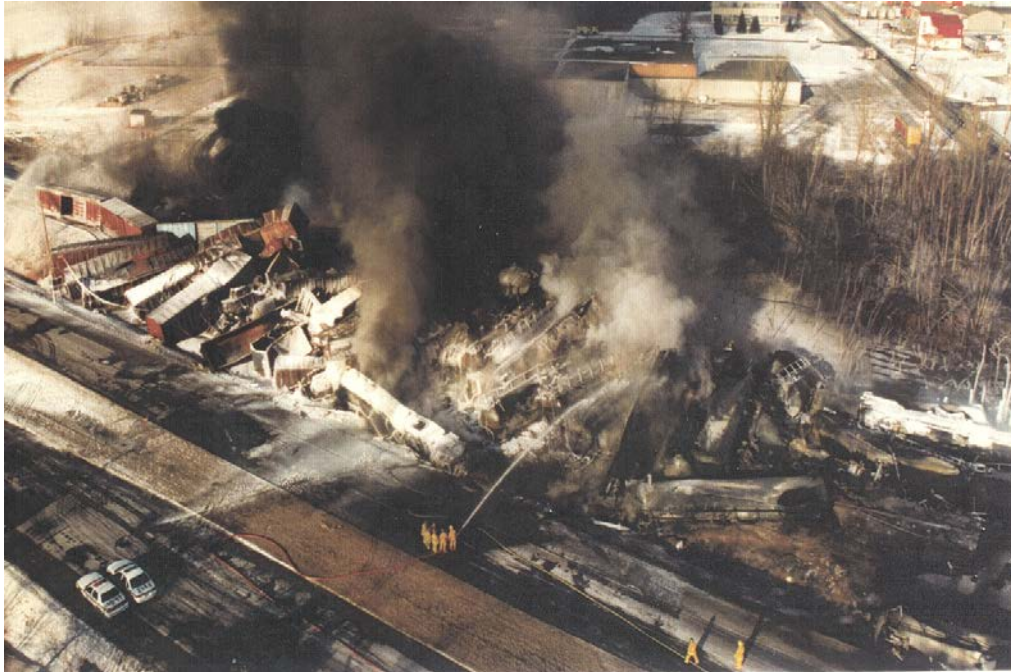
The cars were scattered across both tracks and in the ditches on either side of the tracks (see Figure 2). The locomotives from train 306 were engulfed in flames and lay on the south side of the track, in the ditch between the railway tracks and Laurier Boulevard (Highway 116). The

tank cars loaded with hydrocarbons from train 783 were punctured, and almost all rolling stock in the derailment area was on fire. The fire was isolated and brought under control during the night of 30 to 31

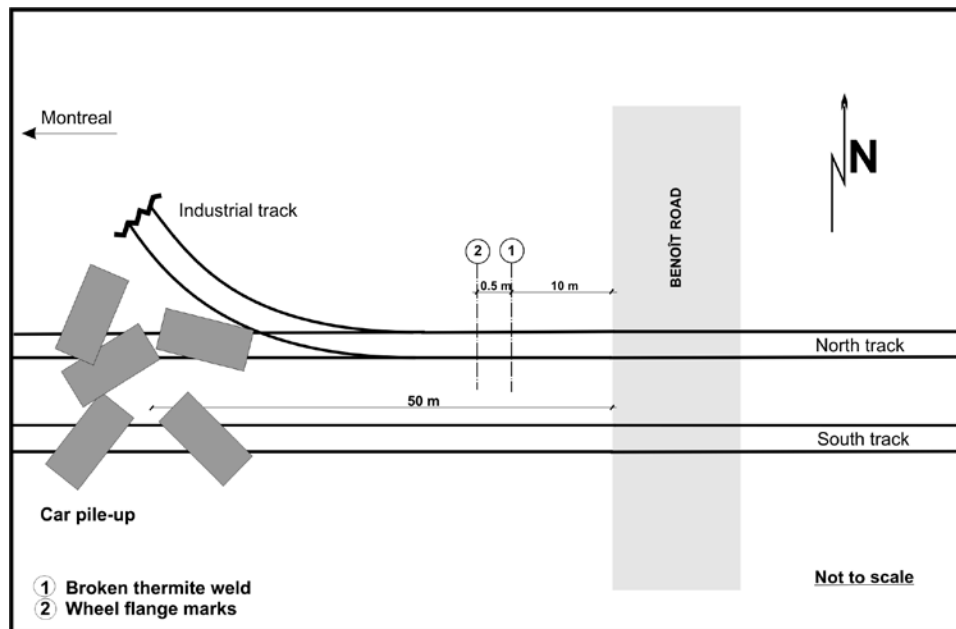
The south rail of the north track broke at a thermite weld located 10 m west of the end of the crossing and 1.5 m east of the switch point for the industrial turnout (see Figure 3).

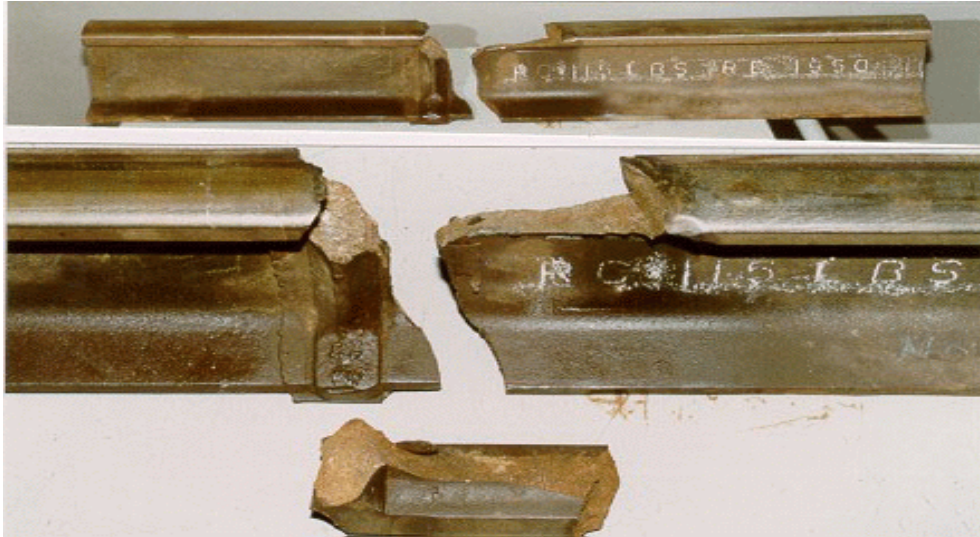
The rail was displaced laterally and the east rail end was rolled over. The break had the form of a T; it was vertical in the base and web, separated into two horizontal branches at the junction of the web and the head of the rail, and then continued vertically again in the head (see Figure 4). A rail head section, 150 mm in length, separated from the rail and was found on the ground beside the south rail, a few feet east of the weld.

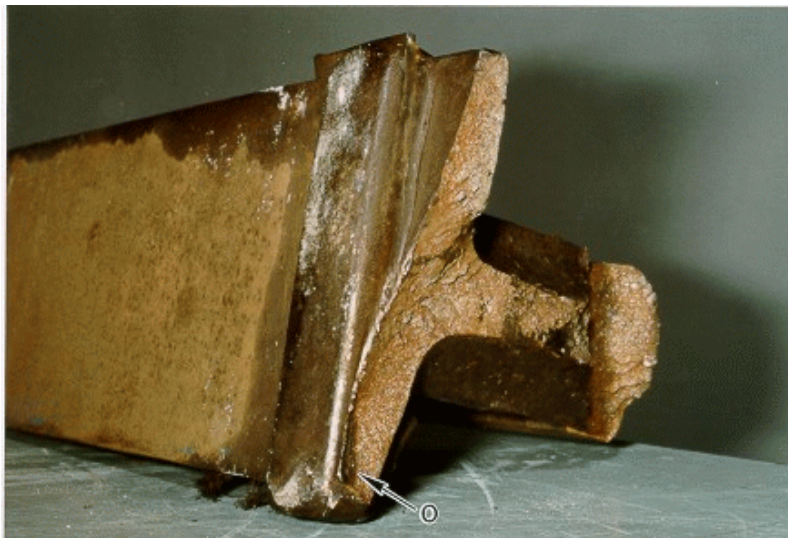
A semi-circular dark area containing a pre-crack was located on the field side of the weld fracture surface, on the lower corner of the rail base (see Figure 5). It was 29 mm wide and 6 mm high and was located 22 mm from the weld axis. The pre-crack was located in the heat-affected zone of the weld, near a sudden change in the cross-section. The surface of the pre-crack was highly oxidized and showed no signs of recent growth.

The two surfaces of the pre-crack were cut out of the east and west rail sections. Analysis of these pieces with a scanning electron microscope and a metallurgical microscope confirmed that the pre-crack had begun in an area of acicular ferrite, a microstructure that has less resistance to fracture and impact, and that there was no recent extension of the pre-crack.

Residual strength was analyzed using specialized fracture mechanics software. For a defect comparable in size to that found on the thermite weld (29 mm wide by 6 mm high), residual strength falls from 92 ksi to 30.13 ksi, or approximately 33 per cent of the initial yield strength.

The chevron markings observed on the fracture surfaces are consistent with a rapid overstress fracture. The direction of these markings indicates that the break originated in the pre-crack area located in the lower corner of the rail base. Once initiated, the fracture occurred quickly, with the head of the rail breaking last. The pre-crack showed no signs of recent growth. It lacked the black colouration, which is usually associated with oxidation at high temperature, indicating that it formed after the weld was made, probably as a result of residual stresses created during welding. The thickness of the oxide layer indicates that the pre-crack was at least nine months old.
