RAILWAY INVESTIGATION REPORT

R99S0100

CROSSING COLLISION/DERAILMENT

VIA RAIL CANADA INC.

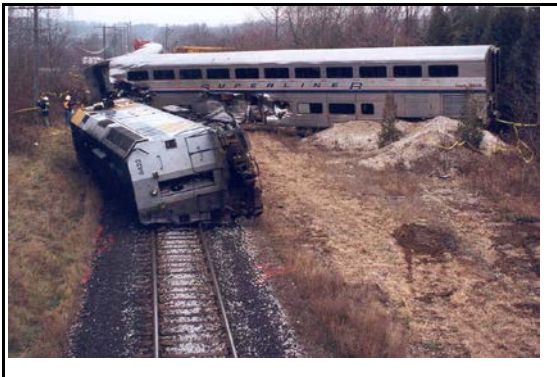
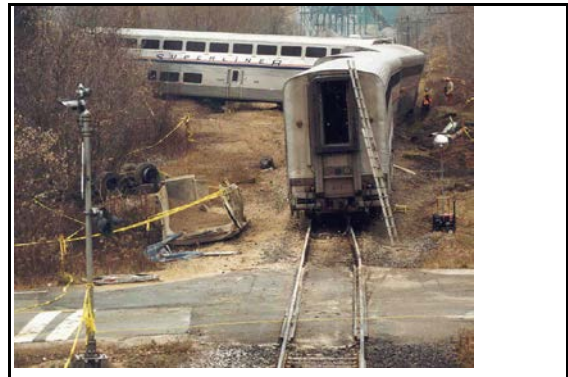
The first car behind the locomotive tracked westward, in the derailed position, until it became detached from the locomotive. It travelled in a west-southwest direction, stopping 362 feet west of the crossing, perpendicular to the track. The following three coaches tracked parallel with the main track, leaning at varying angles. The back end of the last car came to rest at a point 52 feet west of the crossing.

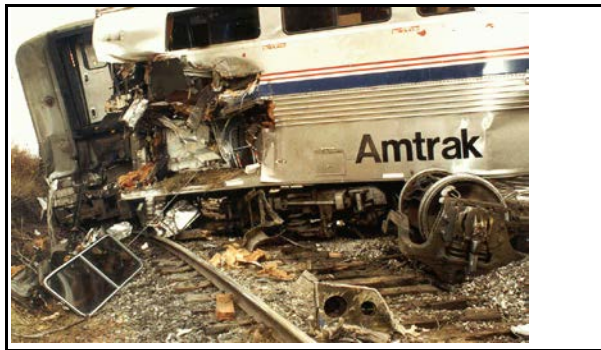
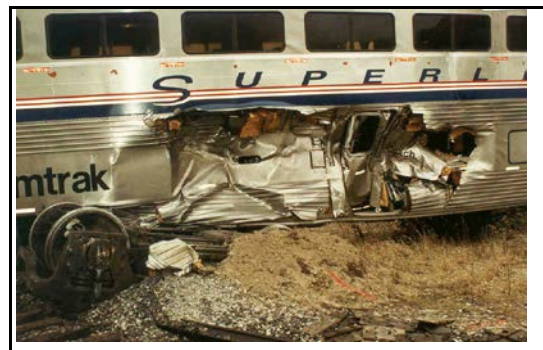
Figures 3 & 4 - Damage to coach 34036

AMT coach 34036, the first (lead) car behind the locomotive, sustained major damage to the right (north) side. When the locomotive separated from its trucks, the lead car was dragged westward, striking the displaced locomotive trucks. Just east of the mid-section of the car, a large section of the stainless steel sheeting, measuring 6 feet 3 inches high by 20 feet 3 inches long, was torn away by the impact. The double-occupancy seats in this area were exposed to the outside, and the stairwell to the upper level seating was crushed. A large hole at the extreme east end of the car, measuring 6 feet 3 inches high by 11 feet long, destroyed the compartment housing electrical and plumbing controls for the operation of the car, and a window was ejected from the upper level. A total of 12 Z-type construction posts were destroyed along with approximately 35 feet of longitudinal channel beam. This coach eventually separated from the locomotive and came to rest across the main track, causing additional damage to the undercarriage.

Heavy post-accident damage to the coaches resulted in deformation of the car body and upper deck stairwell, which heavily impeded egress from the washrooms and upper seating area. The side sheathing and structural side post of AMT 34036 were extensively damaged when the coach struck the detached locomotive trucks, tearing a large hole in the side sheathing. The cars are designed to resist an inward transverse load; however, the loads experienced were in excess of the design requirement.

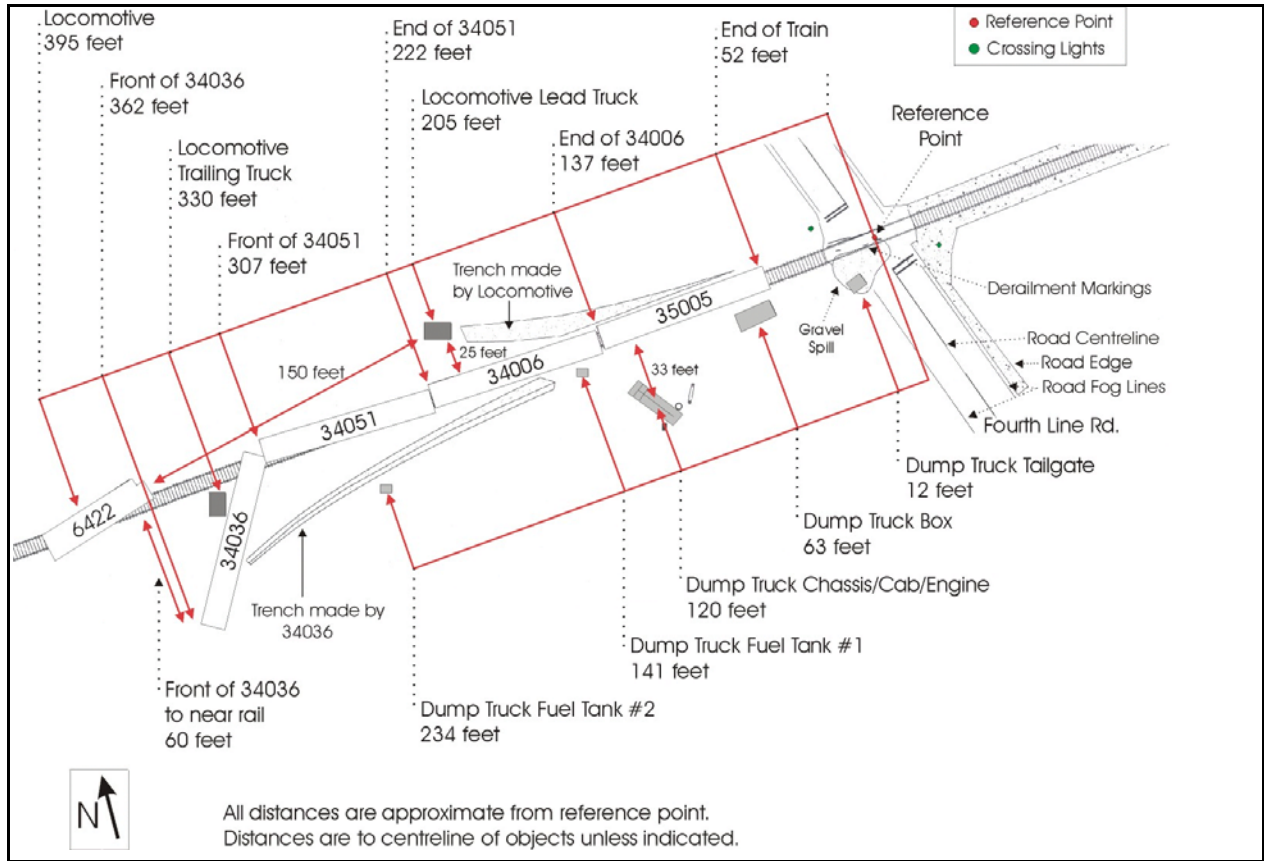
Appendix A—Diagram of Accident Site

15 feet south of the track. Parts of the truck were strewn on both sides of the track as far away as 234 feet from the crossing. Appendix A contains a site diagram showing approximate locations and measurements
