**AVIATION INVESTIGATION REPORT
A13Q0098**

**FORCED LANDING FOLLOWING FUEL EXHAUSTION
AVIATION FLYCIE INC.
BEECHCRAFT KING AIR 100, C-GJSU
MONTRÉAL/ST-HUBERT AIRPORT, QUEBEC, 8 NM E
10 JUNE 2013**

Aviation Investigation Report A13Q0098

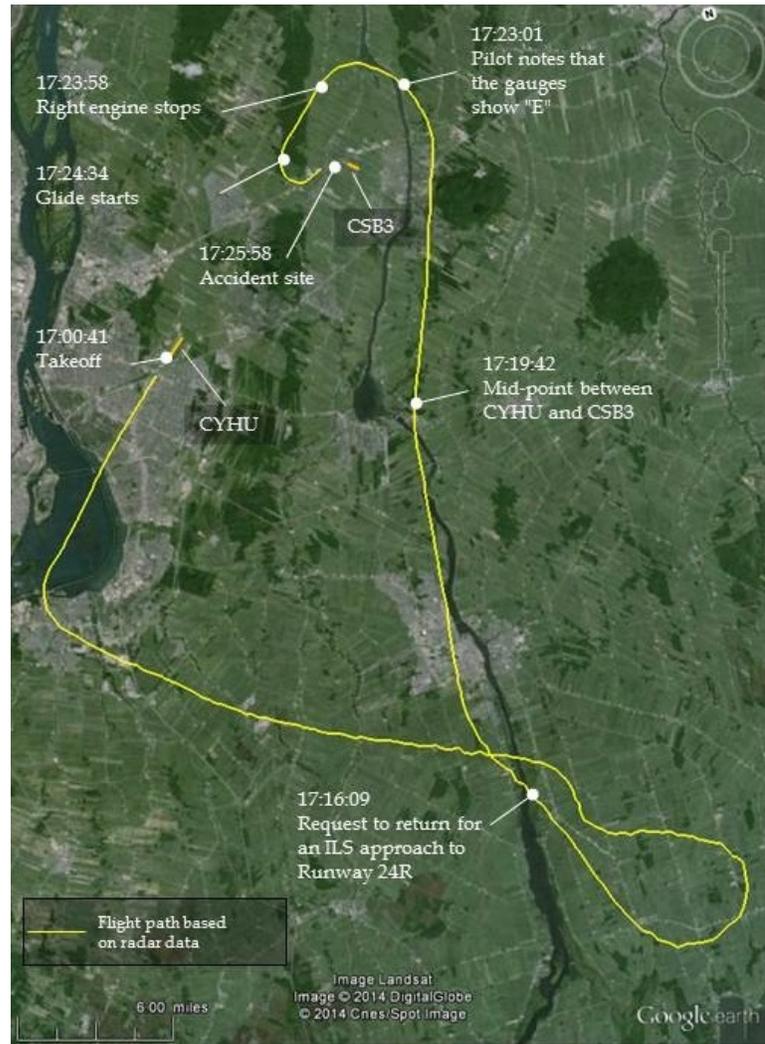
At approximately 1714, once the tests were completed, the aircraft, which was about 25 nautical miles (nm) south of CYHU, set a direct course for CYHU. At 1716, the pilot advised air traffic control (ATC) that the tests had been completed and asked to return to CYHU with a simulated instrument landing system (ILS) approach to Runway 24R (Figure 1).

Figure 1. Aircraft flight path based on radar data (Source: GoogleEarth, with TSB annotations)

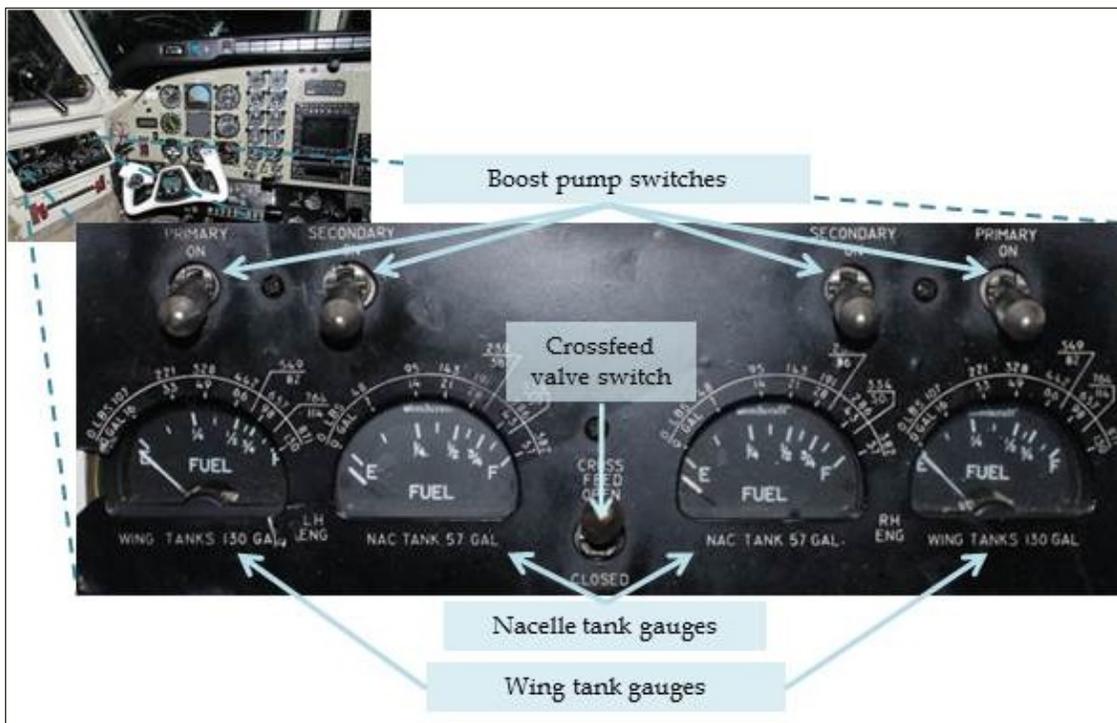
The fuel panel is located on the pilot's left (Figure 3). It includes the 4 fuel gauges, the switches of the 2 primary boost pumps and those of the 2 secondary boost pumps, and the crossfeed valve switch. One wing tank gauge and one nacelle tank gauge are located on each side of the crossfeed valve switch.

Figure 3. Fuel panel and switches

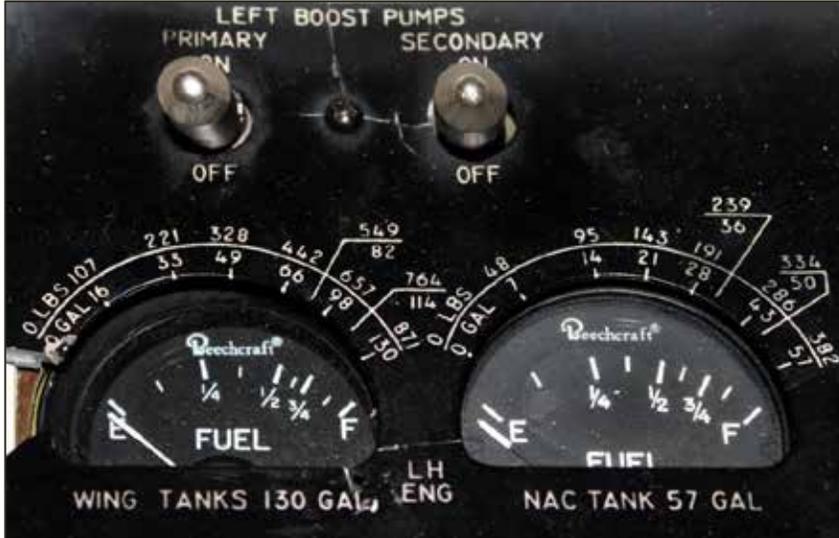
The fuel gauges are graduated from "E" (empty) to "F" (full). Fuel quantity is displayed in fractions, pounds, and gallons. The gauges are not graduated in linear fashion; the needle moves in smaller increments as it approaches the "F" mark. For example, the "1/4 full" mark is located near the middle of the dial. The scale of the wing tank gauges is graduated from 0 to 130 U.S. gallons, whereas the scale of the nacelle tank gauges is graduated from 0 to 57 U.S. gallons (Figure 4).

Figure 4. Graduation of the gauges

Calibration of the fuel gauges is not required, and no adjustment is called for in the aircraft maintenance manual. In the event that a gauge provides a faulty reading, the instrument is replaced.

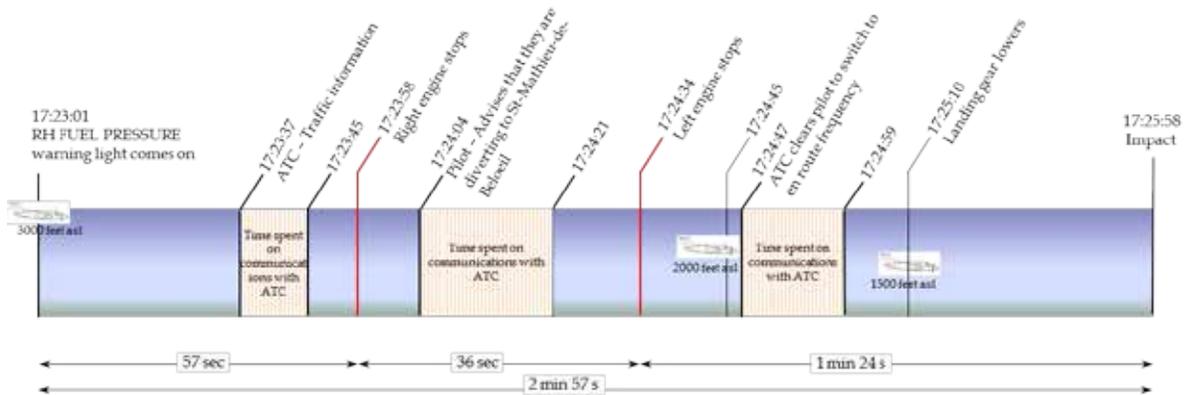
There were 3 radio communications between C-GJSU and the Montréal terminal control area after the RH FUEL PRESSURE light illuminated (Figure 6).

Figure 6. Communications between the pilot and air traffic control (ATC)

After the right engine stopped, the pilot advised the controller that the flight would be diverting to CSB3, but did not provide a reason. Unaware of the flight's emergency status, the controller acted as per the *Air Traffic Control Manual of Operations* (ATC MANOPS) instructions for normal communications. As such, the information transmitted and the requests made by the controller constituted a source of distraction for the pilot. The last communication from the controller to C-GJSU took place 13 seconds after the second engine had stopped, and consisted of informing the pilot of nearby traffic and clearing the pilot to switch to the enroute frequency. The pilot acknowledged but did not report that an emergency situation was in progress.

The aircraft impacted the ground 1 minute later, in a field located 0.5 nm south of the selected runway. A "mayday" call had not been transmitted. In addition, the pilot's intention of landing at CSB3 from the opposite side of the approach circuit in use had not been communicated on the aerodrome's traffic frequency.

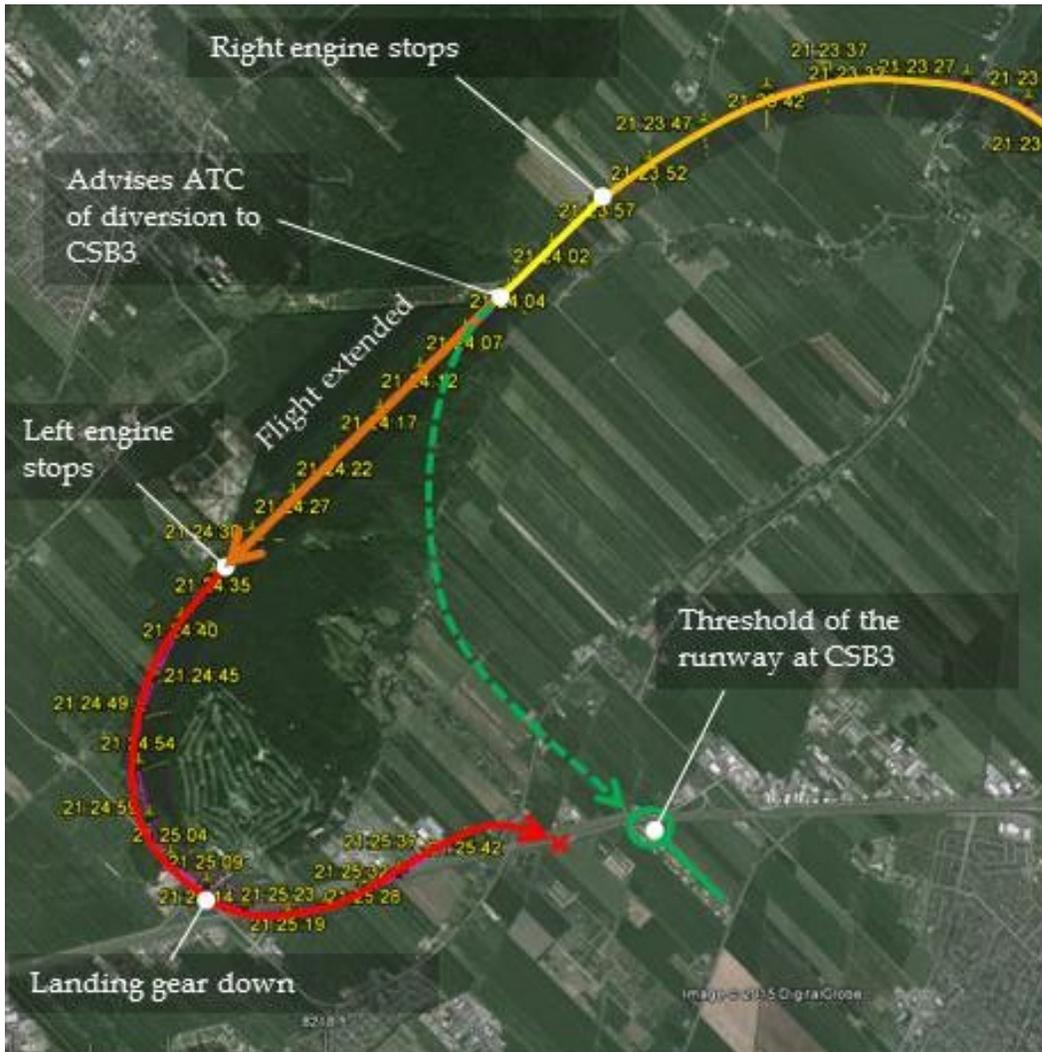
The pilot had neither declared an emergency nor notified ATC of the situation. The controller was somewhat puzzled by the change in plan, since C-GJSU was on final approach and 9.5 nm from CYHU, and asked the pilot to confirm that the aircraft was no longer going to land at CYHU. These communications lasted 17 seconds, at the end of which the controller cleared the flight to proceed to CSB3. Meanwhile, C-GJSU remained on its flight path toward CYHU (Figure 15).

Figure 15. Extension of the flight path toward St-Mathieu-de-Beloeil Airport (CSB3), Quebec
(Source: GoogleEarth, with TSB annotations)
