RAILWAY INVESTIGATION REPORT

R01M0024

MAIN TRACK DERAILMENT

STEWIACKE, NOVA SCOTIA

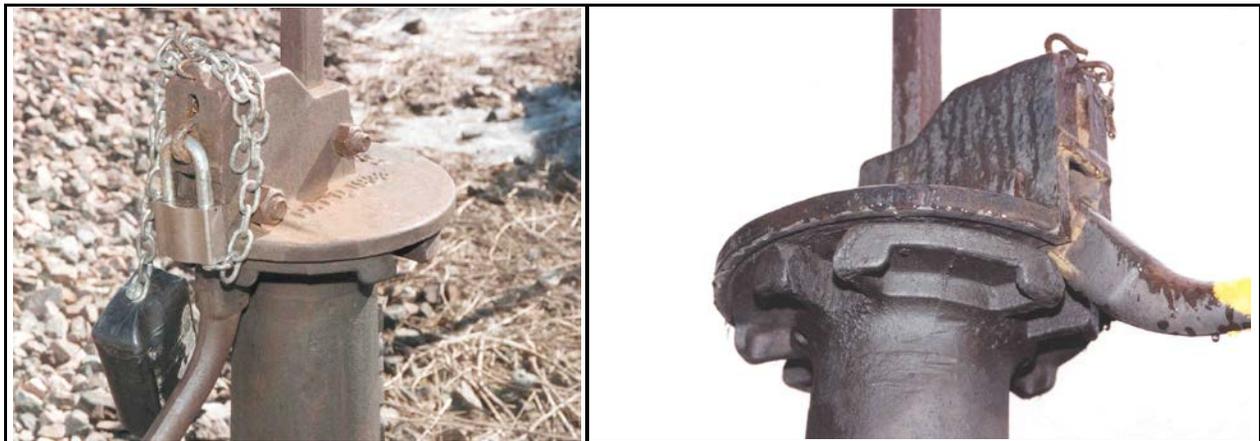
Maintenance personnel adjust switch points so that they are tight to the stock rail when set in the normal (closed) position. When the switch handle is fully rotated then lowered into its retaining slot and locked (Figure 12), the switch points apply a compressive force against the stock rail. Because the switch points are sitting on lubricated flat steel plates, as soon as the switch handle is unlocked and raised out of the slot, the force is released and the switch point generally moves away from the stock rail, opening the switch a slight amount. An examination of the occurrence switch stand revealed that the sole action of raising the switch handle in its slot vertically to the level of the table (Figure 13) was enough to cause the switch points to open approximately 1/4 inch.

Even in a condition where a hand throw switch handle is down in its retaining slot but left unlocked, over time, vibration and dynamic forces imposed on the switch under the weight of passing trains can cause the points to flex and open. Unless the points are held tight to the stock rail by the connecting rod and secured by the stand

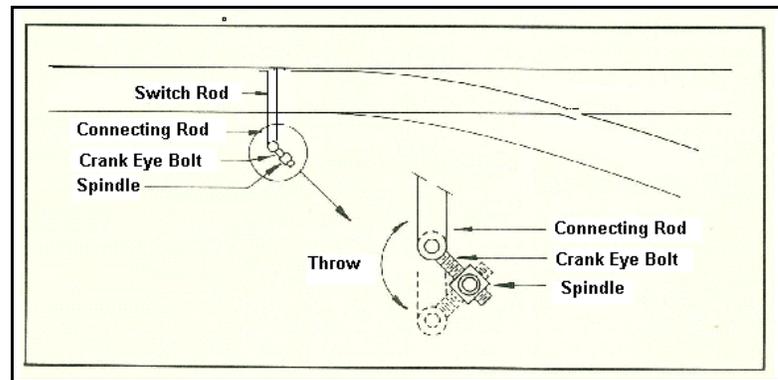
The switch target and tip assembly is directly affixed to the switch stand mast. The switch stand mast is linked to a spindle and switch handle (Figure 14). Therefore, there is a direct relationship between the lateral movement of the switch handle and the change in aspect of the switch target and mast. As the mast is rotated 90 degrees to move the switch points from the normal to the reverse position, the target attached to the mast and spindle moves to the same degree. The design of the switch stands and their associated targets dates from the early 1930s.
