**RAILWAY INVESTIGATION REPORT
R13D0054**

RUNAWAY AND MAIN-TRACK DERAILMENT

**MONTREAL, MAINE & ATLANTIC RAILWAY
FREIGHT TRAIN MMA-002
MILE 0.23, SHERBROOKE SUBDIVISION
LAC-MÉGANTIC, QUEBEC
06 JULY 2013**

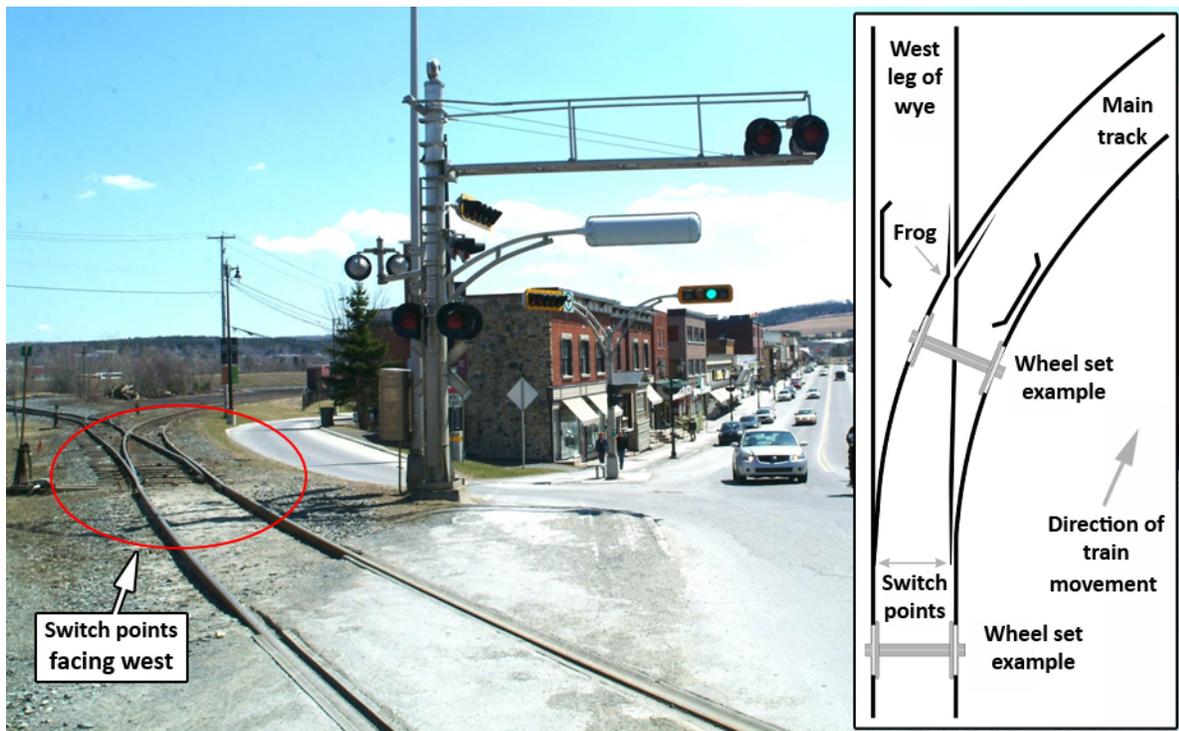
The MMA Megantic Station was located in a commercial district of Lac-Mégantic, where the Sherbrooke and Moosehead Subdivisions met. Frontenac Street, a main thoroughfare, ran through the centre of the town. The main track intersected with Frontenac Street just west of the Megantic West turnout and was maintained for a maximum speed of 15 mph. The turnout was located at Mile 0.23, with the switch points facing west (Photo 4).

Photo 4. Frontenac Street public grade crossing, looking eastward. The circled area denotes the location of the switch points and the frog for the Megantic West turnout (photo: Pierre Blondin, with TSB annotations).

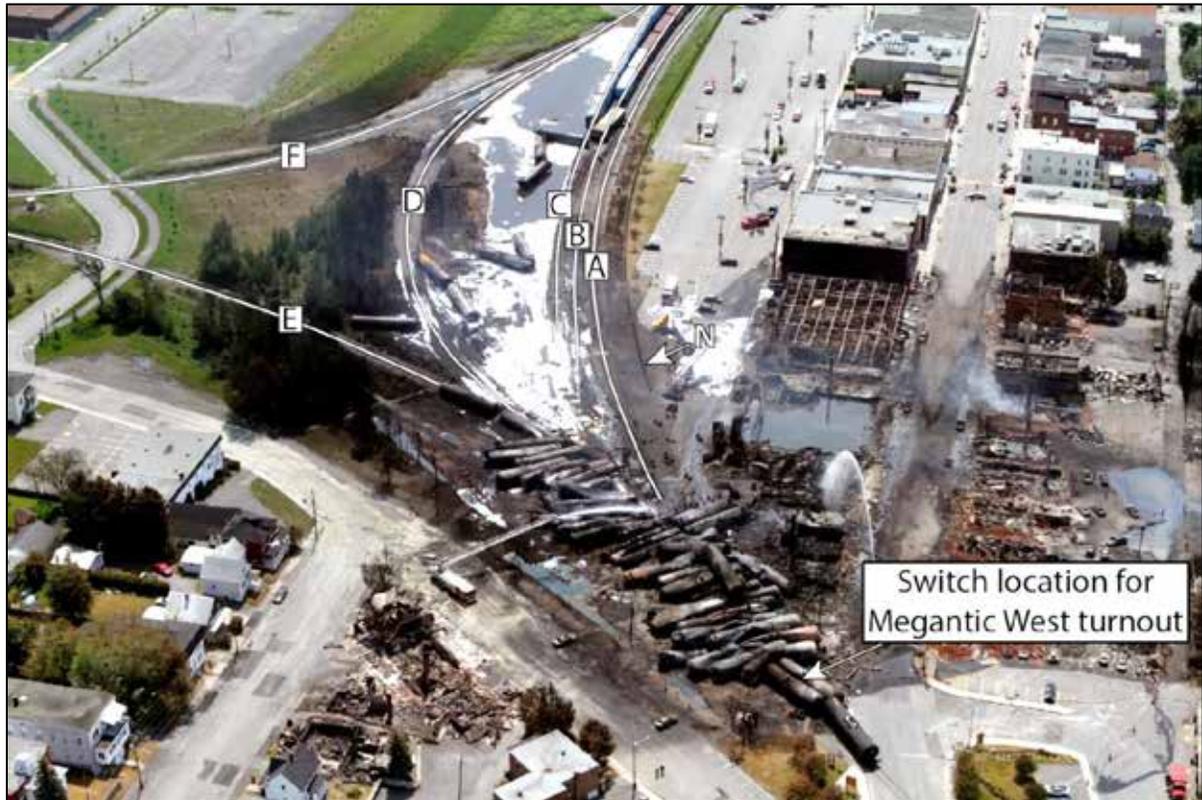
The derailed equipment covered the main track, 3 adjacent yard tracks, and the west leg of the wye, which is a triangular arrangement of tracks that can be used for turning rail equipment (Photo 5).¹¹ At the time of the accident, there were box cars parked in yard tracks 1 and 2.

Photo 5. Eastward view of the location of the tracks in relation to the first derailed cars: main track (A), yard track 1 (B), yard track 2 (C), yard track 3 (D), and the west and east legs of the wye tracks (E and F)

- The damage to the main track started approximately 20 feet east of Frontenac Street.
- The main-track turnout, approximately 400 feet of main track, and an additional 2000 feet of yard and wye tracks, including 3 turnouts, were destroyed.
- Approximately 500 feet from the crossing, the main track was shifted about 4 feet to the north.
- Yard tracks 1 and 2 were demolished from the west-end turnout for about 600 and 500 feet, respectively.
- Rails were curled and twisted, unsettled from tie plates, and moved randomly. Due to the severity of the fire, most track components were badly damaged.
- The Frontenac Street southeast public-crossing cantilever mast and the control box were shattered. Road traffic lights, electrical wires, lighting posts, and other appliances were also damaged.

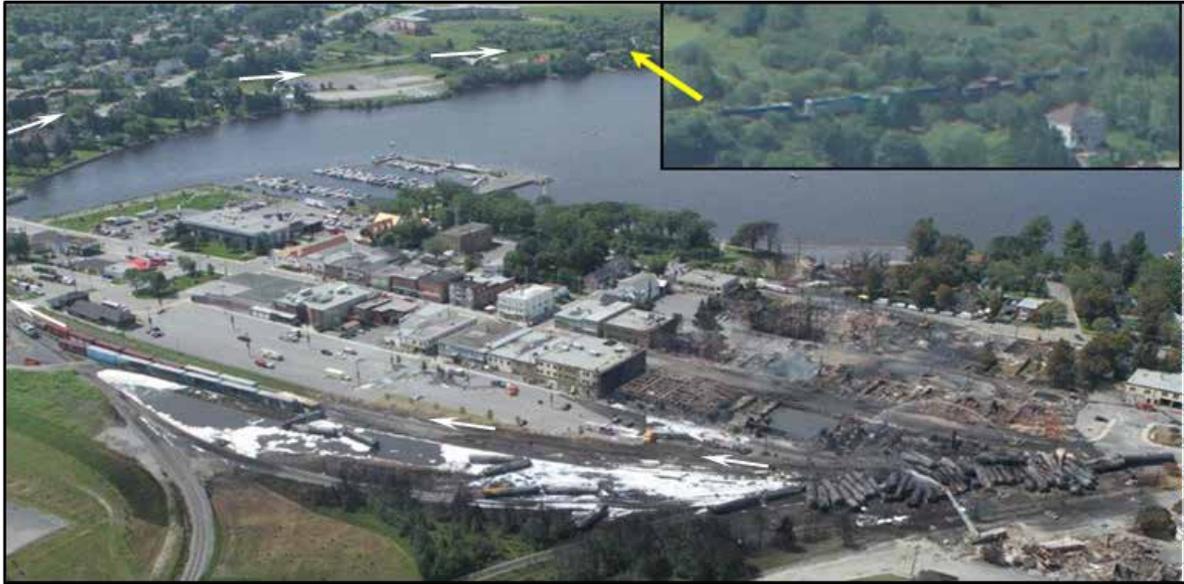
The locomotive consist came to rest approximately 4400 feet east of the Lac-Mégantic derailment site, at Mile 116.41 of the Moosehead Subdivision (Photo 6).

Photo 6. Location of the locomotive consist (Mile 116.41 of the Moosehead Subdivision) in relation to the derailment site. The white arrows denote the route of the locomotive consist, which followed the main track.

- There was no damage to the track between the derailment site and the location of the locomotives.
- There was a black oily residue, similar to the residue observed at Nantes, on the ground adjacent to the lead locomotive (MMA 5017), as well as about 600 feet east of where the locomotives came to rest.

- Hand brakes were applied on all 5 locomotives and the VB car.
- There was severe wear on some of the brake shoes and various degrees of blueing¹² on most of the wheels.

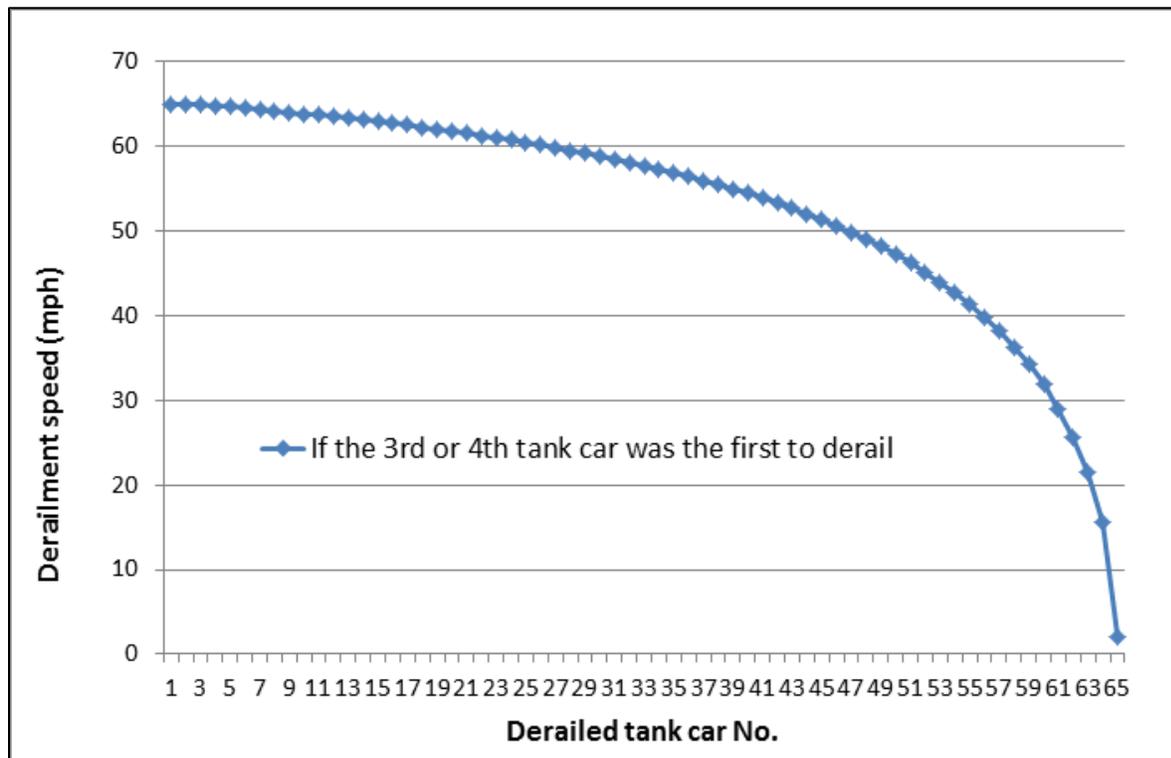
Figure 5. Estimated speed at which each car derailed if the third or fourth car was the first to derail³²

At the time of the derailment, the train was near the Megantic West turnout. The train was analyzed to assess the in-train forces as it transitioned from the downhill grade of 1.26% to the relatively flat terrain of 0.2% at Megantic. A vehicle dynamics simulation of a Class 111 tank car negotiating the curve at Megantic Station was also conducted (see Engineering Laboratory Report LP188/2013 for complete details). It was determined that a combination of the centrifugal force and the dynamic forces generated by the track geometry conditions at a speed of 65 mph was sufficient to cause the derailment. With extremely high lateral forces on the high rail, gauge widening could occur. Furthermore, with complete unloading on the low rail, wheel lift could occur. Either of these conditions or a combination could cause track damage and a derailment.

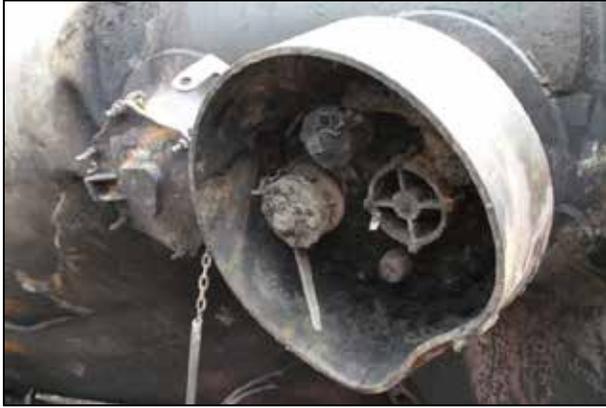
The top fittings of 32 of the 63 tank cars were housed in a $\frac{3}{4}$ -inch-thick steel circular protective housing designed to provide top discontinuity protection in accordance with applicable AAR requirements⁴⁰ (Photo 21).

Photo 21. Protective housing providing top discontinuity protection for tank car fittings (removed cover)

- The top fittings were breached on 4 of the 27 cars (15%) that were equipped with top discontinuity protection housings and that sustained impact damage.
- The top fittings were breached on 16 of the 26 cars (62%) that were equipped with a hinged housing and that sustained impact damage.

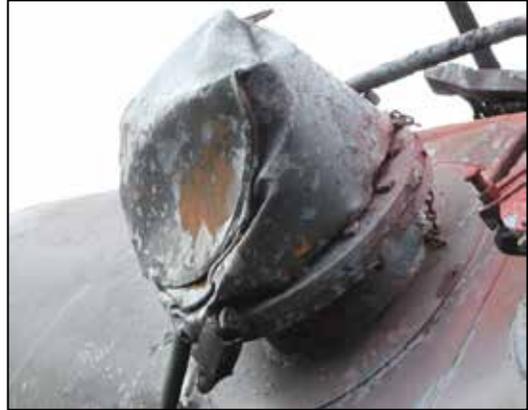
The top fittings of the remaining 31 tank cars were located in a hinged housing that did not have to meet any of the top discontinuity protection requirements (Photo 22).

Photo 22. Hinged housing for tank car fittings

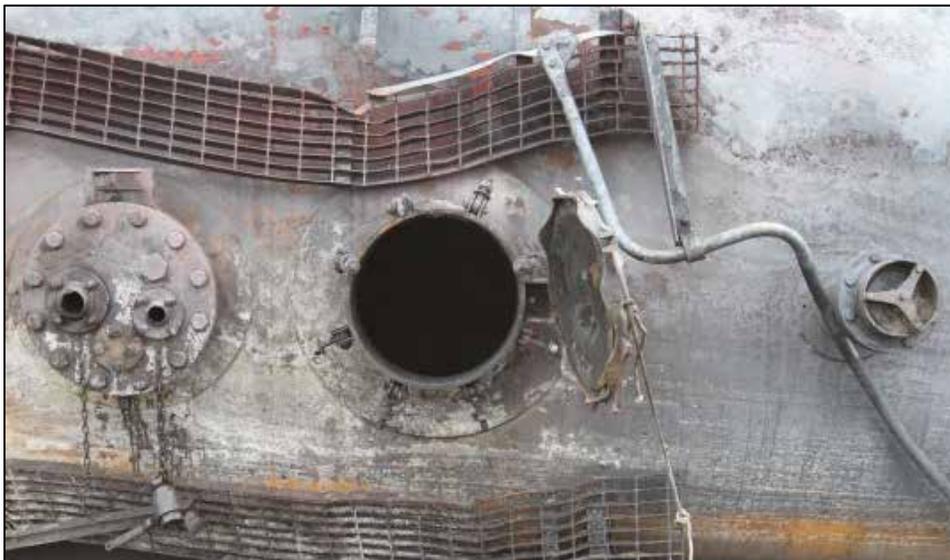
- The manway gaskets on most of the derailed tank cars were damaged by extended exposure to the post-derailment fire.
- The manway cover of 2 cars had separated as a result of impact damage.
- The manway cover hinges, bolts, or lugs of 22 tank cars exhibited impact damage that may have compromised their seals.

Photo 23. Manway cover and opening

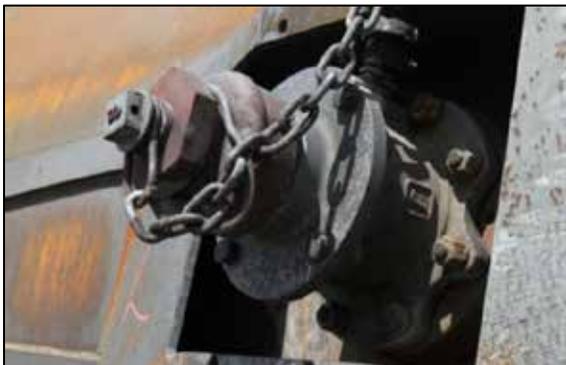
- There were 36 tank cars with sheared-off BOV nozzles (Photo 26).
- Seven of these tank cars had damaged or missing BOV handles, resulting in the ball valve being open or partially open, which led to a release of product.
- Six tank cars were equipped with internal plug-type BOVs. None of these BOVs were breached.
- The BOV handle assemblies of 43 tank cars were deformed, impact-damaged, or missing.

Photo 25. Bottom outlet valve

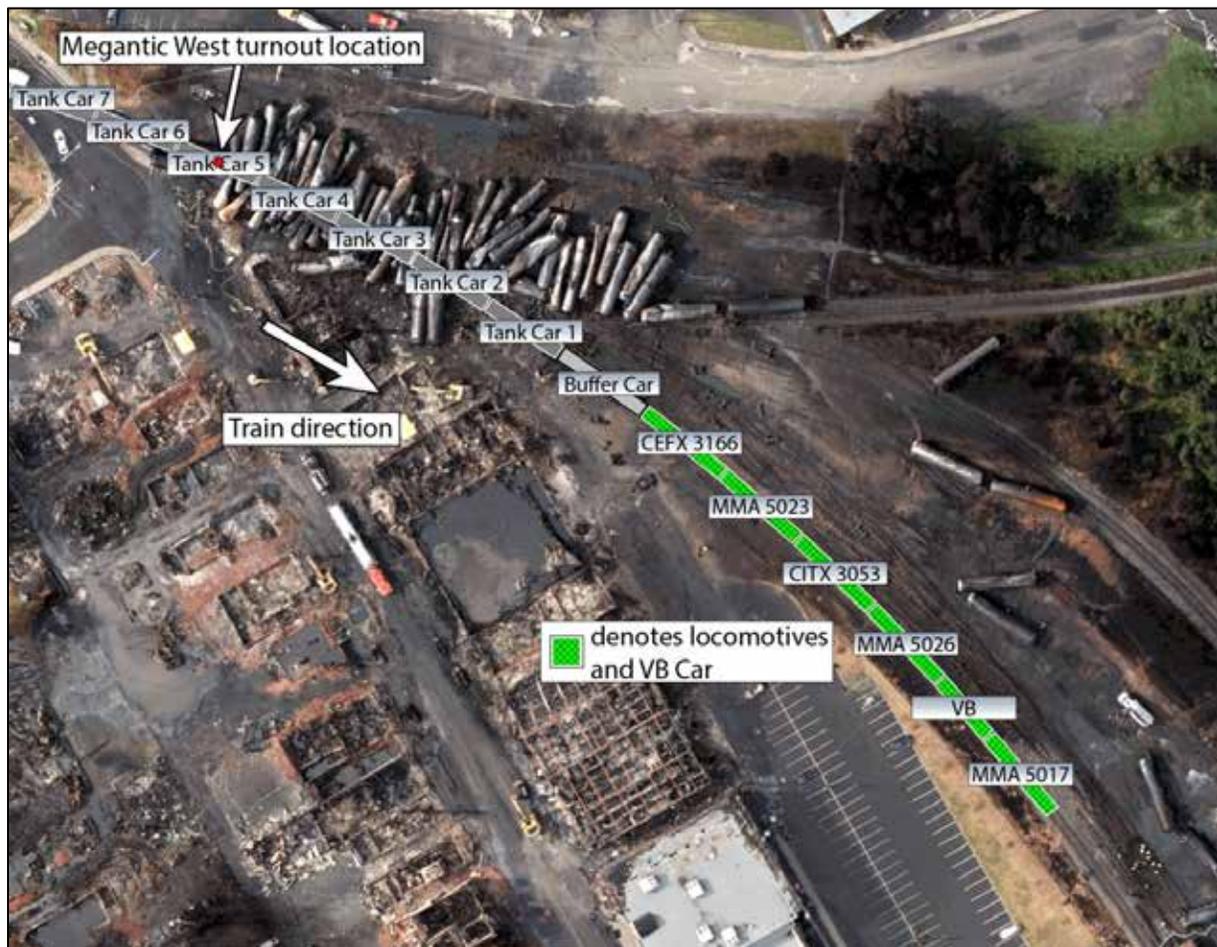
The general trajectory of the derailed equipment also confirmed that the point of derailment (POD) was at or near the Megantic West turnout. To determine which cars were most likely the first to derail, the TSB analyzed LER information to establish the locations of the cars when the brake pipe pressure dropped to zero, as this indicated the moment of separation caused by the derailed equipment. Results show that tank cars 4 through 6 were closest to the POD at that time (Photo 29).

Photo 29. Location of the train when the brake pipe pressure dropped to 0 psi (sources: AeroPhoto and locomotive event recorder data)

An examination of the damage and of the final resting locations of the first derailed cars, starting from the front of the train, allowed the investigation to conclude that the derailment most likely occurred ahead of the sixth tank car.
