AVIATION INVESTIGATION REPORT

A0000279

INCIDENT—RUNWAY OVERRUN

ANTONOV124-100 UR-82029

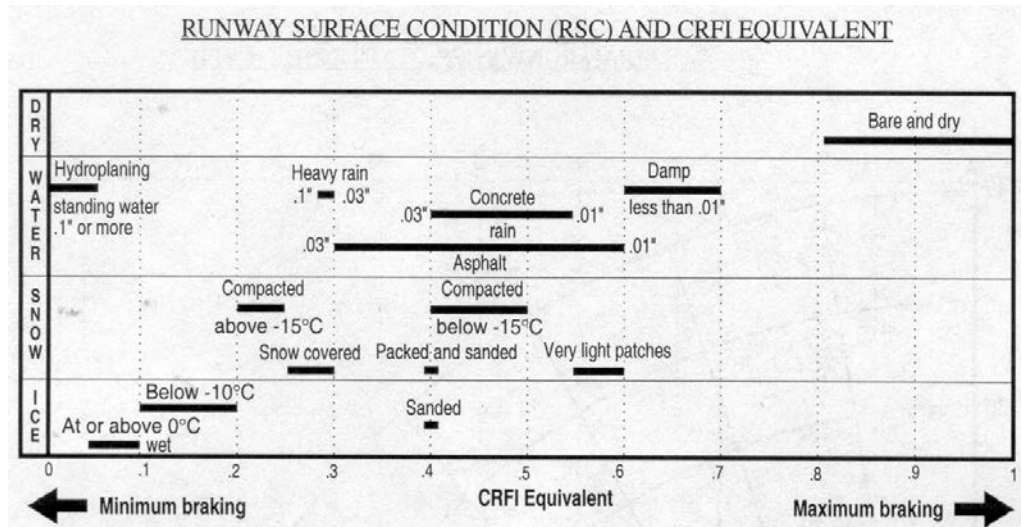
CRFI readings of 0.40 or less, which represent low braking coefficients of friction, are required to be reported as a special notice to airmen. The CRFI of 0.30, obtained 16 minutes before the overrun, was not reported on the notice to airmen system because the Windsor airport was closed immediately after the occurrence.
