AIR TRANSPORTATION SAFETY INVESTIGATION REPORT A18W0116

POWER LOSS AND LOSS OF CONTROL IN FLIGHT

Aries Aviation International
Piper PA-31, C-FNCL
Calgary/Springbank Airport, Alberta, 40 nm SW
01 August 2018

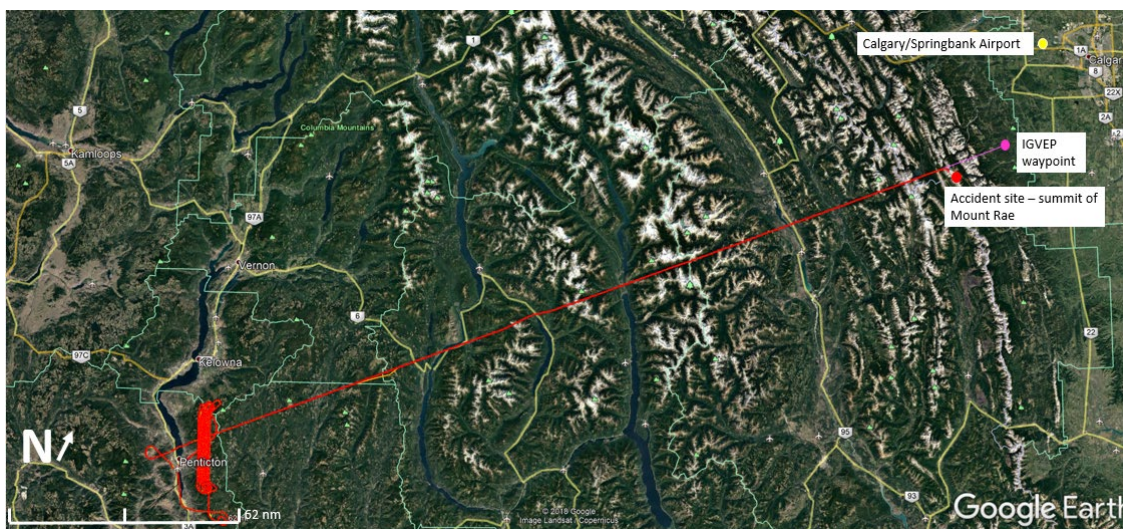
Figure 1. Occurrence aircraft's route of flight. Red line depicts aircraft track. (Source: Google Earth, with TSB annotations)
