Transportation
Safety Board
of Canada

MARINE TRANSPORTATION SAFETY INVESTIGATION REPORT M19C0054

STRIKING OF A MOORING DOLPHIN

Roll-on/roll-off ferry *Apollo*
Matane, Quebec
16 March 2019

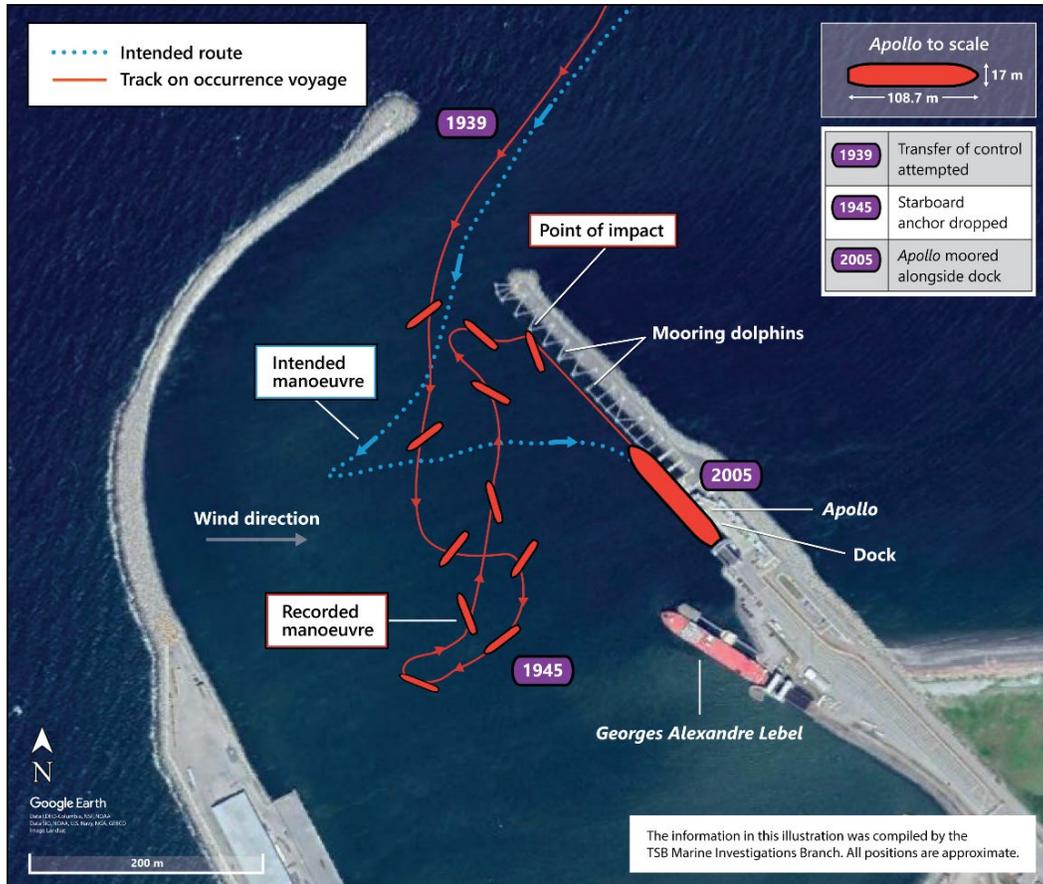
Figure 3. *Apollo*'s intended manoeuvre (dotted line) and recorded manoeuvre (solid line) on the occurrence voyage with time stamps (Source: Google Earth, with TSB annotations)

At approximately 1930, just before the vessel arrived in the port, the master communicated his intended docking manoeuvre to the bridge team. To mitigate the risk posed by the winds, the master had planned a docking manoeuvre that would make use of at least 1 anchor. He had the crew standing by to release 1 or both anchors if needed. The master intended to proceed into the port with the bow windward, drop the port anchor to create a pivot point if needed, and then back stern-first to the dock (Figure 3).

At approximately 1942, the master ordered the mooring team to drop the port anchor to create a pivot point for the vessel. Shortly after the anchor was dropped, the wind pushed the *Apollo* toward the rail ferry *Georges Alexandre Lebel*, which was moored nearby, bringing the stern of the *Apollo* to within 45 m of the rail ferry's bow (Figure 3). The master immediately ordered the mooring team to drop the starboard anchor to stop the *Apollo* from getting any closer. The starboard anchor was dropped at approximately 1945.

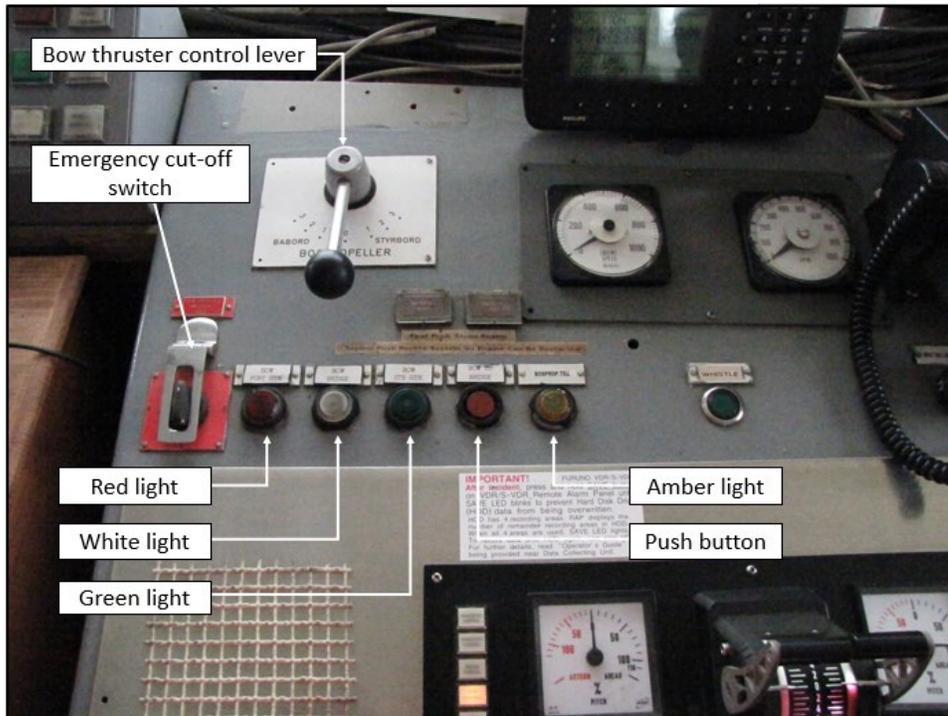
Figure 11. Bow thruster control layout on the bridge console (Source: TSB)

On the *Apollo*, the bridge console had 4 indicator lights (red, white, green, and amber) to provide the operator with information about the status of the bow thruster (Figure 11).

The red light, which was labelled “Bow Port Side,” indicated that the direction of thrust was to the port side. The green light, which was labelled “Bow Std Side,” indicated the direction of thrust was to the starboard side. The white light, which was labelled “Bow Bridge,” illuminated only in conjunction with the amber light, which was labelled “BogProp.Till,”⁸⁴ to indicate that control of the bow thruster was at the bridge console. When both the white and amber lights were illuminated, the brightness of both lights was reduced.

When control of the bow thruster was transferred to one of the bridge wing consoles, the white light would extinguish and the amber light would remain lit to indicate that control was at one of the bridge wing consoles, without specifying which one. The investigation determined that not all of the bridge crew were aware of what each of the bow thruster indicator lights on the bridge console signified.

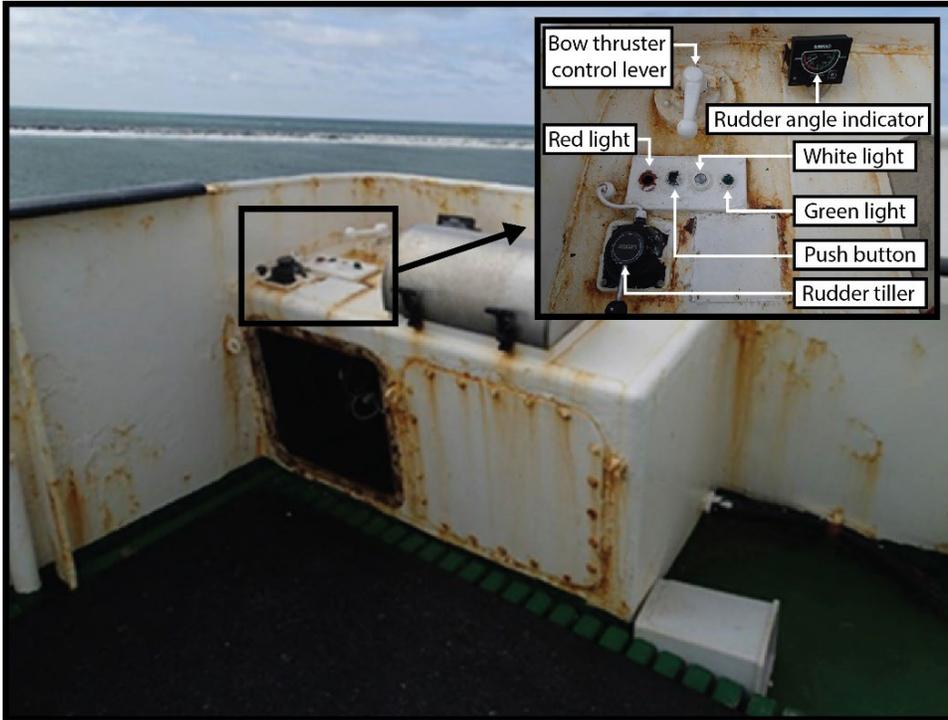
Figure 12. Port bridge wing console (Source: TSB)

The bridge wing consoles had equipment layouts and indicator lights that differed from the bridge console and from each other. The port bridge wing console had 3 unlabelled indicator lights (white, green, and red) (Figure 12). The red and green lights indicated direction of thrust to port and starboard, respectively. The white light indicated that the bow thruster was active at the port bridge wing console. The starboard bridge wing console had no indicator lights (Figure 13). During post-occurrence testing by the TSB, it was determined that none of the 3 lights on the port bridge wing console were operational.

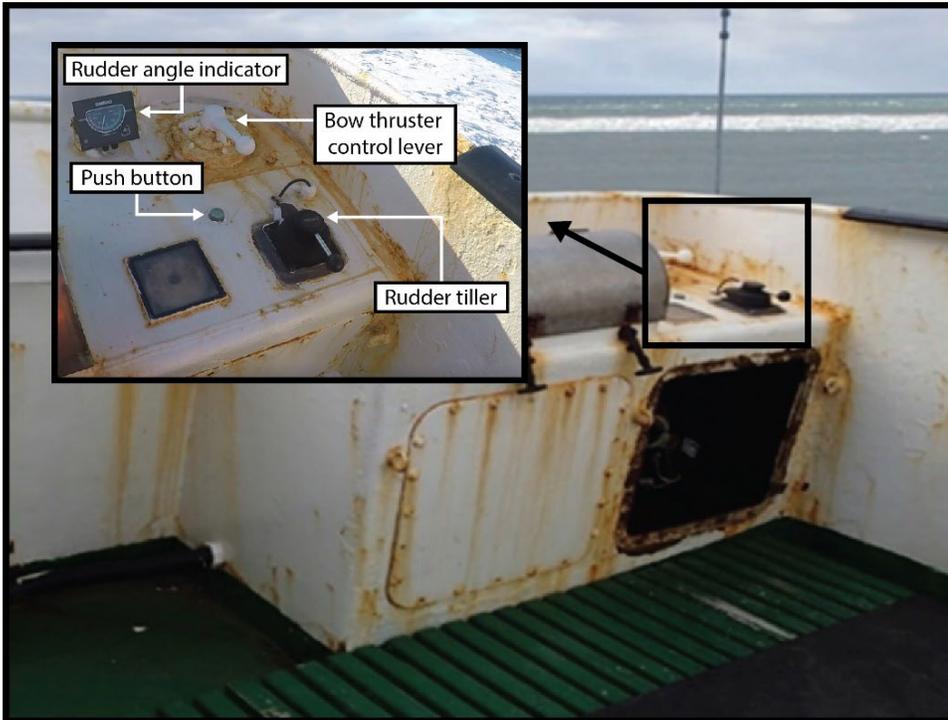
Figure 13. Starboard bridge wing console (Source: TSB)

wing console to indicate the bow thruster's operational status, but these lights were no longer present at the time of the occurrence (Figure 13).
