# RAIL TRANSPORTATION SAFETY INVESTIGATION REPORT R20D0088

## COLLISION BETWEEN A TRAIN AND A TRACK UNIT

VIA Rail Canada Inc. passenger train VIA 68 and  
STL 099285 hi-rail vehicle  
Mile 30.5, Canadian National Railway Company Kingston Subdivision  
Les Cèdres, Quebec  
06 December 2020

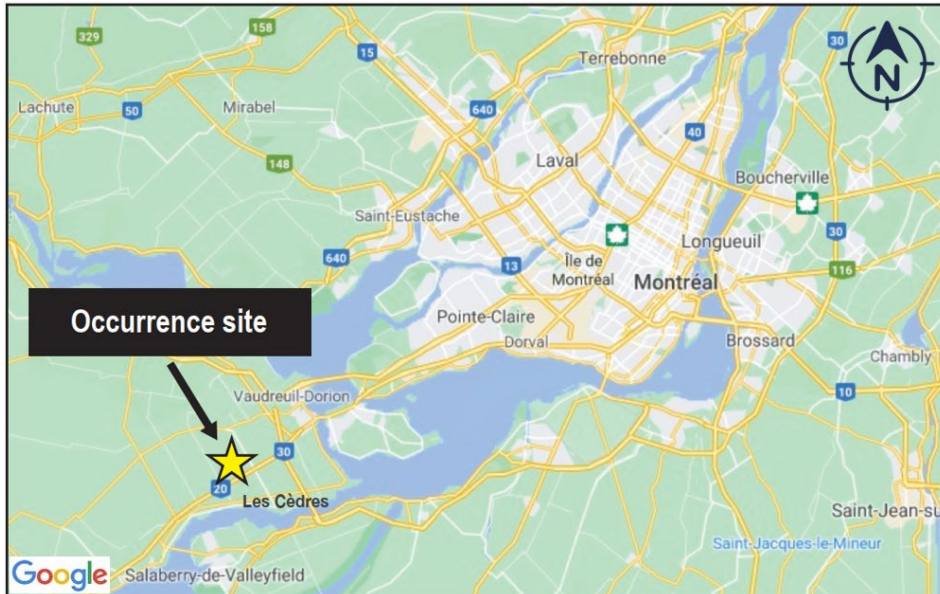
Figure 1. Occurrence site (Source: Google Maps, with TSB annotations)

At about 2132,<sup>1</sup> the train was travelling east at the authorized speed (95 mph) on the north main track of the Canadian National Railway Company (CN) Kingston Subdivision. As the train approached Mile 31, the 2 engineers on board the locomotive noticed a bright light in the distance. When the operating locomotive engineer realized that the light appeared to be coming from rolling stock on the same track as the train, he immediately initiated a full service air brake application and sounded the locomotive horn and bell. A few seconds later, the train, still traveling at nearly 83 mph, struck a pick-up truck type hi-rail track unit (STL 099285) at Mile 30.5, in the municipality of Les Cèdres, Quebec (Figure 1).

Following the impact, the operating locomotive engineer initiated an emergency brake application. The locomotive dragged the hi-rail track unit approximately 2500 feet before the train stopped. There were no injuries, and no fuel was spilled.
