RAIL TRANSPORTATION SAFETY INVESTIGATION REPORT R22T0045

UNCONTROLLED MOVEMENT AND DERAILMENT

Canadian Pacific Railway Company
Cut of cars
Mile 196.7, Belleville Subdivision
Toronto Yard
Toronto, Ontario
13 March 2022

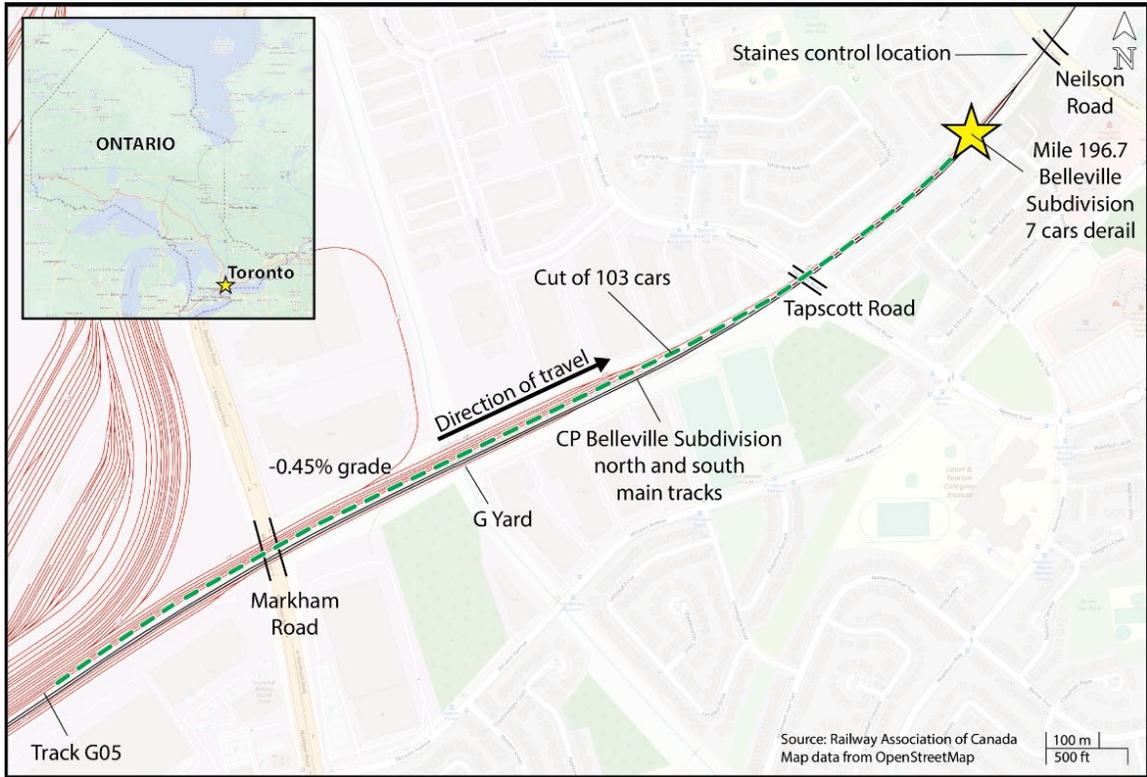
The cut of cars ran uncontrolled for approximately 3200 feet. The cars then encountered a split switch derail¹² at Mile 196.7 of the Belleville Subdivision and the leading 7 cars derailed (Figure 2).

Figure 2. Map showing track G05 in Toronto Yard and the point of derailment, with inset showing the location of Toronto, Ontario (Source: Railway Association of Canada, *Canadian Rail Atlas*, with TSB annotations)
