RAIL TRANSPORTATION SAFETY INVESTIGATION REPORT R24Q0089

MAIN-TRACK DERAILMENT

Quebec North Shore and Labrador Railway
Ore train BAL-481-F
Mile 25.4, Wacouna Subdivision
Near Saumon Station, Quebec
03 November 2024

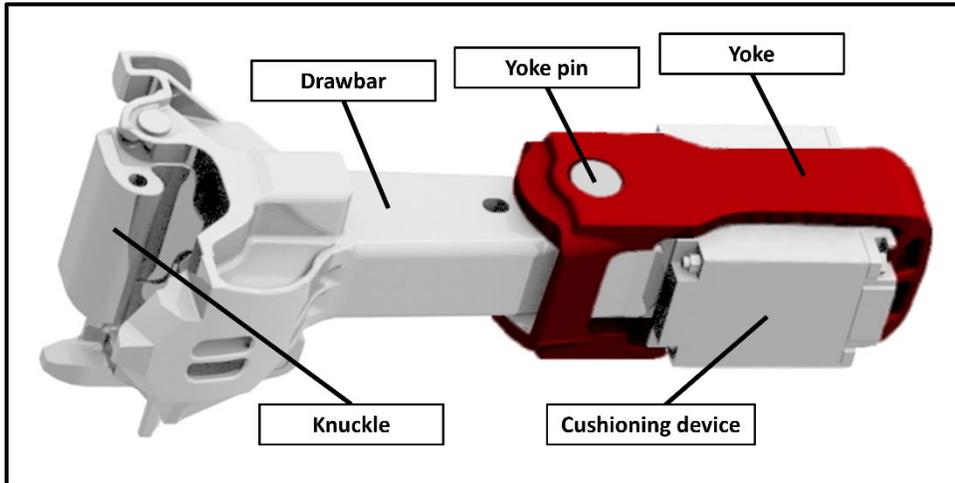
The coupler, a type F, is equipped with a drawbar attached to the yoke using a vertical yoke pin (Figure 7), which is held in place by a horizontal carrier plate (Figure 4).

Figure 7. Example of a type F coupler like the one on car IOCC 11431, showing the drawbar, yoke and yoke pin, knuckle, and cushioning device (Source: TSB)
