# AIR TRANSPORTATION SAFETY INVESTIGATION REPORT A23P0136

## LIGHTNING STRIKE AND LOSS OF CONTROL

Helijet International Inc.  
Sikorsky S-76C++ (helicopter), C-GXHJ  
Sidney, British Columbia, 10 NM NE  
24 October 2023

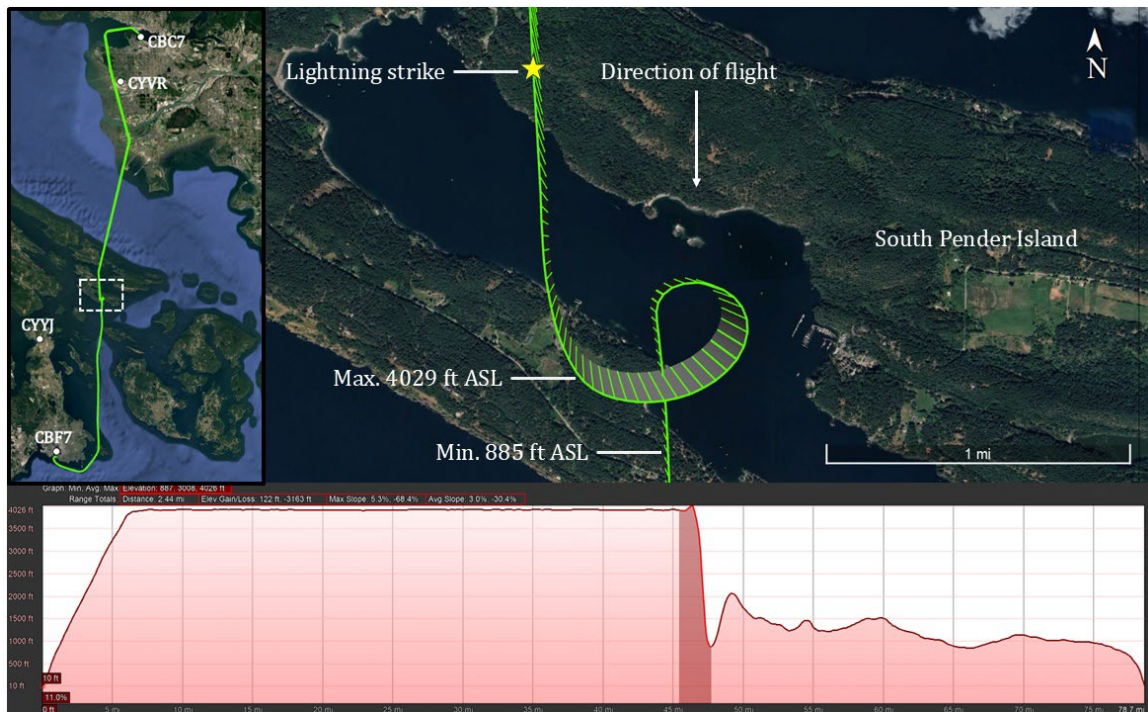
At 0930:21, the helicopter entered an uncontrolled rapid descent from 4029 feet to 885 feet ASL in 36 seconds, reaching a maximum of 63° left roll and 44° pitch down (Figure 1). As the helicopter emerged from the clouds, the captain regained visual reference to the ground and was able to reduce the helicopter's roll angle and stop the descent. The vertical acceleration peaked at 2.48g<sup>5</sup> before the helicopter climbed back up to 2073 feet ASL.

Figure 1. The complete occurrence flight path (inset) with the occurrence segment enlarged to indicate the location of the lightning strike and the maximum and minimum altitude above sea level (ASL). The graph at the bottom depicts the flight's level altitude followed after the lightning strike and subsequent flight pattern. (Source: Google Earth, with TSB annotations)

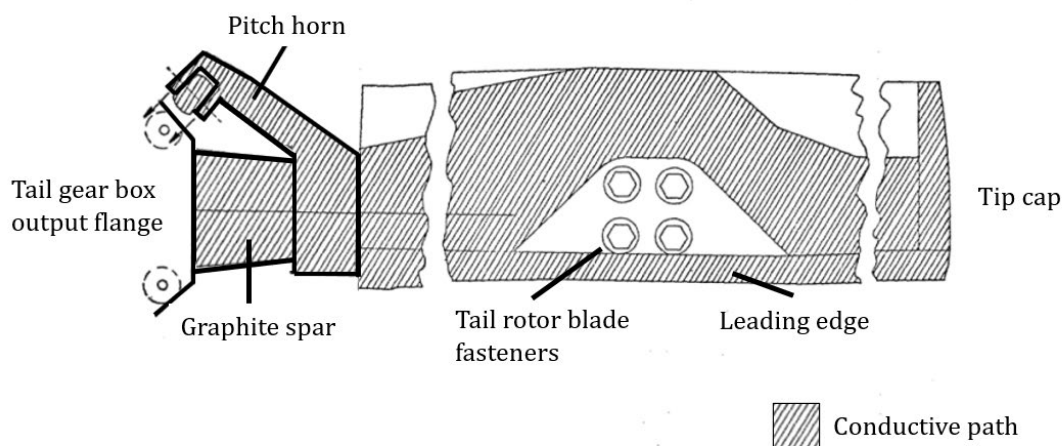
The tail rotor blades similarly use the aluminum wire fabric in the blade skin and tip cap to allow the lightning strike charge to transfer to the pitch horn and tail gear box output flange and onwards to the tail gear box and fuselage. To prevent damage to the graphite spar, the fabric remains separated from the tail rotor blade fasteners that attach the spar to the blade and an insulating cover is applied over the blade fasteners (Figure 5). The inboard section of the spar is also protected with an aluminum wire fabric coating that transfers any flashover from the blade root to the output flange.<sup>13</sup>

Figure 5. Sikorsky S-76 tail rotor blade showing the conductive path from the tip cap to the tail gear box output flange using the combination of the aluminum wire fabric, pitch horn, and graphite spar (Source: Sikorsky Aircraft Corporation, *Lightning Protection for the S-76 Helicopter*, with TSB annotations)

The manufacturer conducted lightning protection testing on 3 tail rotor blade assemblies using the 200 kA peak current amplitude specification set by the U.S. Department of Defense<sup>14</sup> and the Society of Automotive Engineers (SAE).<sup>15</sup> The separate assemblies each consisted of a single tail rotor blade and spar that was attached to an off-aircraft tail gear box output flange, outboard retaining plate, pitch change beam, and a pitch control rod.<sup>16</sup> Following the simulated lightning strike, the manufacturer conducted static load tests and analyzed the aerodynamic effects on the blade assembly that had sustained the most damage. It was concluded that the assembly can survive a severe lightning strike and maintain operational capability.<sup>17</sup>

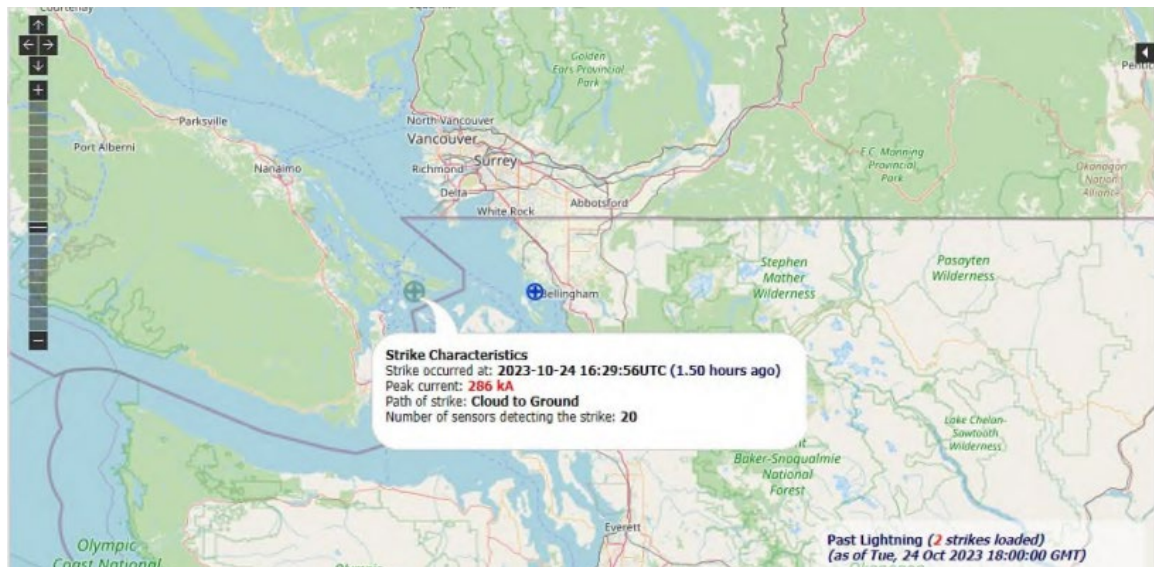
The strike detected by the CLDN at 0929:56 over South Pender Island struck the occurrence helicopter while it was cruising at approximately 3930 feet ASL. The strike was recorded with a peak current of 286 kA that had a maximum rate-of-rise<sup>28</sup> of 161.5 kA per microsecond (Figure 6).

Figure 6. Canadian Lightning Detection Network real-time lightning parameters showing the characteristics of the lightning strike at 0929:56 Pacific Daylight Time over South Pender Island (Source: Canadian Lightning Detection Network of Environment and Climate Change Canada)

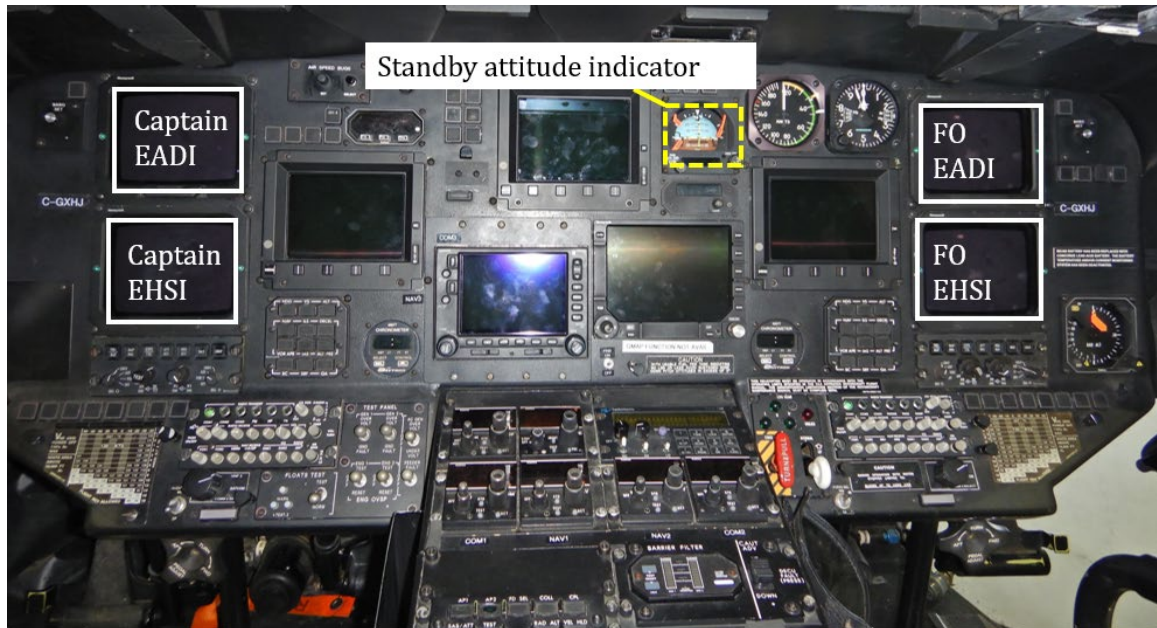
Figure 7. The occurrence helicopter instrument panel highlighting how the smaller size and central location of the standby attitude indicator differ from the larger electronic attitude direction indicator (EADI) and electronic horizontal situation indicator (EHSI) displays that are directly in front of the captain and first officer (FO) (Source: TSB)

The occurrence flight was in IMC and the flight crew relied on the EADI for situational awareness of the helicopter position and the EHSI to navigate to the destination. At the moment of the lightning strike, all electronic displays momentarily went black and did not provide any information. The standby instruments remained operational.

All electronic displays recovered quickly, but the air data computer (ADC) for the right side of the cockpit had failed and the related flight information was no longer valid on those displays. As a result, the FO was reliant on the standby instrumentation for continued flight in IMC until the captain took control.
